Incident Summary #II-793734-2019 (#10404) (FINAL)

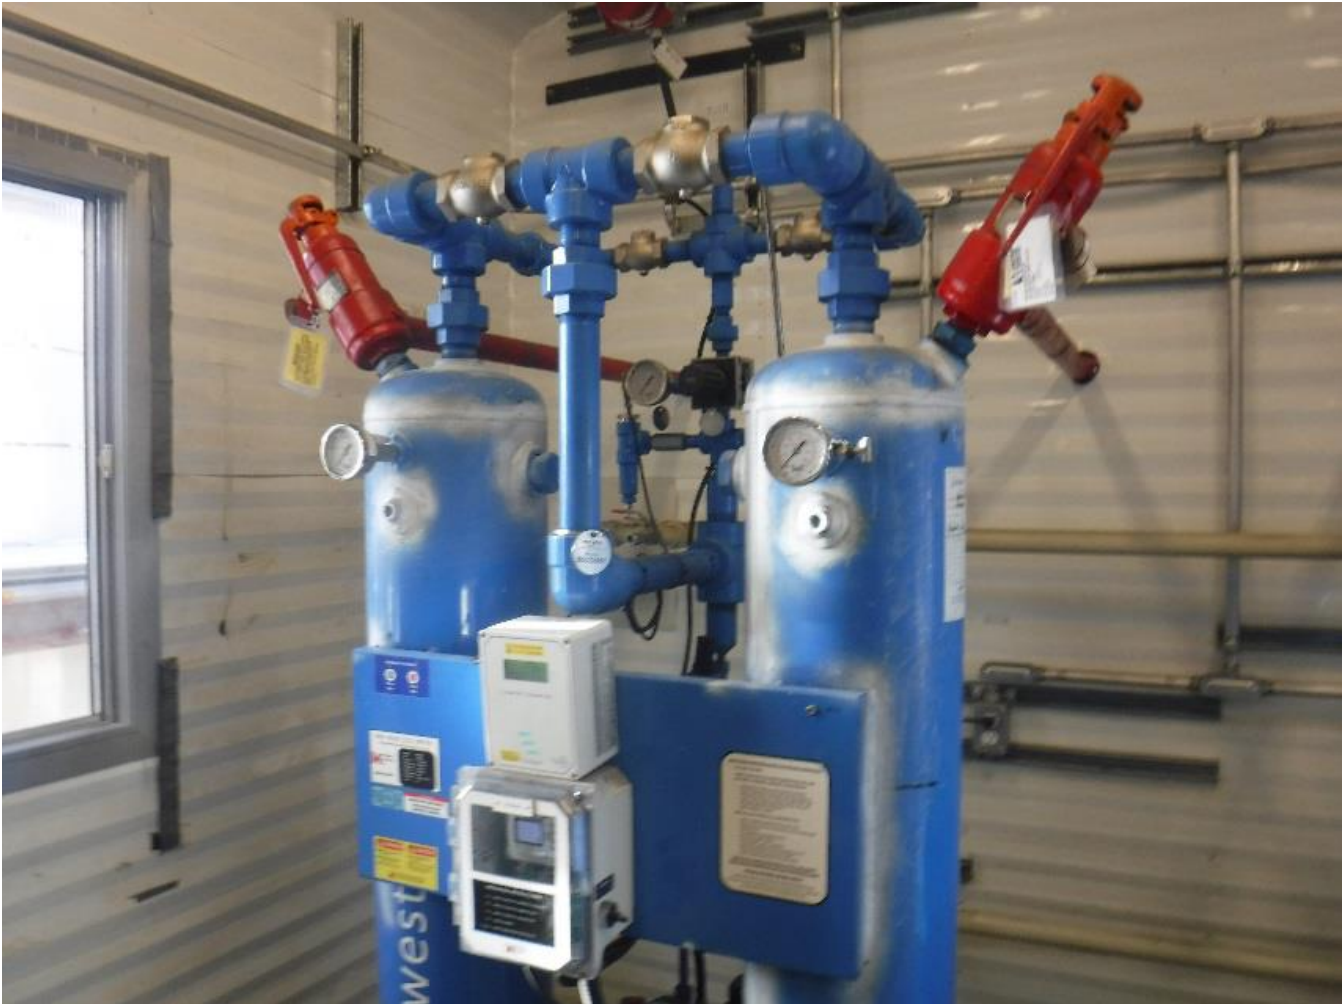
Air dryer overview.

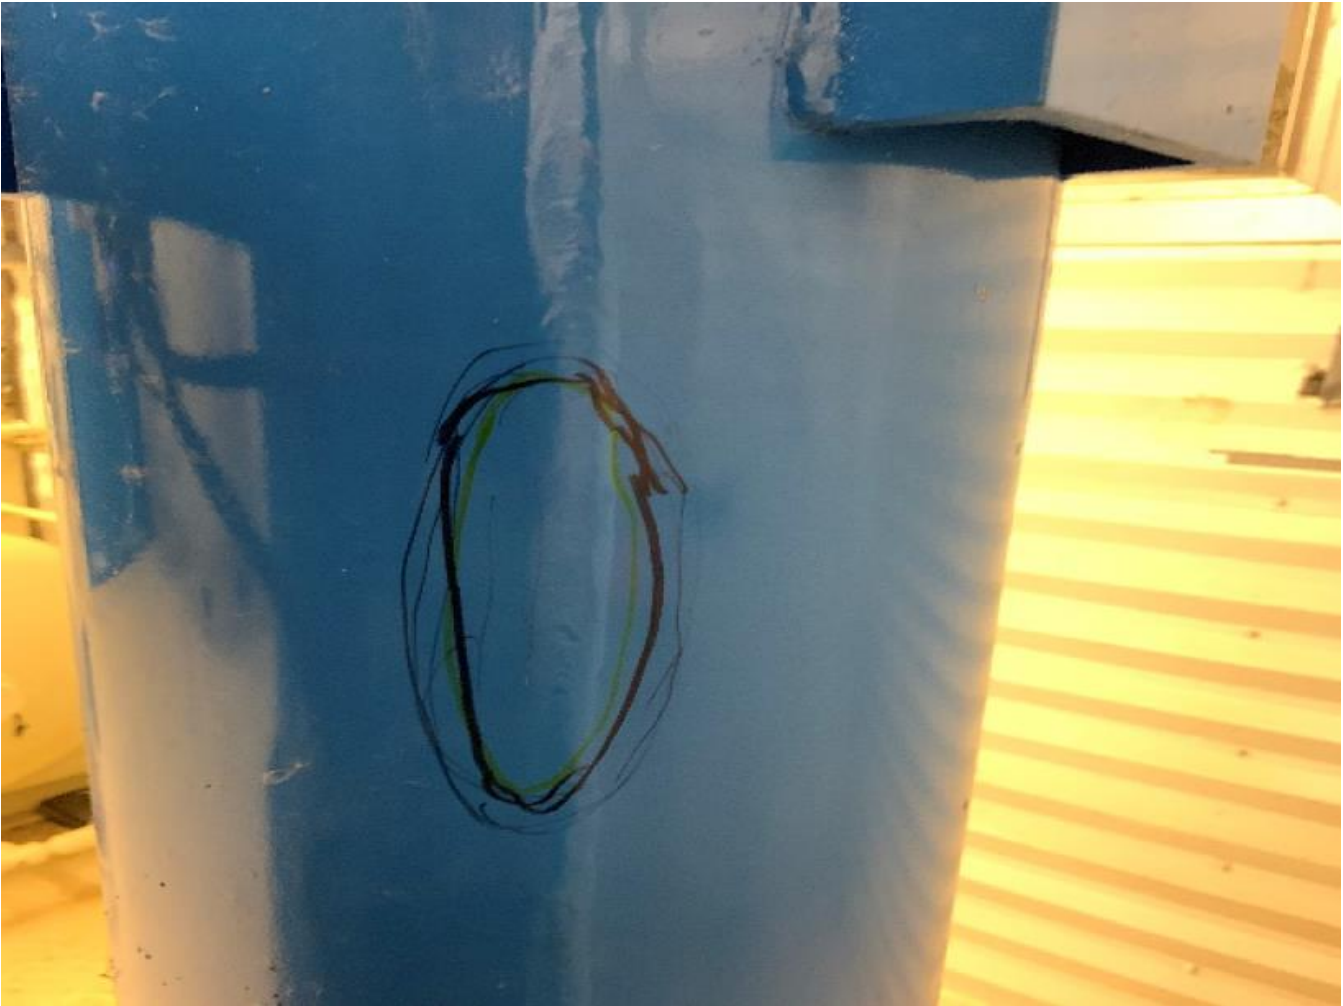
SUPPORTING INFORMATION	Incident Date	December 21, 2018	
	Location	Near Dawson Creek	
	Regulated industry sector	Boilers, PV & refrigeration - Boiler and pressure vessel system	
	Impact	Qty injuries	0
		Injury description	None
		Injury rating	None
	Damage	Damage description	A crack occurred along the vertical weld seam.
		Damage rating	Moderate
	Incident rating	Moderate	
Incident overview	An air dryer pressure vessel developed a crack along the vertical weld seam during operation and released compressed air.		
INVESTIGATION CONCLUSIONS	Site, system and components	The vessel and weld seams contain compressed air during normal operations.	
	Failure scenario(s)	Lack of fusion of weld seam to vessel shell material.	
	Facts and evidence	Radiographic testing indicated that there was a lack of fusion along a portion of the vertical weld seam.	
	Causes and contributing factors	It is plausible that lack of fusion of the weld to the vessel material contributed to the failure of the weld seam.

Area of crack along vertical weld seam.
