Incident Summary #II-671306-2018 (#6615) (FINAL)

SUPPORTING INFORMATION	Incident Date	April 3, 2018	
	Location	Tumbler Ridge	
	Regulated industry sector	Elevating devices - Construction / personal hoist/ man lift	
	Impact	Qty injuries	0
		Injury description	None
		Injury rating	None
	Damage	Damage description	Door for the lift was damaged
		Damage rating	Minor
Incident rating	Minor		
Incident overview	A wind turbine technician rode the lift to top platform, upon arrival they opened the doors to exit lift. The lift then started to descend. A door was damaged then broke off as the lift continued to descend at a slower than normal rate of travel.		
INVESTIGATION CONCLUSIONS	Site, system and components	<p>Wind turbine lifts can be used for personnel or equipment transport within the tower.</p> <p>The lift is equipped with a safety system that must be reset in order to operate it. The technician operates the lift with a constant pressure switch within the lift. A constant pressure switch allows the lift to be energized when the switch is engaged but once the technician removes pressure from the switch, energy will no longer be supplied to the lift and therefore the lift will not be abl

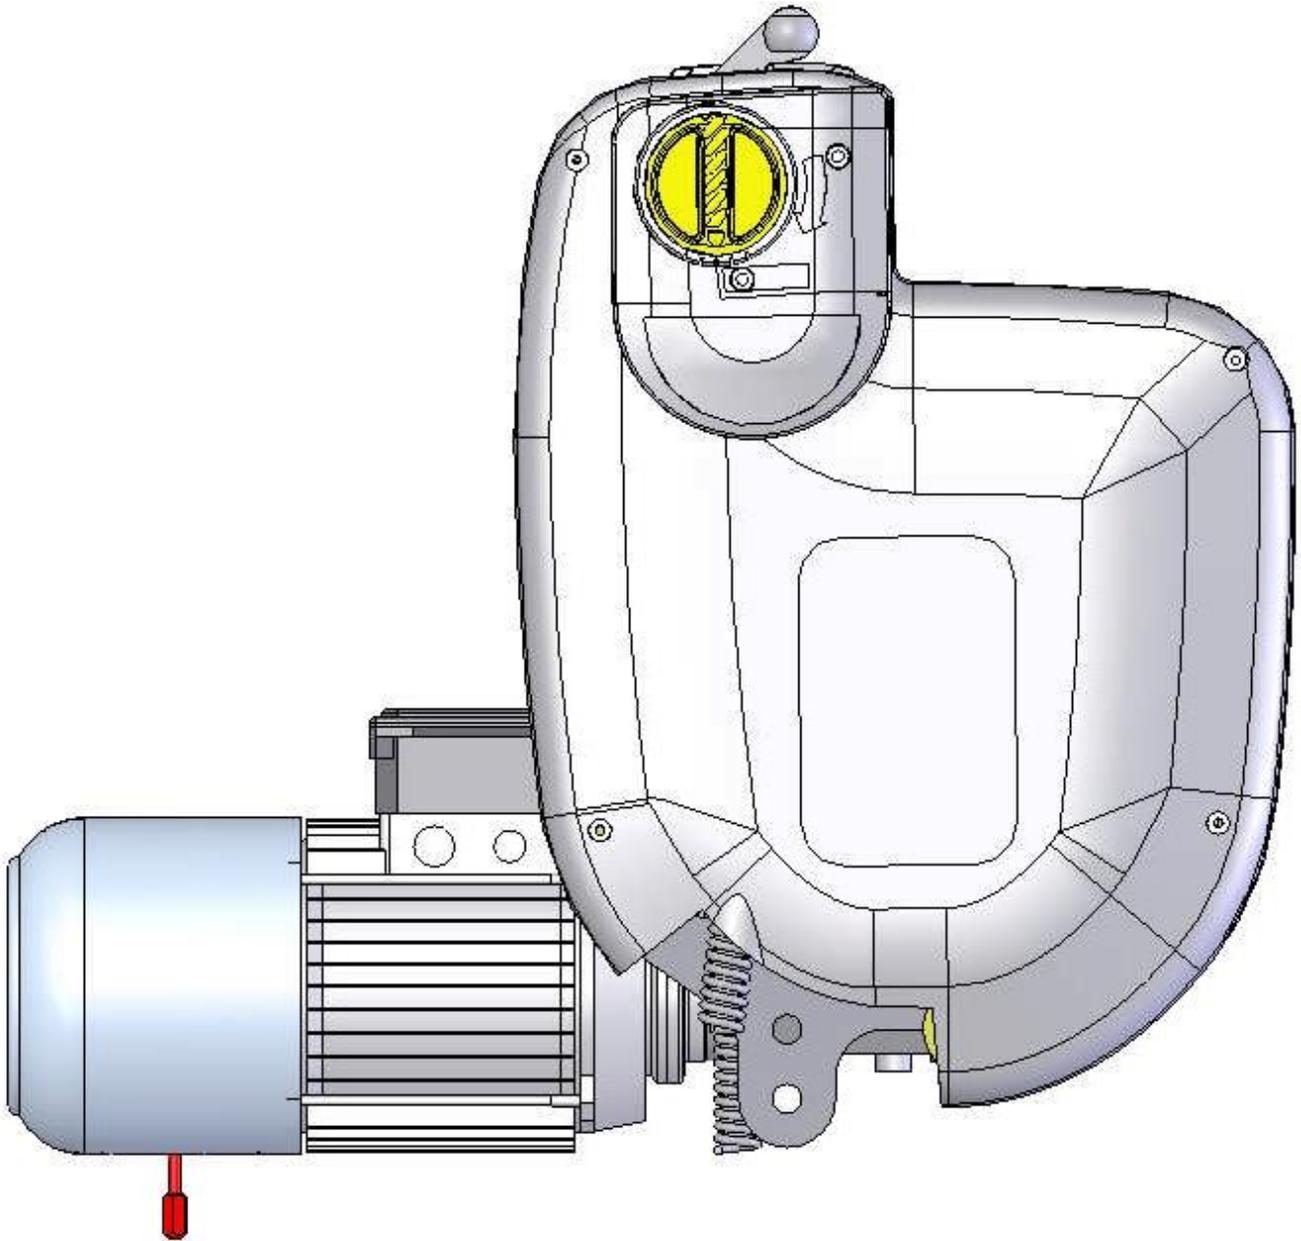
Failure scenario(s)	The electro-magnetic service brake was out of adjustment, therefore unable to hold the weight of the lift and passenger at the top landing.	
	Facts and evidence	<p><u>As Reported by the Technician:</u></p> <ul style="list-style-type: none"> - Completed all tests required by the <i>Turbine Service Lift Daily Inspection log</i> without issue - 1 Technician and gear totaled 125 kg of the lifts 240 kg capacity - Technician rode the lift to the top platform - At the top platform the technician opened the doors and prepared to exit the lift - The lift began to slowly descend prior to the technician exiting

Electric motor and traction hoist, red lever to release electro-magnetic brake for controlled descent

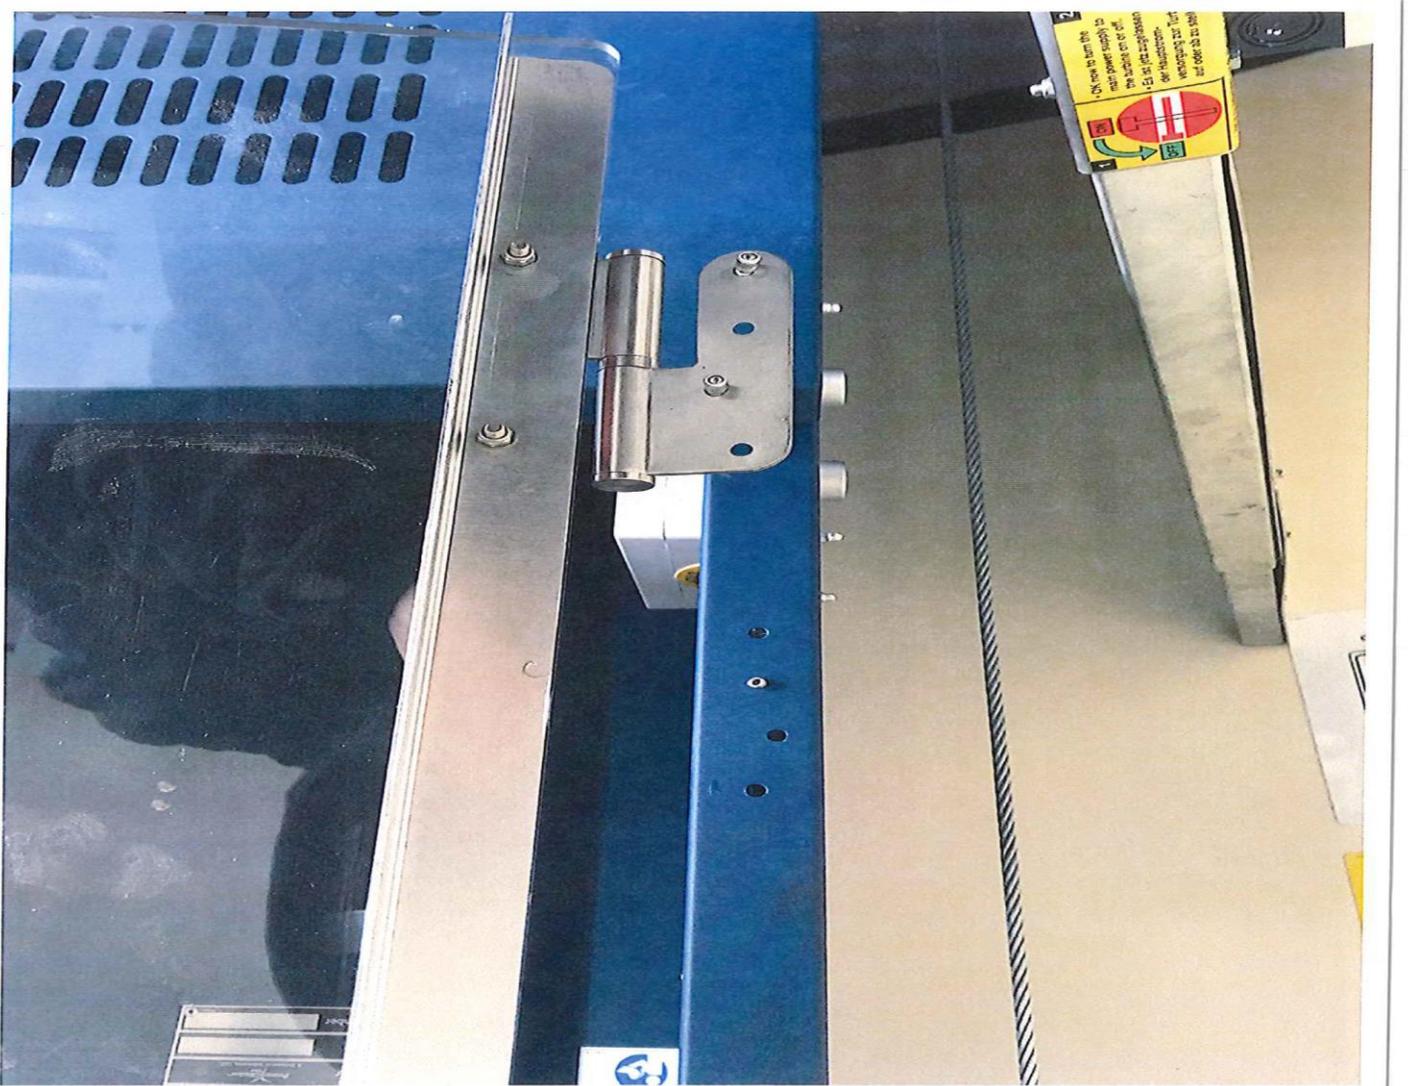
<ul style="list-style-type: none"> - The technician tried to close the doors but one became jammed, the technician tried to ascend the lift with the manual controls but the system would not allow it to move with the doors open. - One door broke off at the hinges, the technician was then able to close the remaining door, get a reset on the safety system and make the lift ascend to the top platform. - The lift again descended when stopped at the top platform - The technician discovered that they could manually stop the descending lift by manipulating the manual lever for the electro-magnetic brake. <p><u>As Reported by Maintenance Contractor:</u></p> <ul style="list-style-type: none"> - They installed and maintained the lift since 2012 - 3 set screws which maintain the 0.008" brake gap brake specific tolerances had come loose - The added weight of the power supply cable made the lift descend while at the top of the tower and not while performing the daily test at the bottom of the tower where the cable weight is minimal, approximately 40 kg difference. - They were unable to produce documentation of the brake gap adjustment being verified and maintenance performed on the lift. <p><u>As Reported by Manufacturer:</u></p> <ul style="list-style-type: none"> - During the installation of all lifts on site in 2012 it was discovered that a batch of the electro-magnetic brakes were shipped without the proper brake settings - The installation contractor was trained on how to properly set and check brake adjustments during the installation in 2012 - After the incident, the lift was inspected and tested with the correct brake adjustments at the factory and operated correctly - Root Cause Analysis is that the electro-magnetic brake was not set properly by the original installation and maintenance contractor

Broken off door at hinges

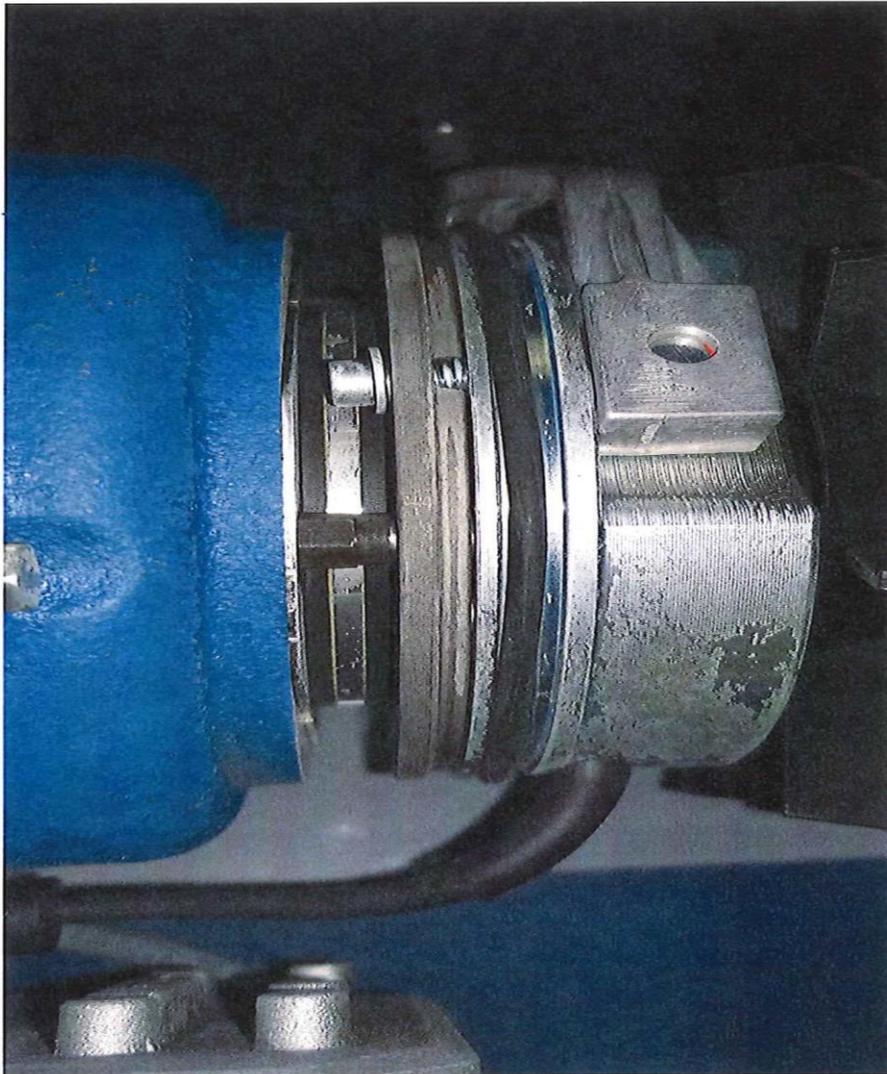
<p>Causes and contributing factors</p>	<p>It is likely that the original installation and maintenance contractor did not ensure the electro-magnetic brake on the lift was properly set, causing the setscrews that maintain specific brake tolerances to become loose and the wind turbine lift to slowly descend from the top platform.</p>

Loose set screw for retaining brake gap adjustment
