Incident Summary #II-1002951-2020 (#16990) (FINAL)

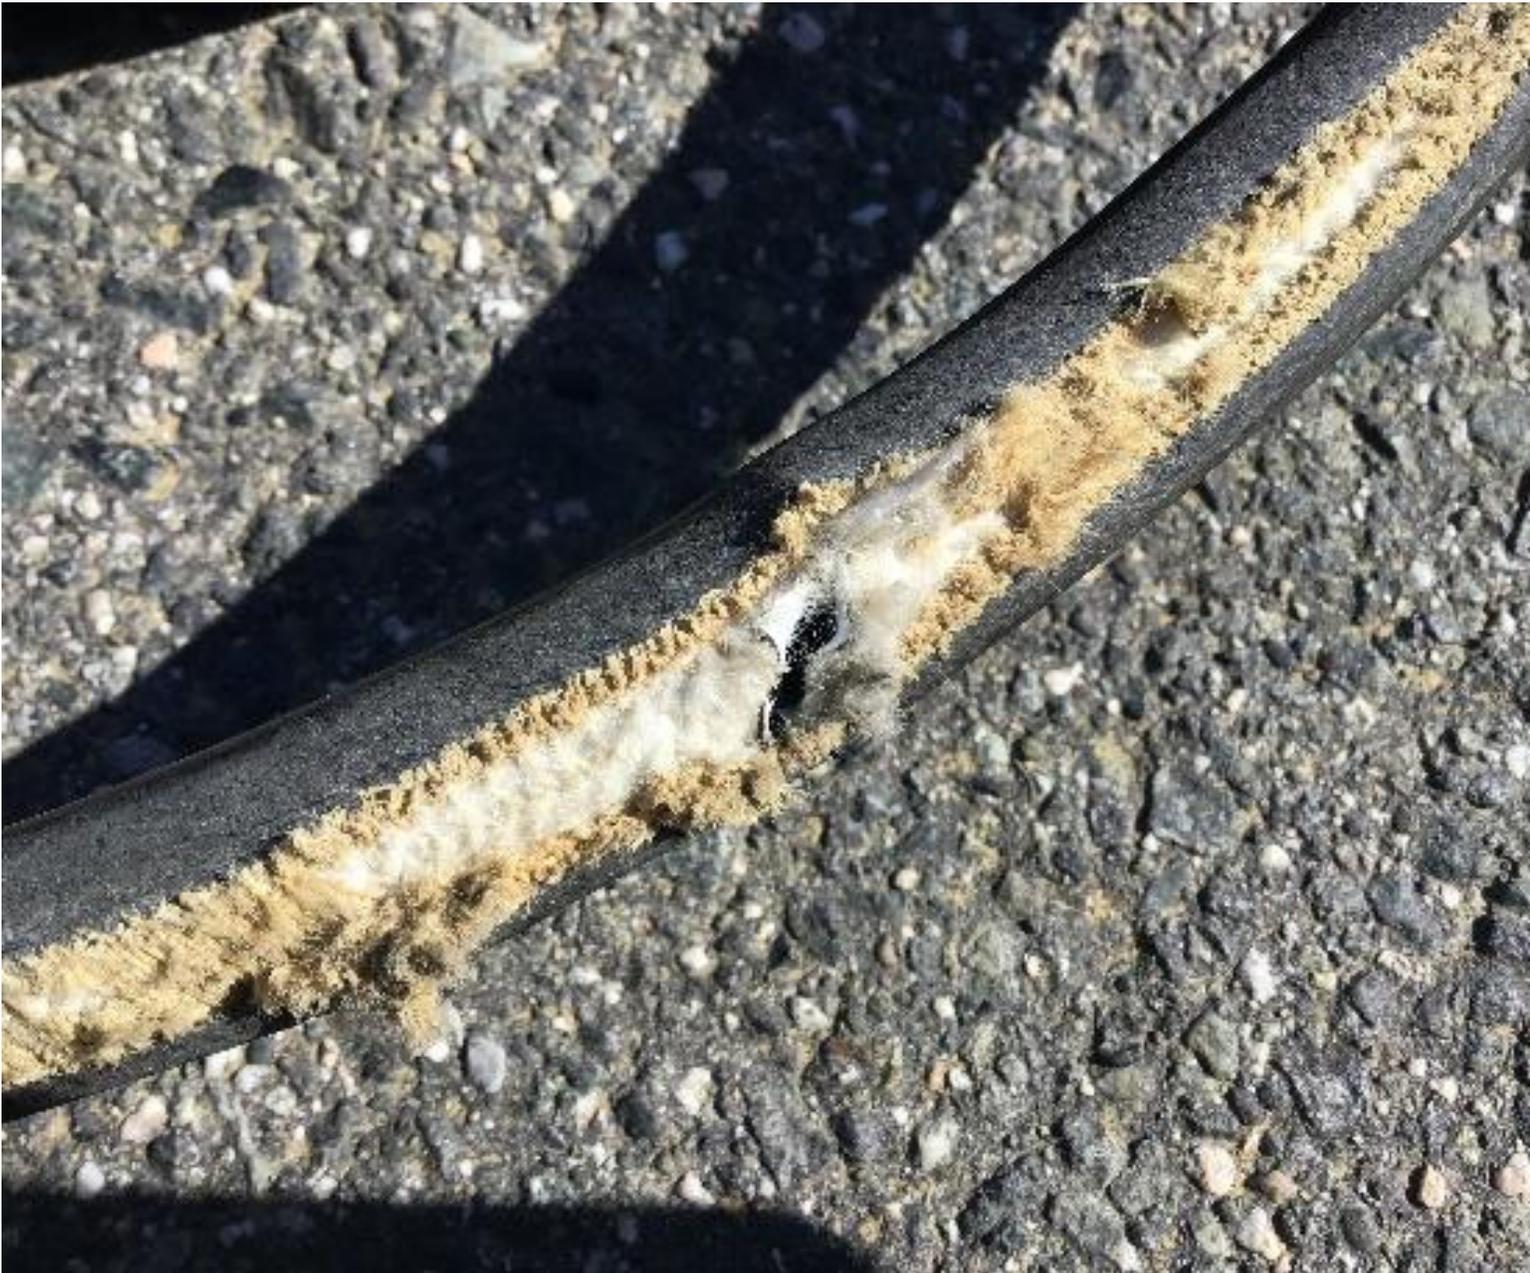
Failure scenario(s)	Damage from mechanical contact on outer jacket and reinforcing fibers in the filling hose may have caused a weak spot that was unable to contain the residual pressure in the hose .	
	Facts and evidence	Filler hose shows extensive abrasion damage to outer jacket and braided fibre reinforcement mesh (Mechanical damage).	
	Causes and contributing factors	It's Possible that interaction between hose and vehicle (pinch point) that could have trapped the filler hose against the sharp edge of baseplate on protection post.

Damaged Filler hose

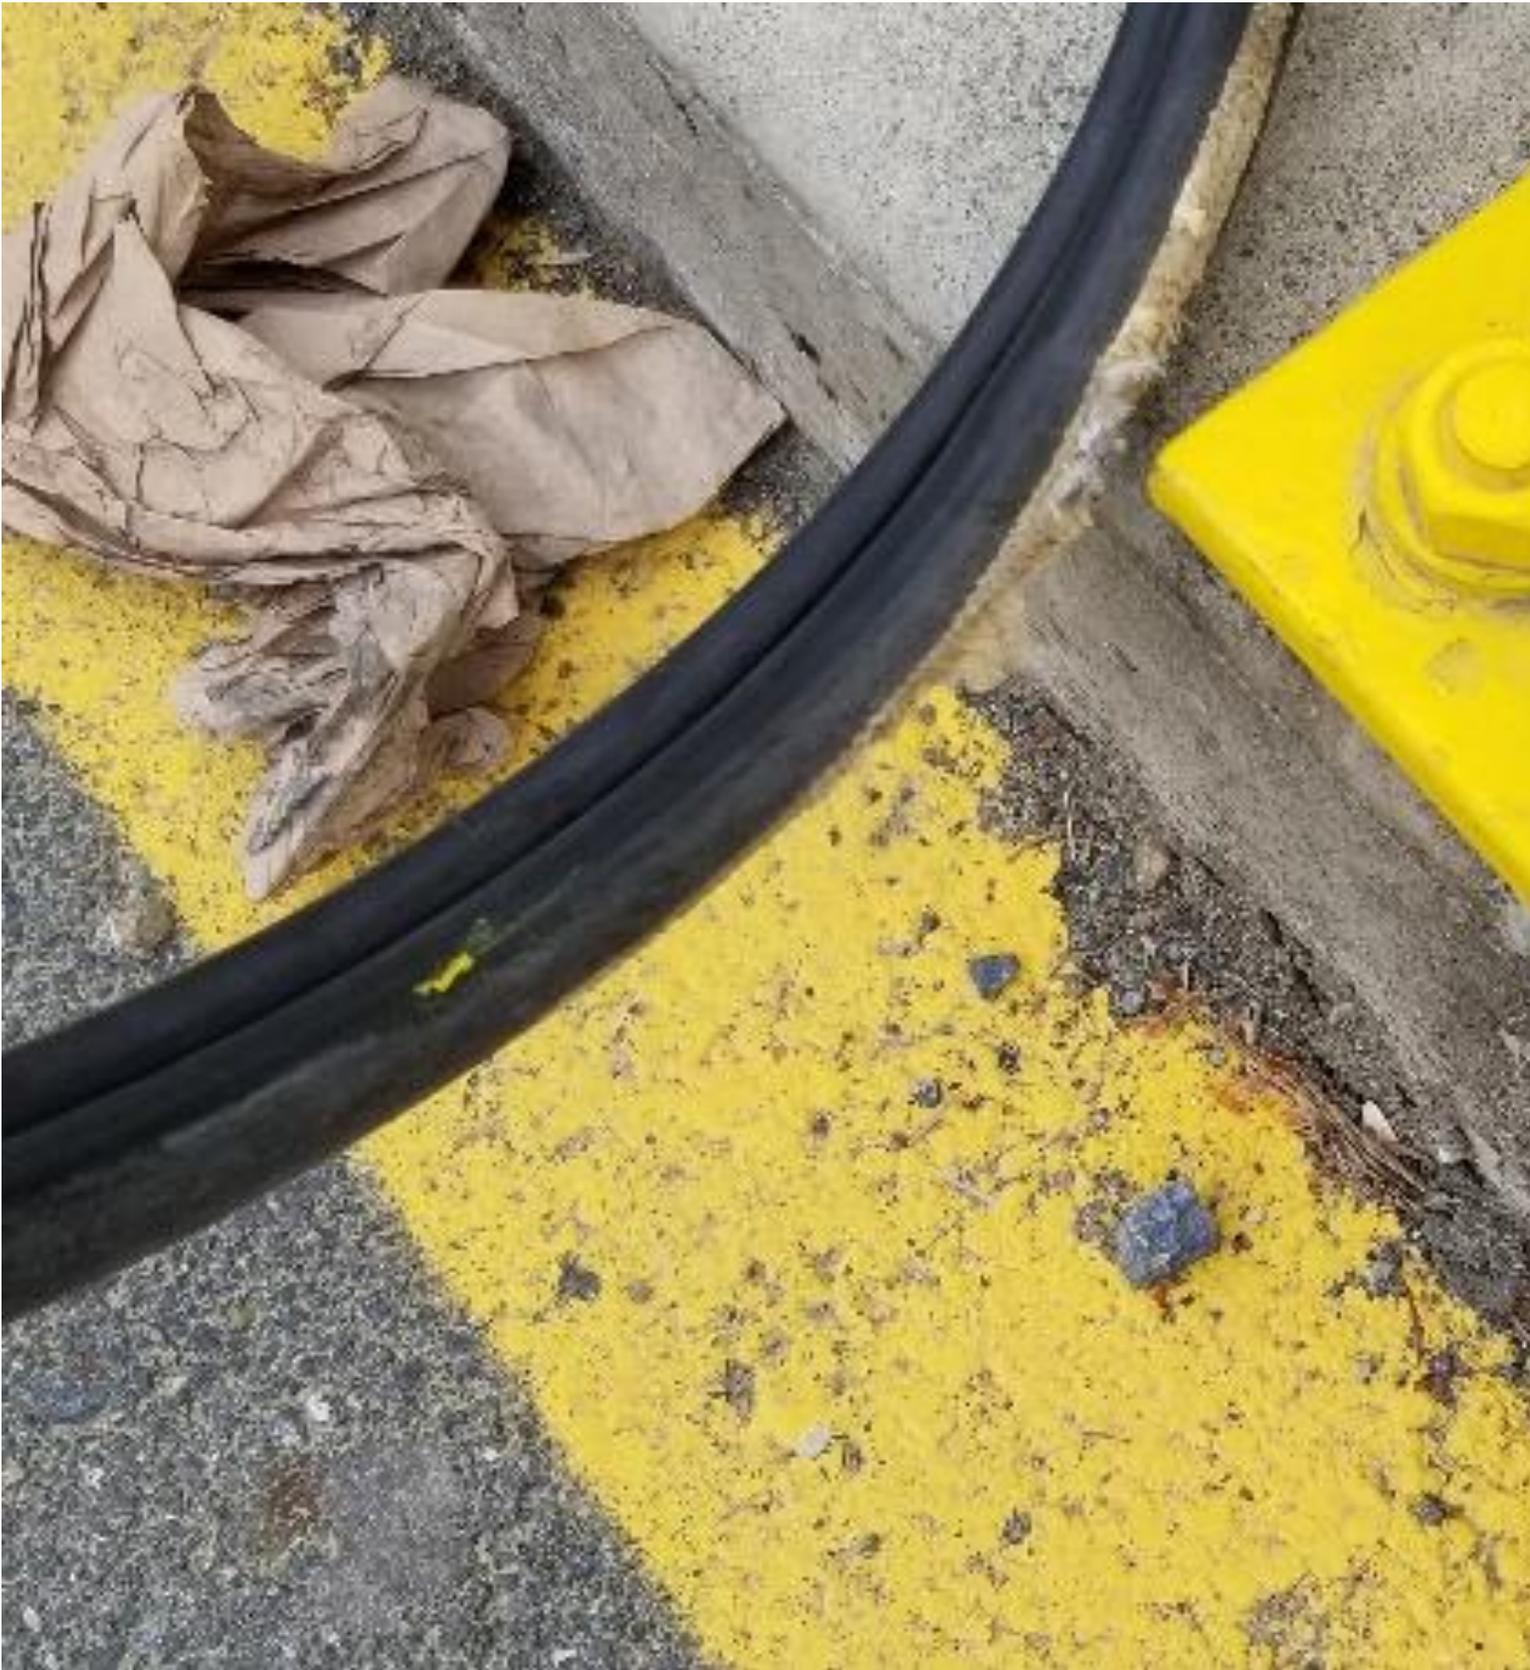
Sharp edge on protection post baseplate.

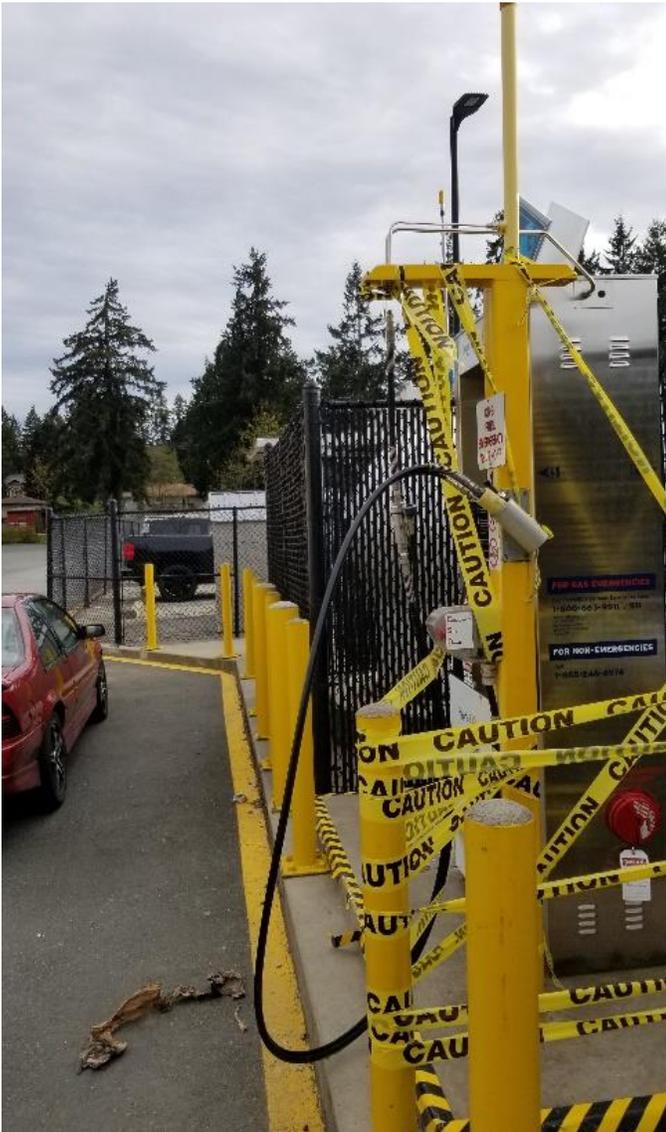
Dispenser showing hose orientation.
