Incident Summary #II-992054-2020 (#16837) (FINAL)

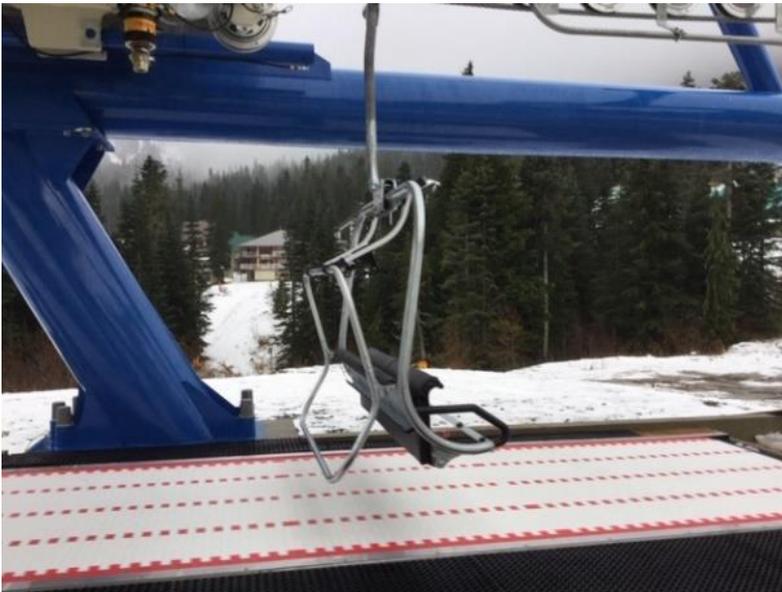
Chairlift loading area with carrier in place. Restraining bar is in the up position.

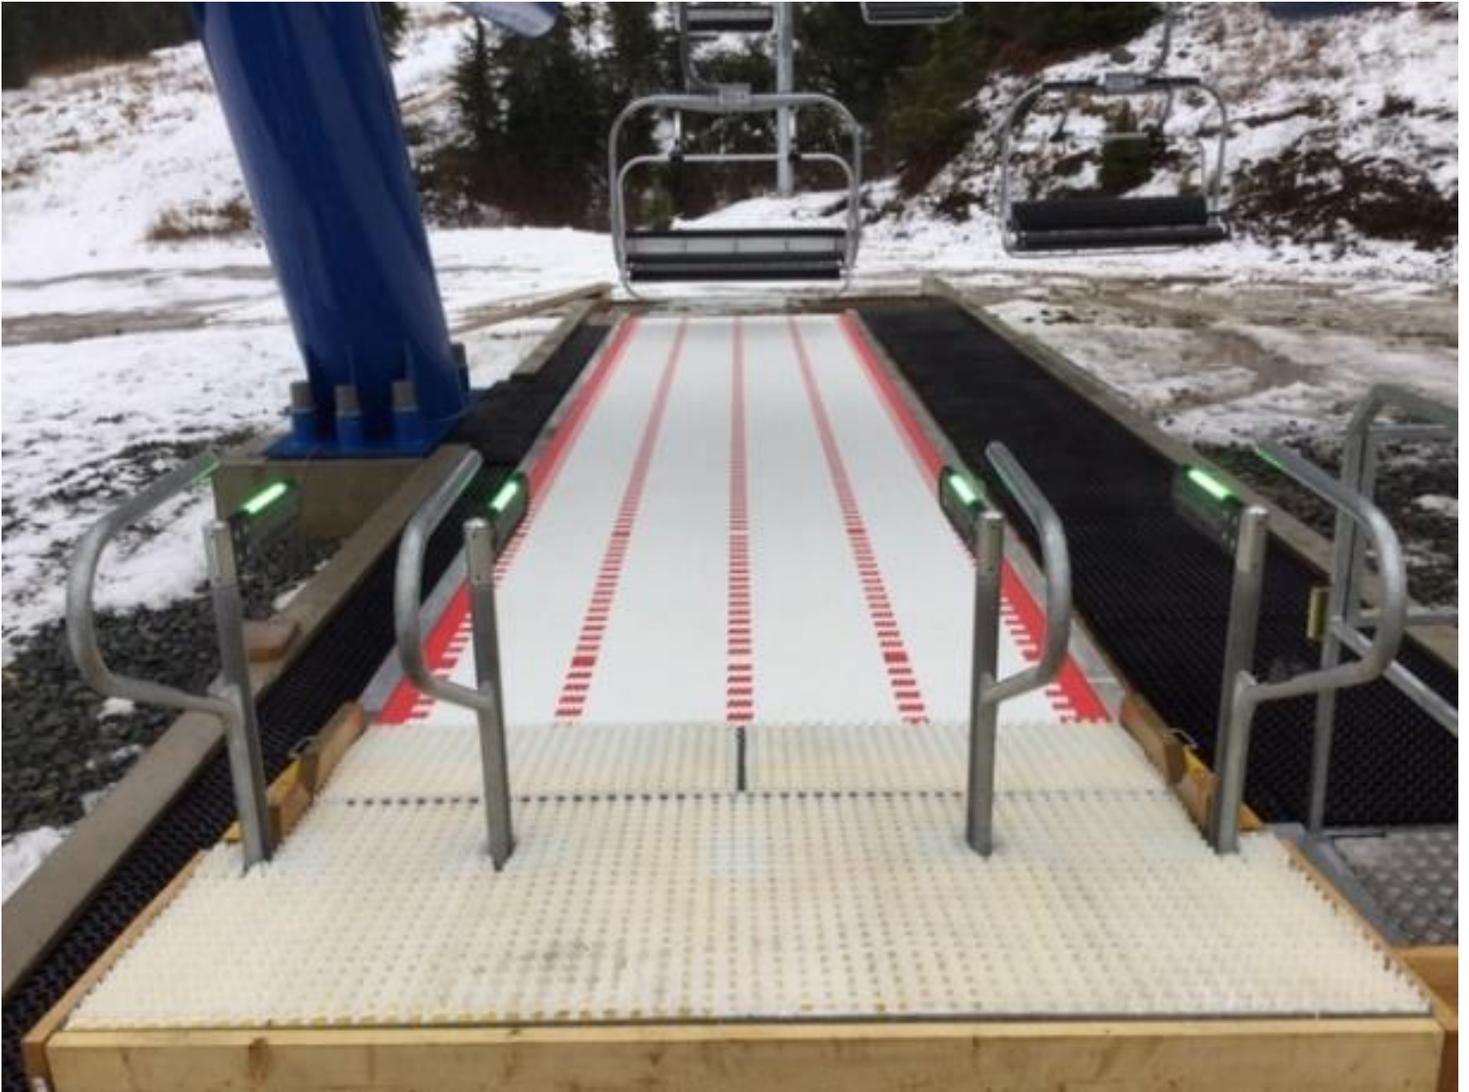
Chairlift carrier leaving loading area. At this point, restraining bar should be in the down position or close to the down position.
