Incident Summary #II-957403-2019 (#16160) (FINAL)

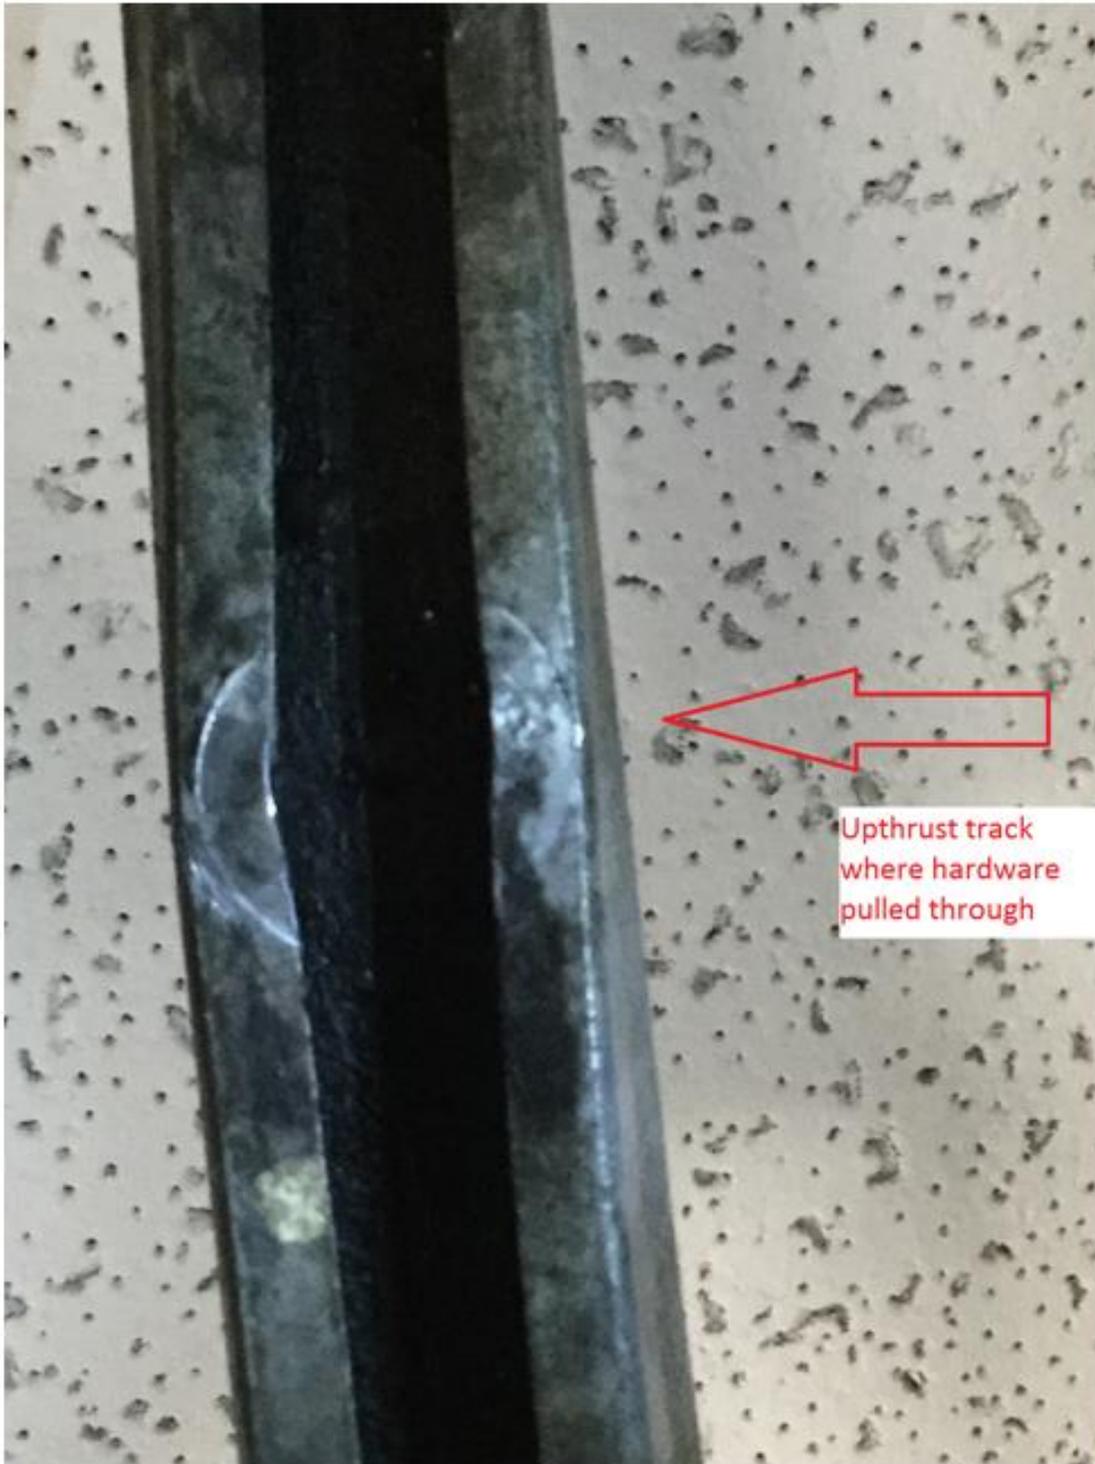
Upthrust track
where hardware
pulled through
