## Incident Summary #II-968894-2020 (#16376) (FINAL)

SUPPORTING INFORMATION	Incident Date	January 12, 2020	
	Location	Vancouver	
	Regulated industry sector	Elevating devices - Escalator or moving walkway	
	Impact	Qty injuries	1
		Injury description	Bruised toe
		Injury rating	Minor
	Damage	Damage description	Shoe got caught in between the step and skirt panel halfway up the escalator
		Damage rating	None
	Incident rating	Insignificant	
Incident overview	A person riding half way up the escalator had their shoe caught between the moving step and the skirt panel.		
INVESTIGATION CONCLUSIONS	Site, system and components	An escalator is a moving staircase which carries people between floors of a building. It has metal steps that have stationary vertical skirt panels on either sides of the metal steps. The gap between the metal steps and skirt panels are regulated by the CSA B44-07 code to prevent objects from being caught in between the moving steps and stationary skirt panels. The skirt panels have a coating that reduces the friction of the panel which helps objects glide off the skirt panel instead of being caught in between.

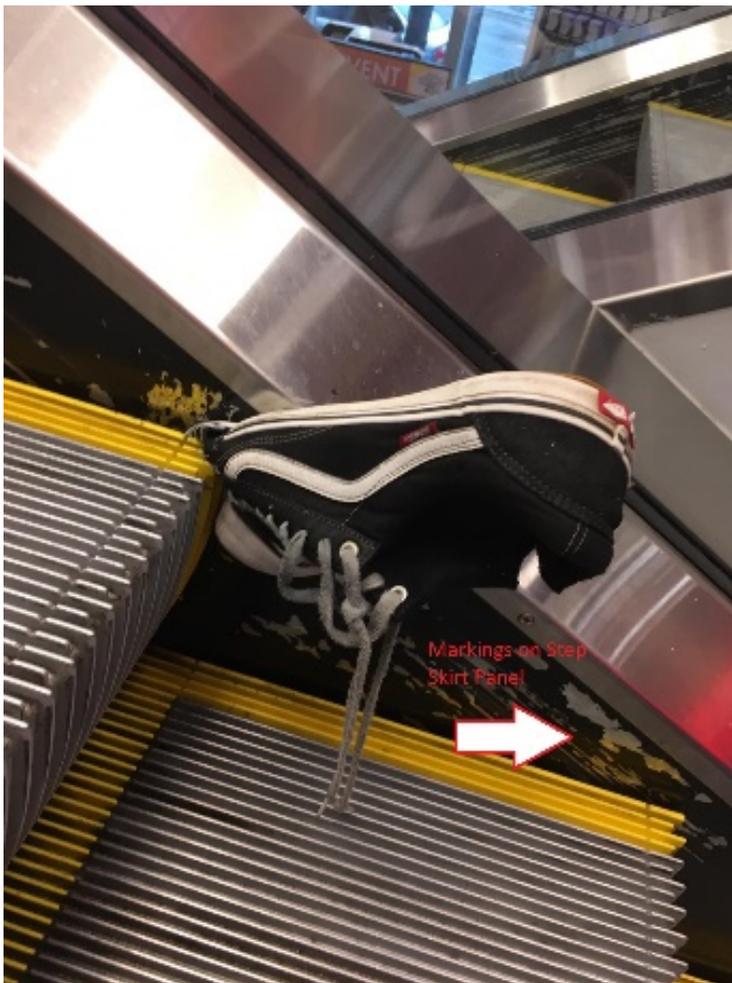
<ul style="list-style-type: none"><li>- Photo showing worn skirt panels which increase coefficient of friction beyond code requirements (pictures 1 &amp; 2)</li><li>- Safety Officer received an email from the maintenance contractor later that afternoon stating that the gaps were reduced to what is allowed by the code</li><li>- Safety Officer returned to site and confirmed that the gaps were code compliant and gave the maintenance contractor permission to release the unit back service.</li></ul>
Causes and contributing factors	It is highly likely that due to the persons footwear dragging against the escalator step skirt which was noted as not being compliant with the B44 code in respect to the permissible gap between the step and the skirt and the increased coefficient of friction due to the worn skirt panels, the person's footwear became pinched between the escalator and the skirt panel.

Picture 1 - Shoe caught between step and step skirt panel

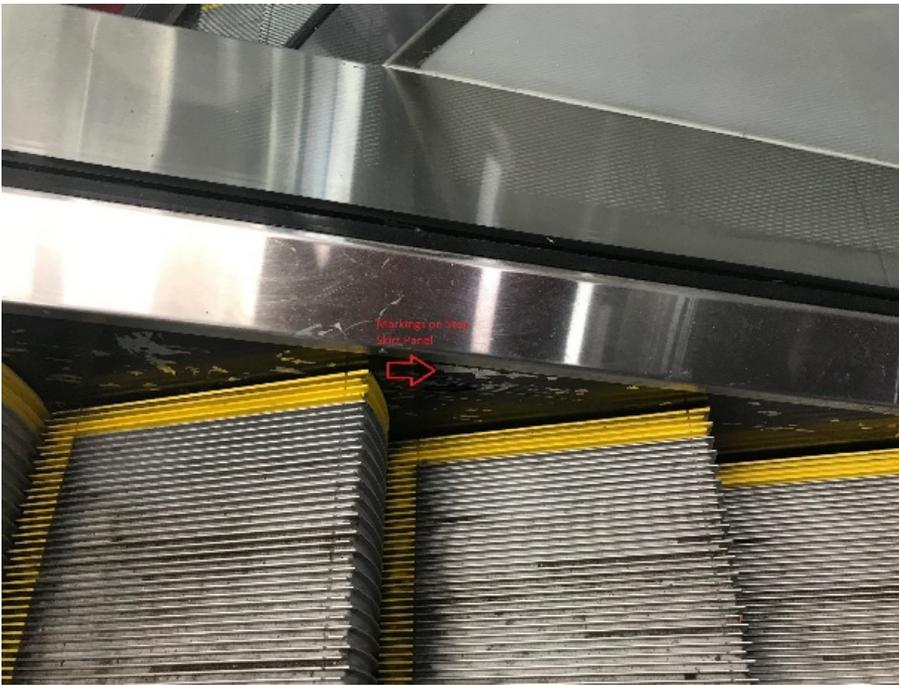
Picture 2 - Step skirt panel without shoe with markings on skirt panel

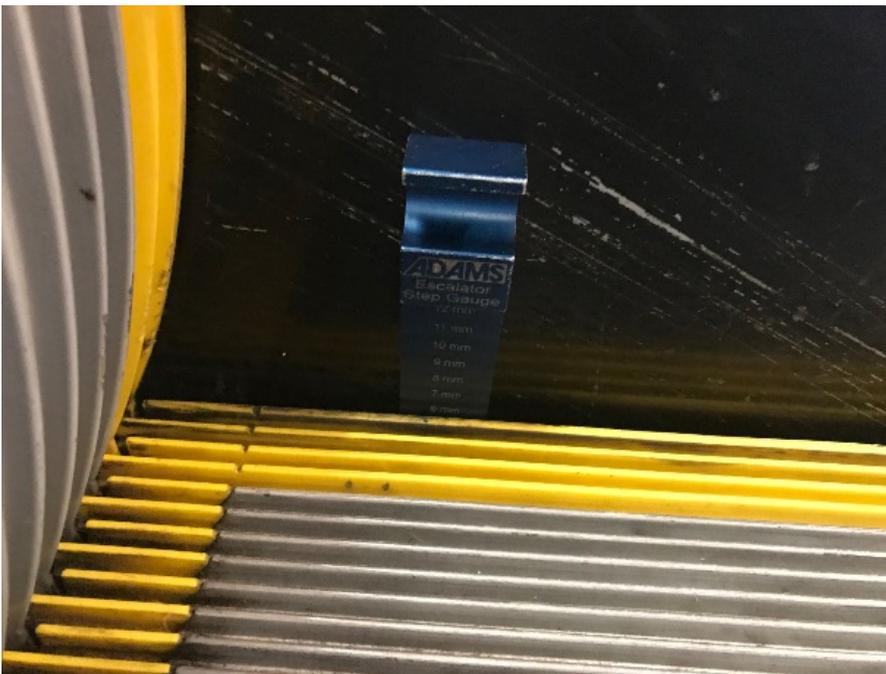
Picture 3 - Step skirt gap measurement at location where the shoe was caught

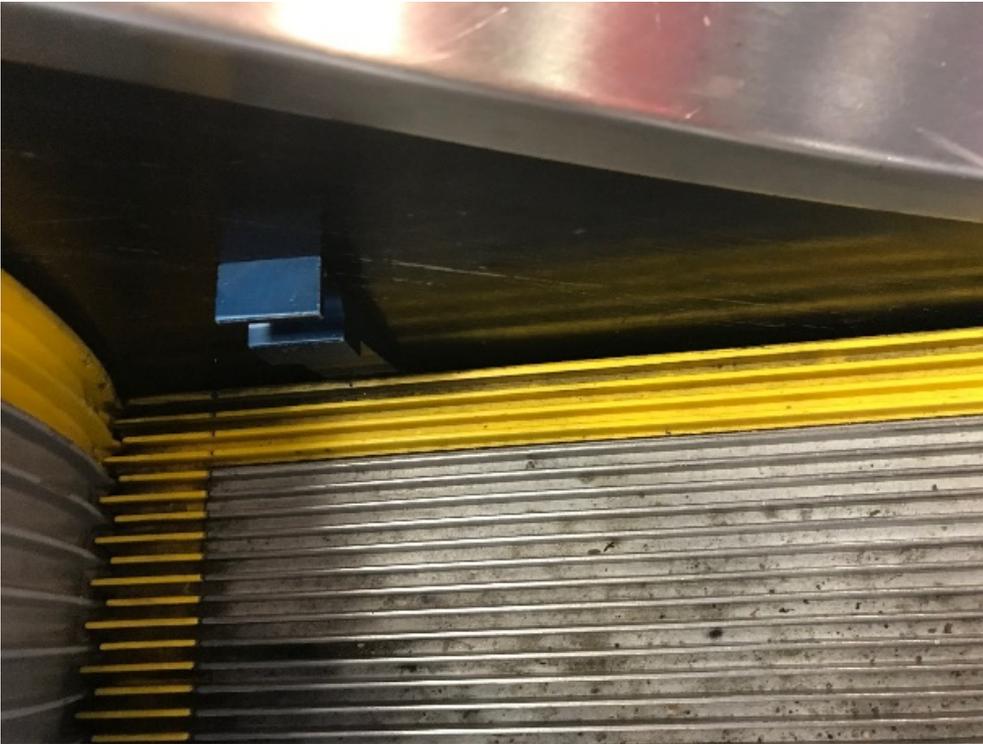
Picture 4 - Step skirt gap at different location on escalator

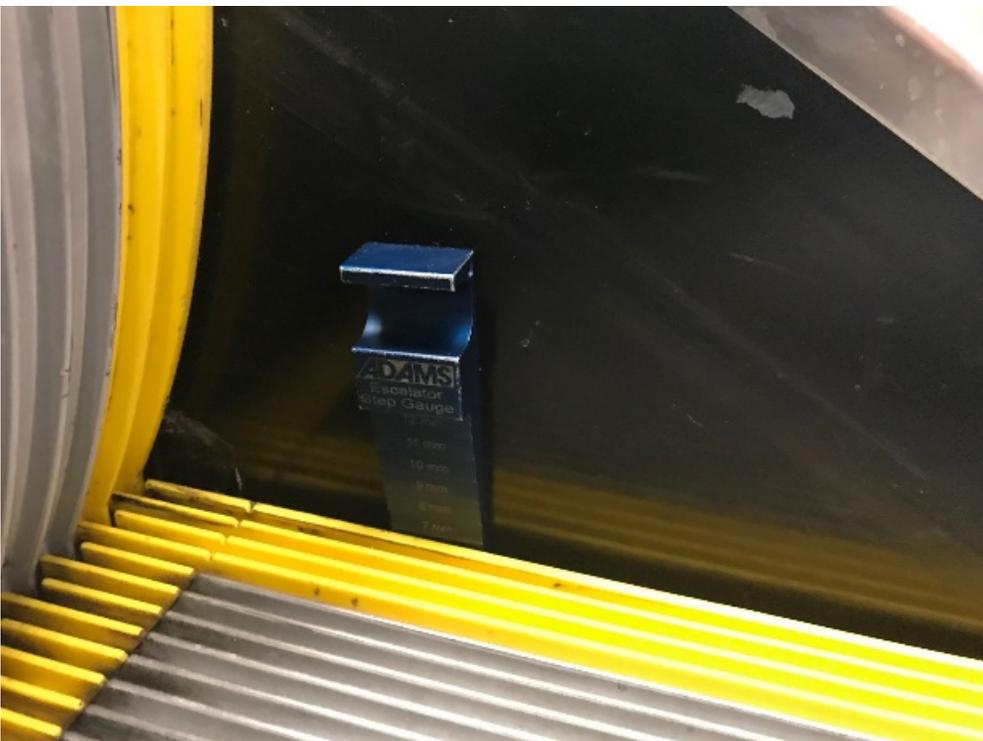
Picture 5 - Step skirt gap at different location on escalator
