Incident Summary #II-1147502-2021 (#20824) (FINAL)

SUPPORTING INFORMATION	Incident Date	February 19, 2021	
	Location	Taylor, BC	
	Regulated industry sector	Gas - Propane system	
	Impact	Qty injuries	3
		Injury description	Occupants of the house were exposed to low levels of carbon monoxide and advised to go to the hospital. No symptoms were reported by the occupants.
		Injury rating	Insignificant
	Damage	Damage description	A Heat Recovery Ventilator (HRV) drew exhaust from three gas appliances back into the house.
		Damage rating	None
	Incident rating	Insignificant	
	Incident overview	<p>Three gas appliances exhaust vents each terminate outside. The products of combustion from these appliances included carbon monoxide.</p> <p>The HRV was operating while one or more of the gas appliances were operating, and the exhaust which contained carbon monoxide was drawn into the HRV air intake, and then into the house ventilation duct work.</p>	
INVESTIGATION CONCLUSIONS	Site, system and components	<p>Gas appliances may produce carbon monoxide (CO) as a product of combustion of natural gas. Most modern appliances produce a small amount of CO which is carried out of the appliance through its

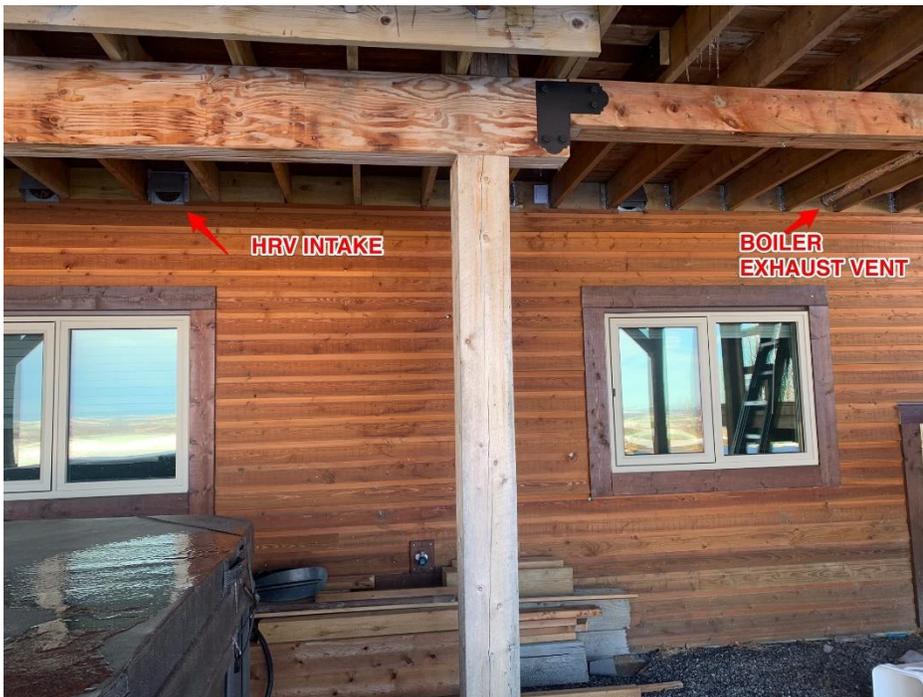
13 feet clearance between closest exhaust vent and HRV intake

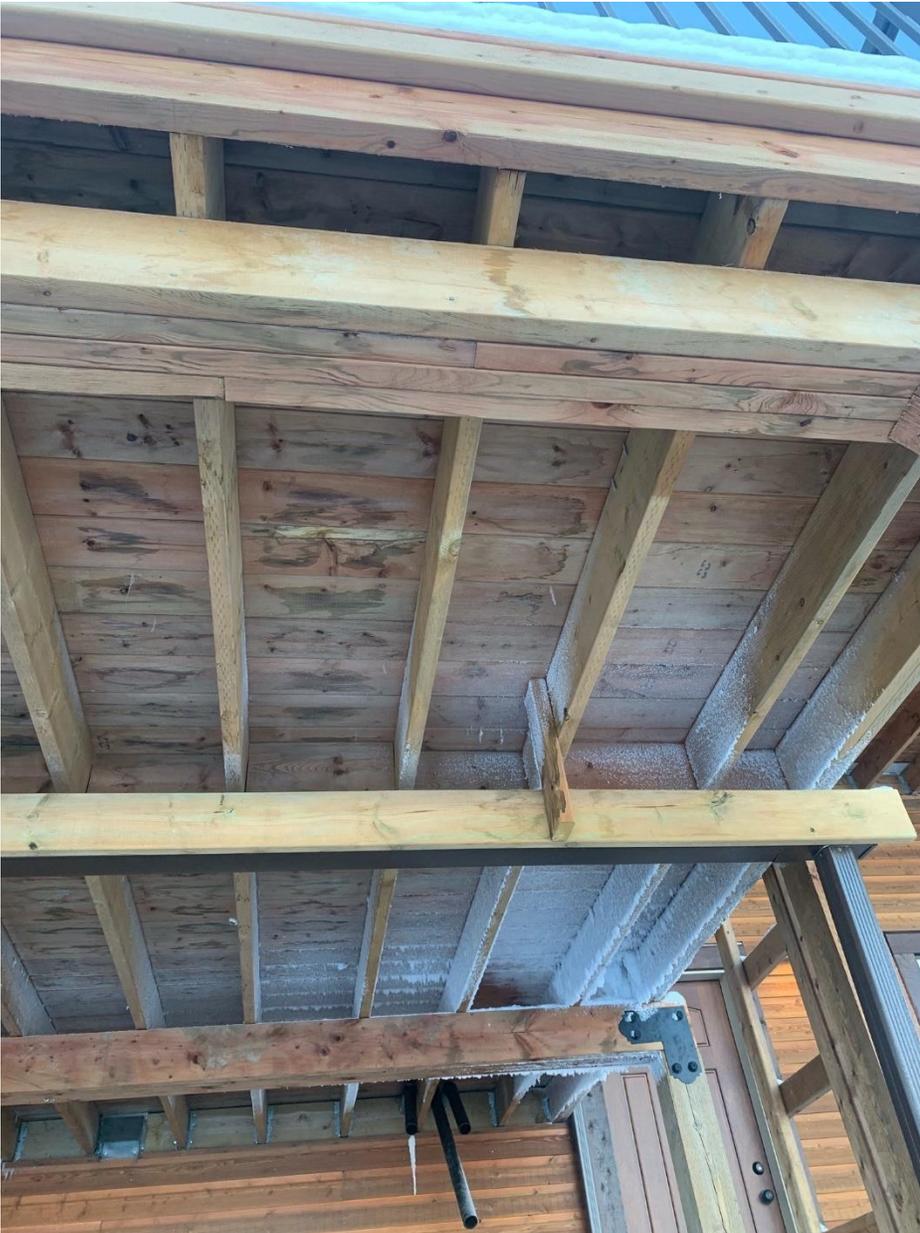
Appliance exhaust vents. Temporary extensions added

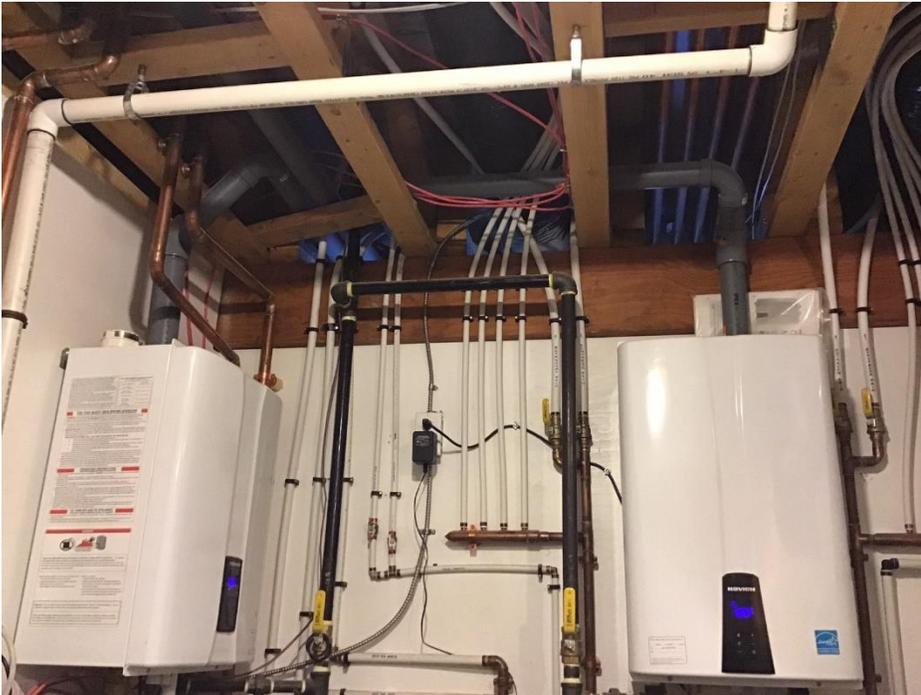
Two, of three gas appliances

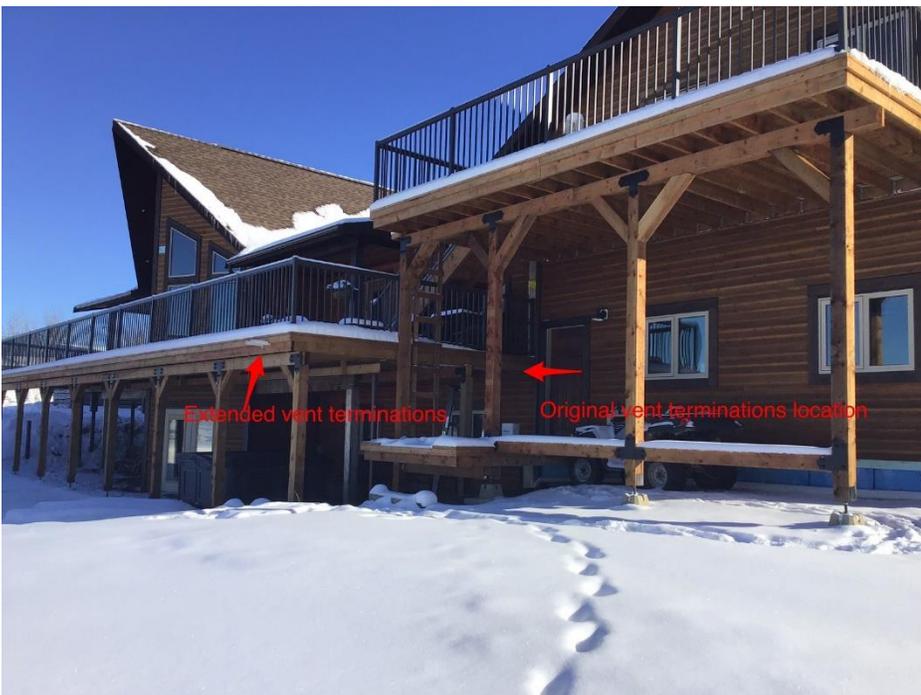
<p>Causes and contributing factors</p>	<p>It is highly likely that the deck over top of the gas appliance exhaust vents prevented the exhaust gases from dissipating outside. Exhaust was trapped under the deck, and the HRV air intake drew the exhaust inside, which distributed exhaust with carbon monoxide throughout the house.</p>

New deck and location of gas appliance vent terminations before and after vents extended.

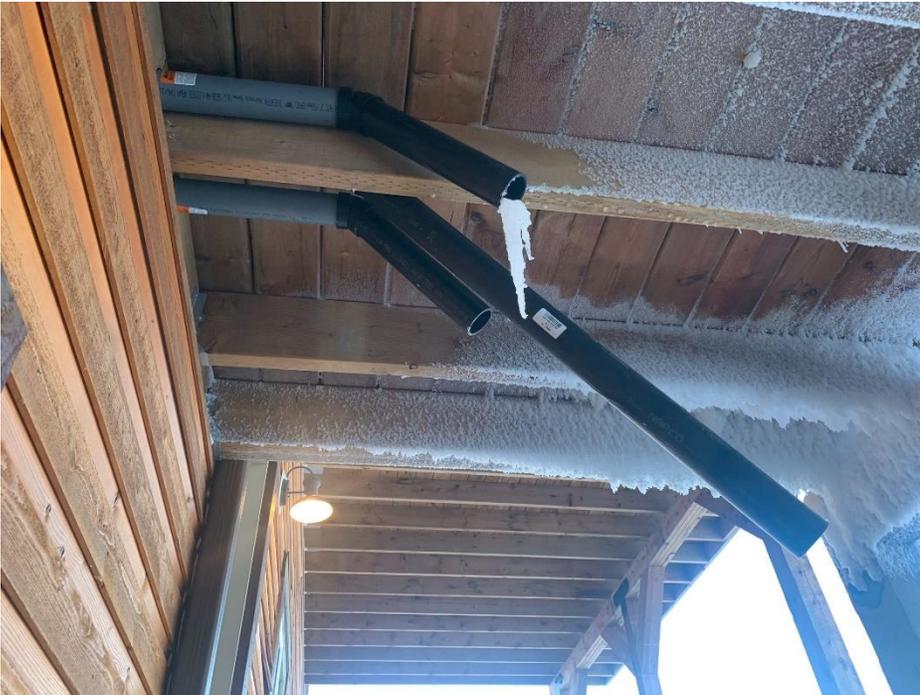
Grey CPVC exhaust vents, Black ABS temporary vent extensions
