Incident Summary #II-1124951-2021 (#20341) (FINAL)

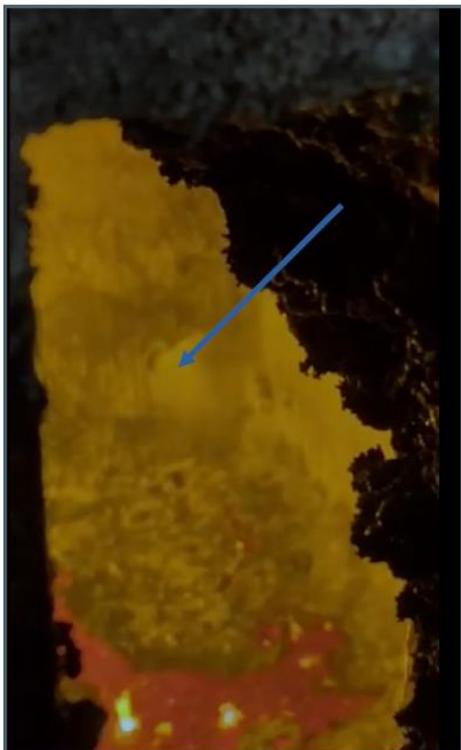
1. Lower Furnace picture of live tube leak

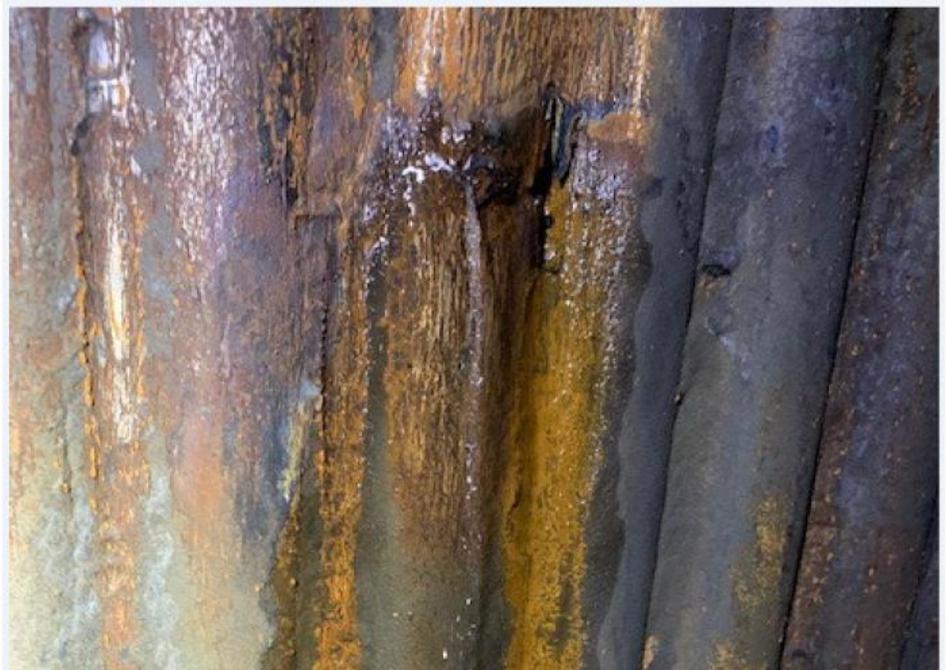
2. Tube leak with static head pressure during lower furnace inspection

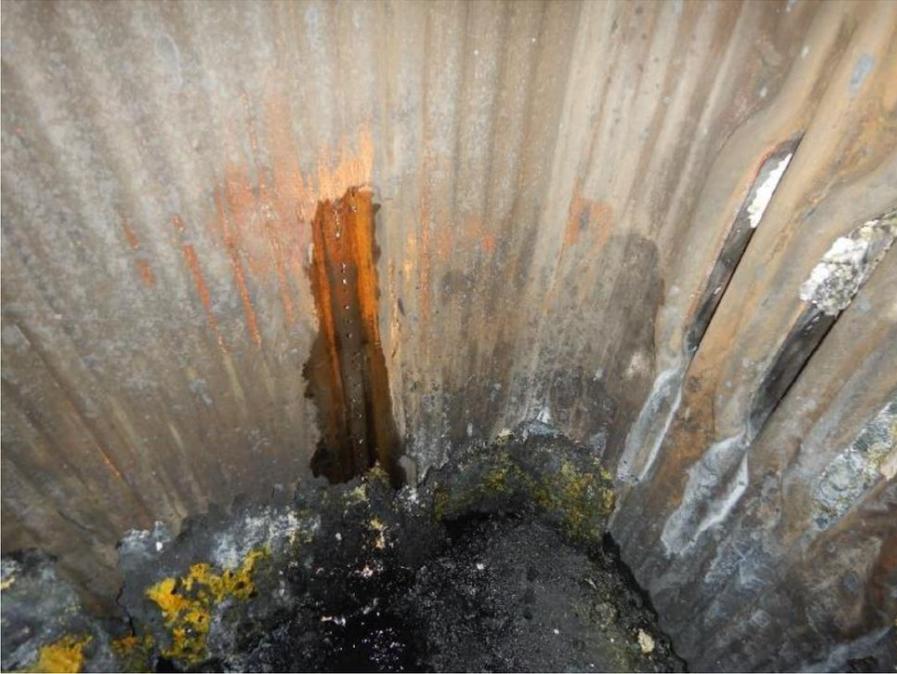
3. Tube Leak Location

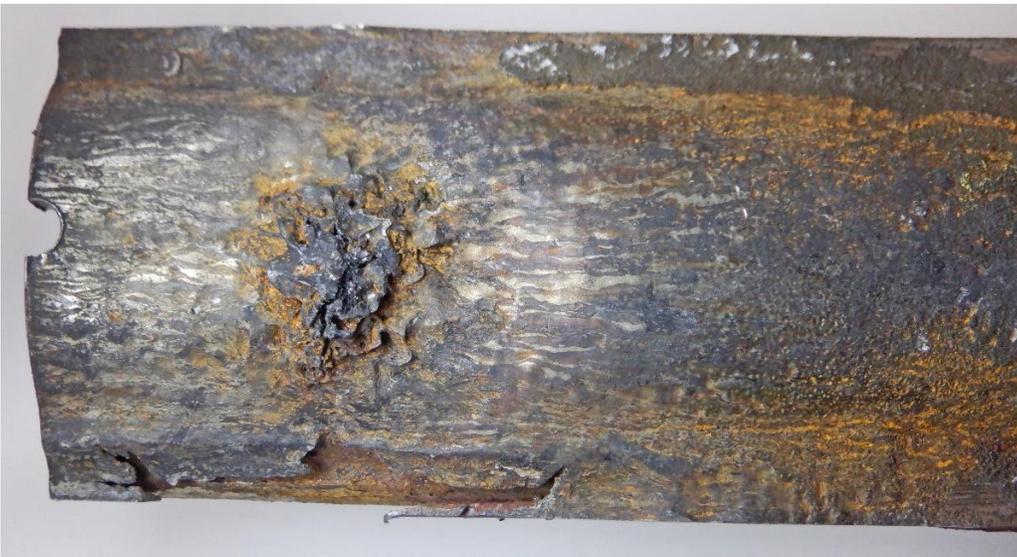
4. Close up view of the failure showing the raised material on outer surface of tube.

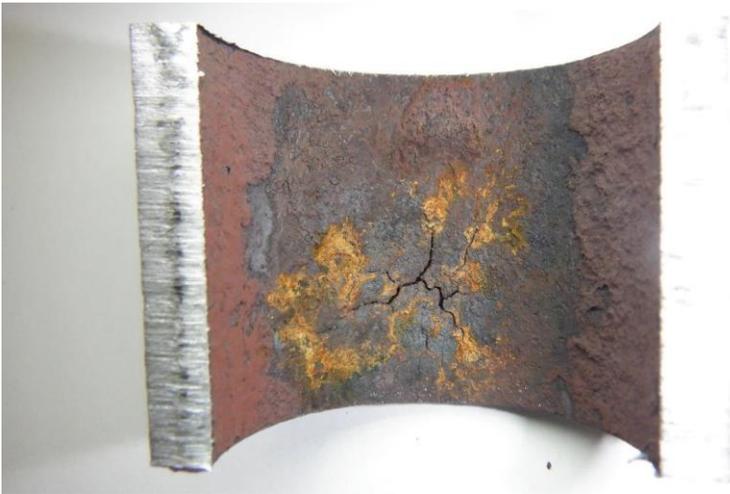
5. View of the interior of the tube at the failure location showing an unusual network of cracks or fissures in the surface.

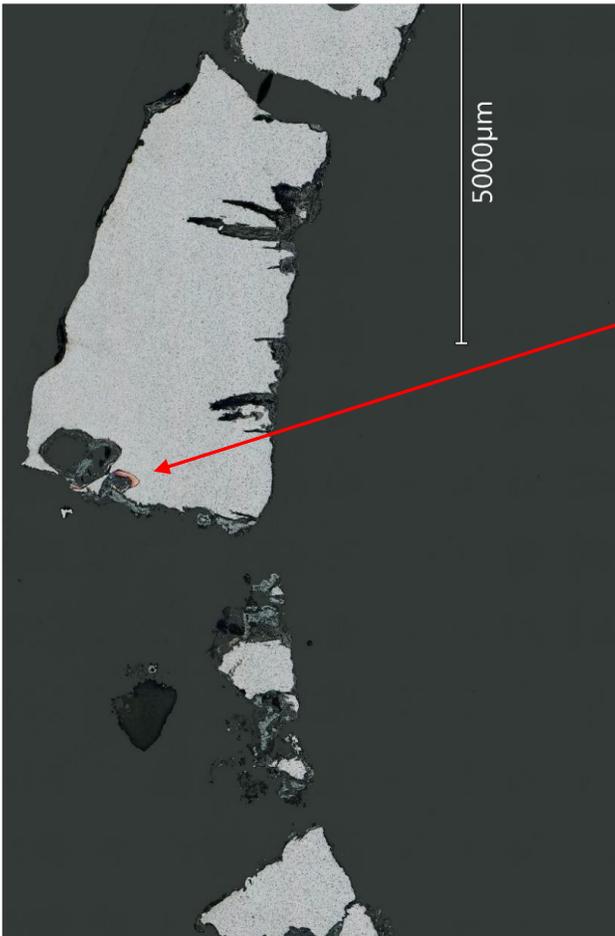
6. Low magnification view of cross section prepared through tube at the leak point. Pits with cracking typical of SAC extending from them are present at the leak site, several of which in this view have perforated the tube. Also present are rounded intrusions into the OD surface. The arrow indicates an unusual copper coloured material lining the rounded void in the wall of the leak.
