## Incident Summary #II-2195416-2021 (#20823) (FINAL)

SUPPORTING INFORMATION	Incident Date	February 13, 2021	
	Location	Castlegar, BC	
	Regulated industry sector	Electrical - Low voltage electrical system (30V to 750V)	
	Impact	Qty injuries	0
		Injury description	None
		Injury rating	None
	Damage	Damage description	Main distribution panelboard and associated branch wiring dwelling sustained fire and heat damages.
		Damage rating	Moderate
	Incident rating	Moderate	
Incident overview	Main distribution 100 amp 120/240 volt panelboard and associated branch wiring in a single family dwelling sustained fire and heat damages when a surge suppressor failed and ignited while providing over-voltage protection.		
INVESTIGATION CONCLUSIONS	Site, system and components	A 120/240 volt surge suppressor was installed in a branch circuit position in a 100 amp 120/240 volt single phase panelboard installed in a basement area of a single family dwelling. The surge suppressor is fitted with components that rupture and create a short-circuit when a voltage value higher than the rated voltage limit is impressed on the equipment it is protecting. The short-circuit trips open an upstream main breaker or f

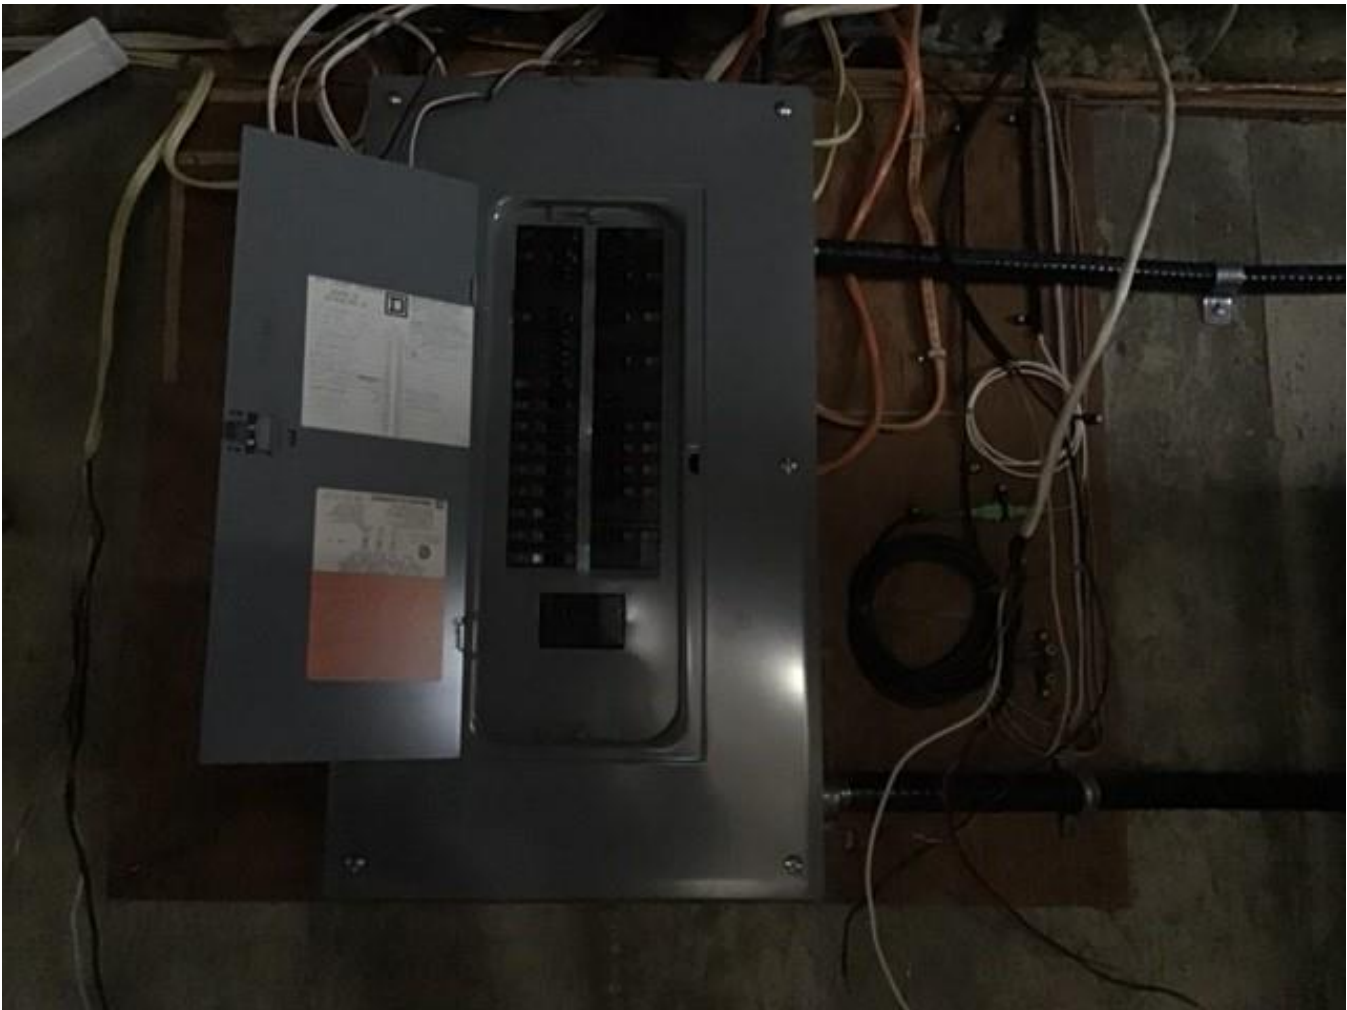
Main dwelling panelboard, installed on basement level

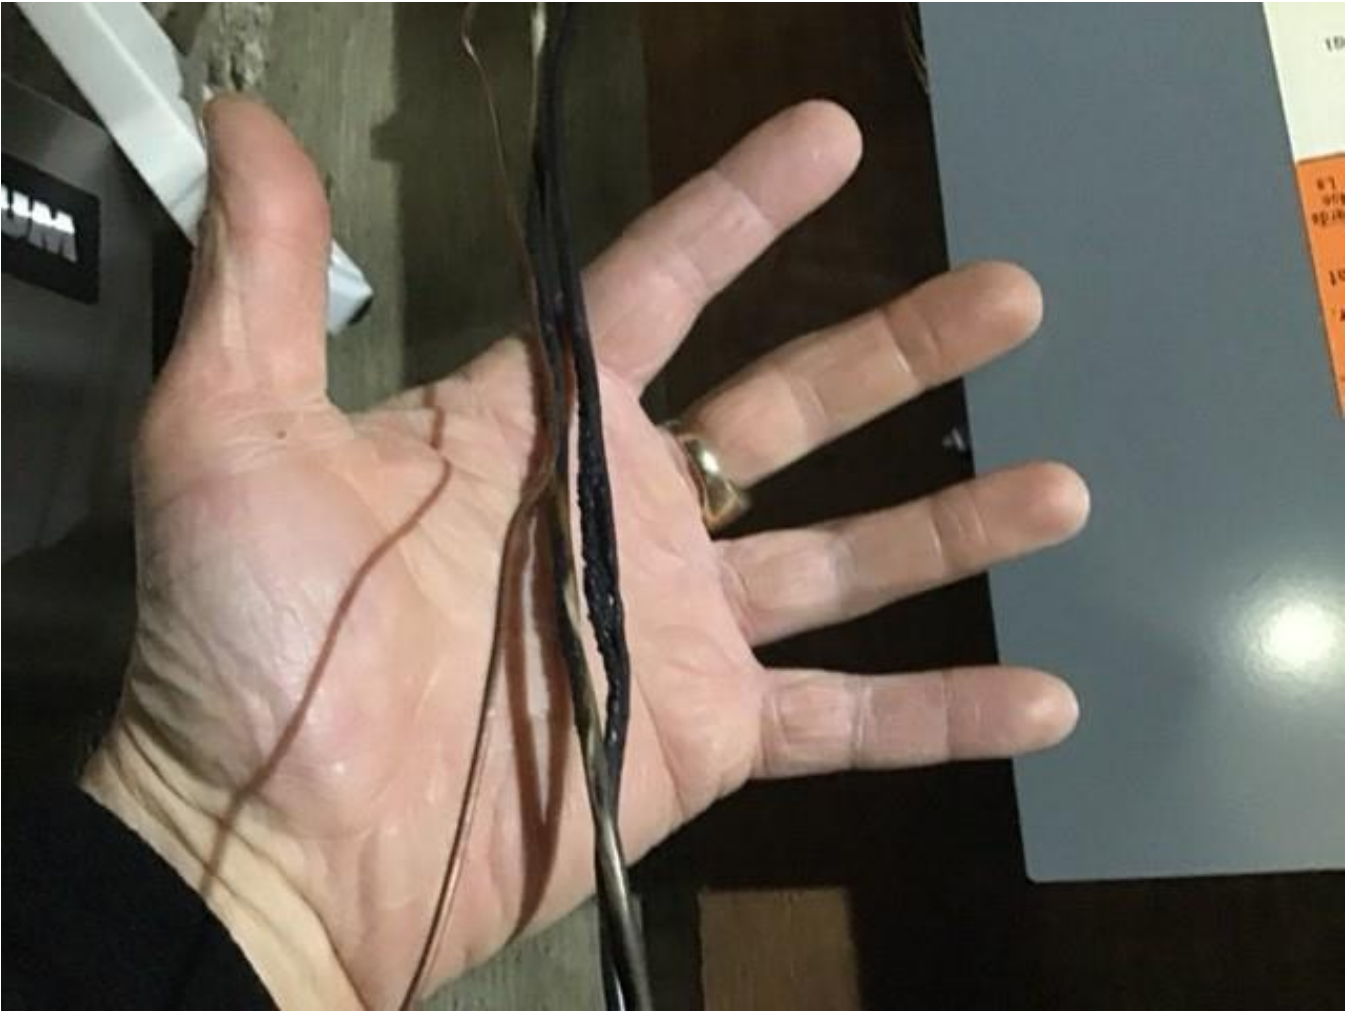
Burnt branch wiring conductor insulation

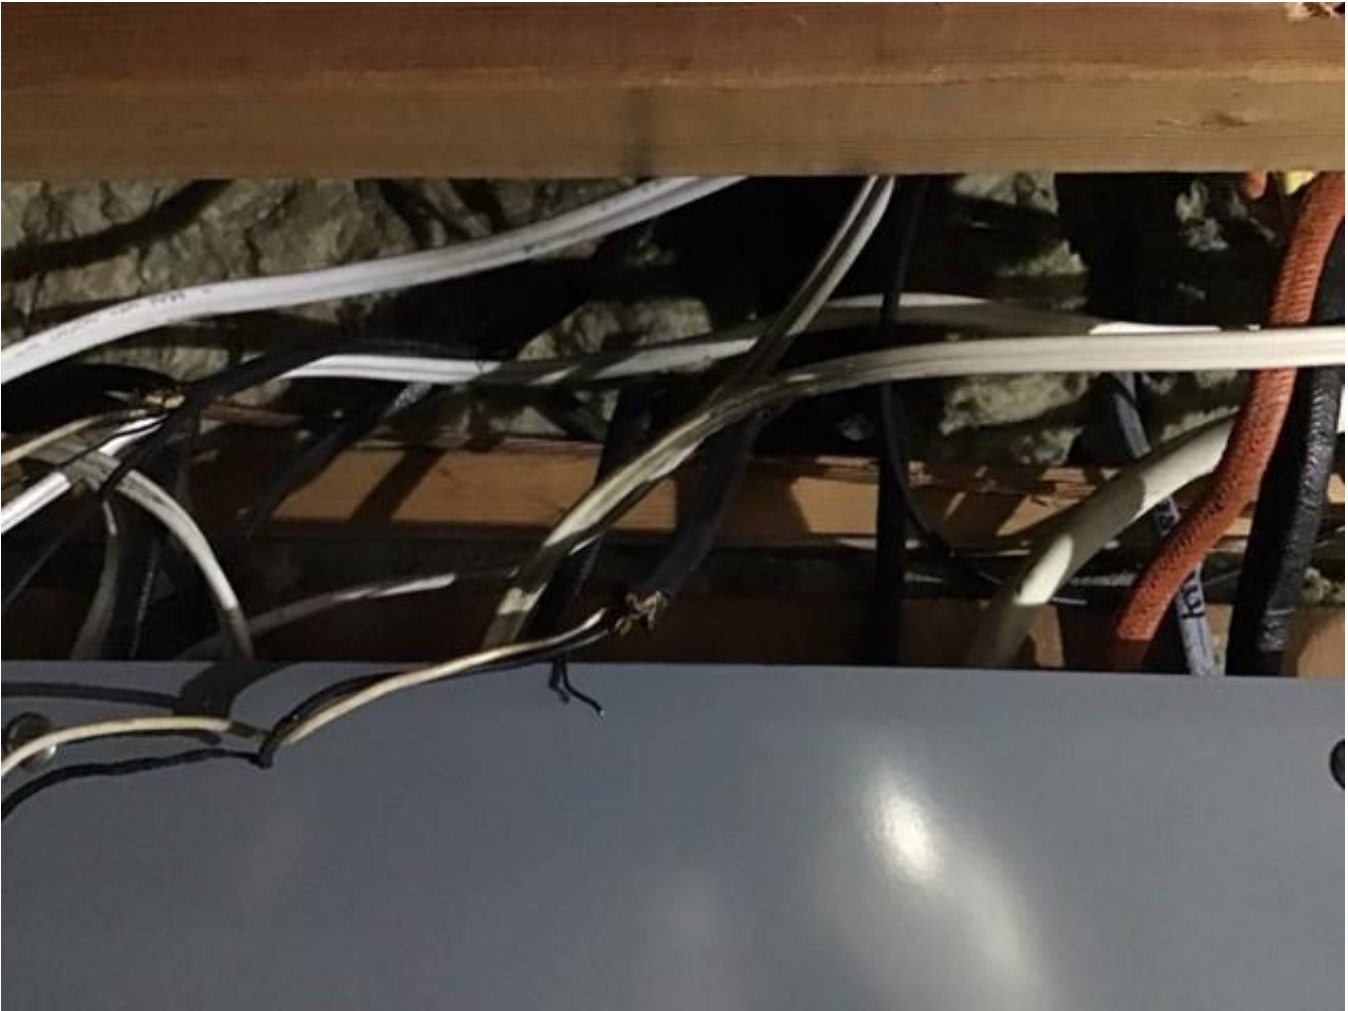
Burnt branch wiring cable insulation above panelboard

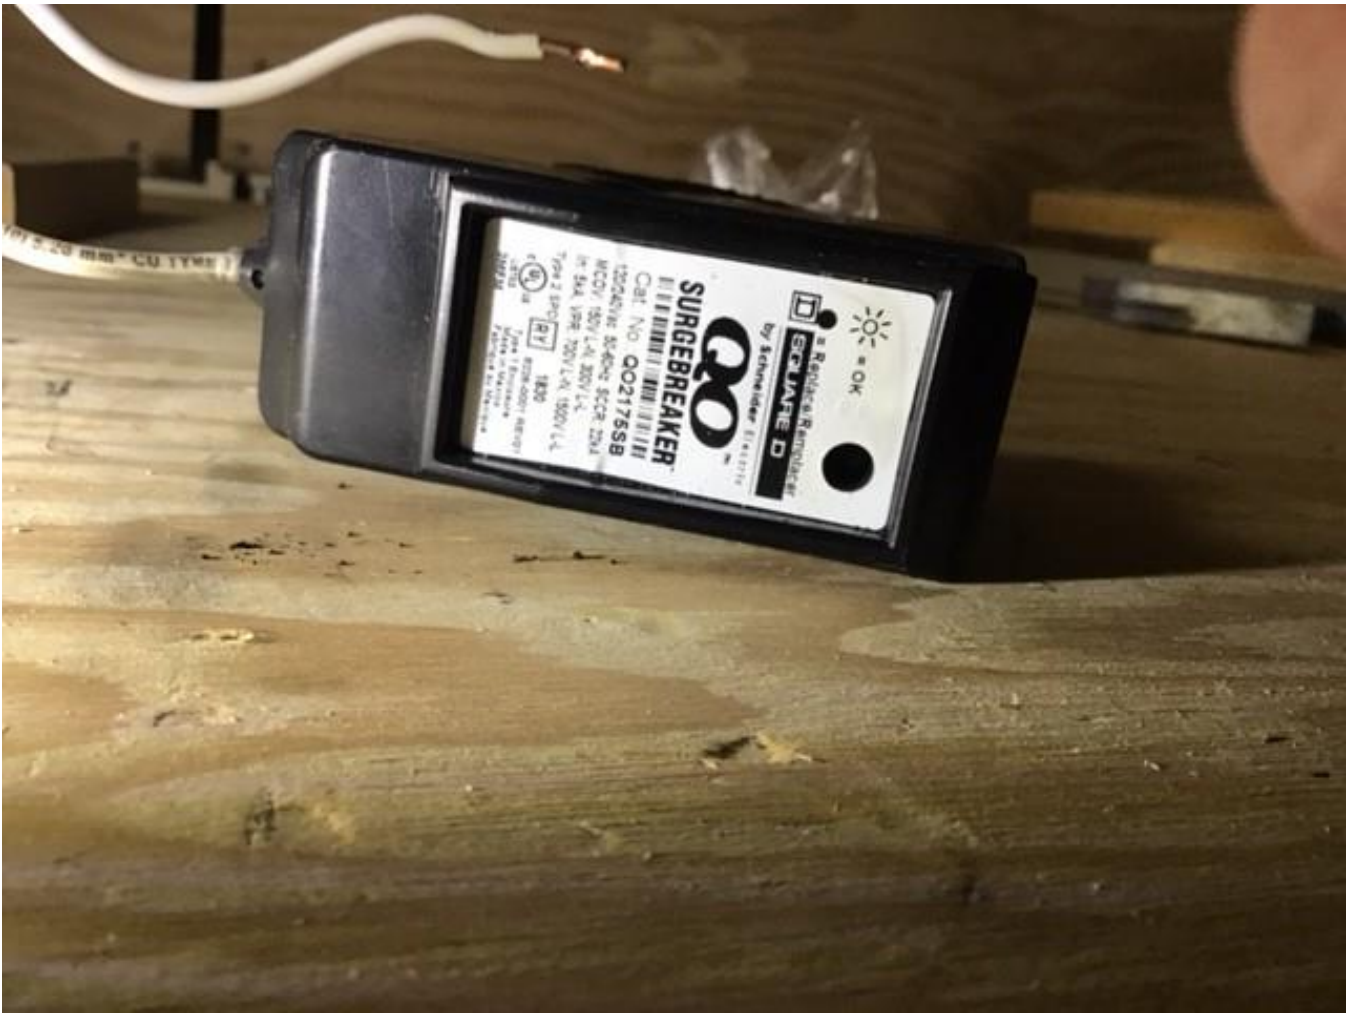
<p>Examination of the surge suppressor and panelboard revealed that the surge suppressor involved in the incident did not create the intended short circuit when the protection devices ruptured on the over-voltage condition. Instead, the plastic enclosure of the surge suppressor ignited when the protection components ruptured. The burning surge suppressor enclosure ignited adjacent plastic panelboard components, adjacent branch wiring conductor insulation, and adjacent branch wiring cable insulation.</p>
Causes and contributing factors	All evidence indicates that the surge suppressor protection did not operate as designed.

Square D Surgebreaker Suppressor QO2175SB 120/240v 5ka – top view

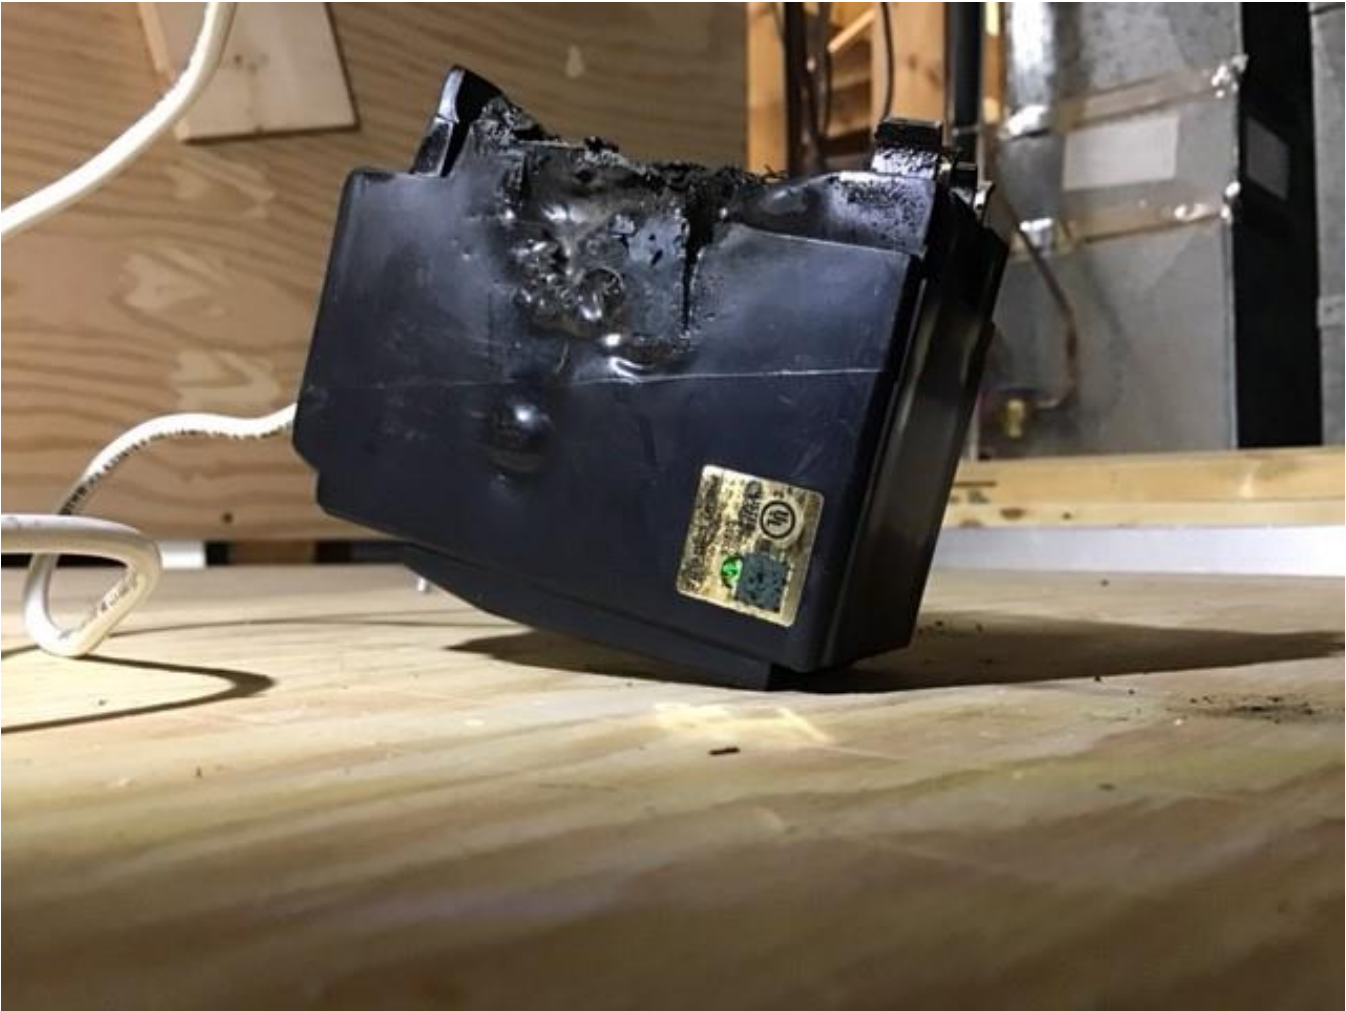
Square D Surgebreaker Suppressor QO2175SB 120/240v 5ka – side view

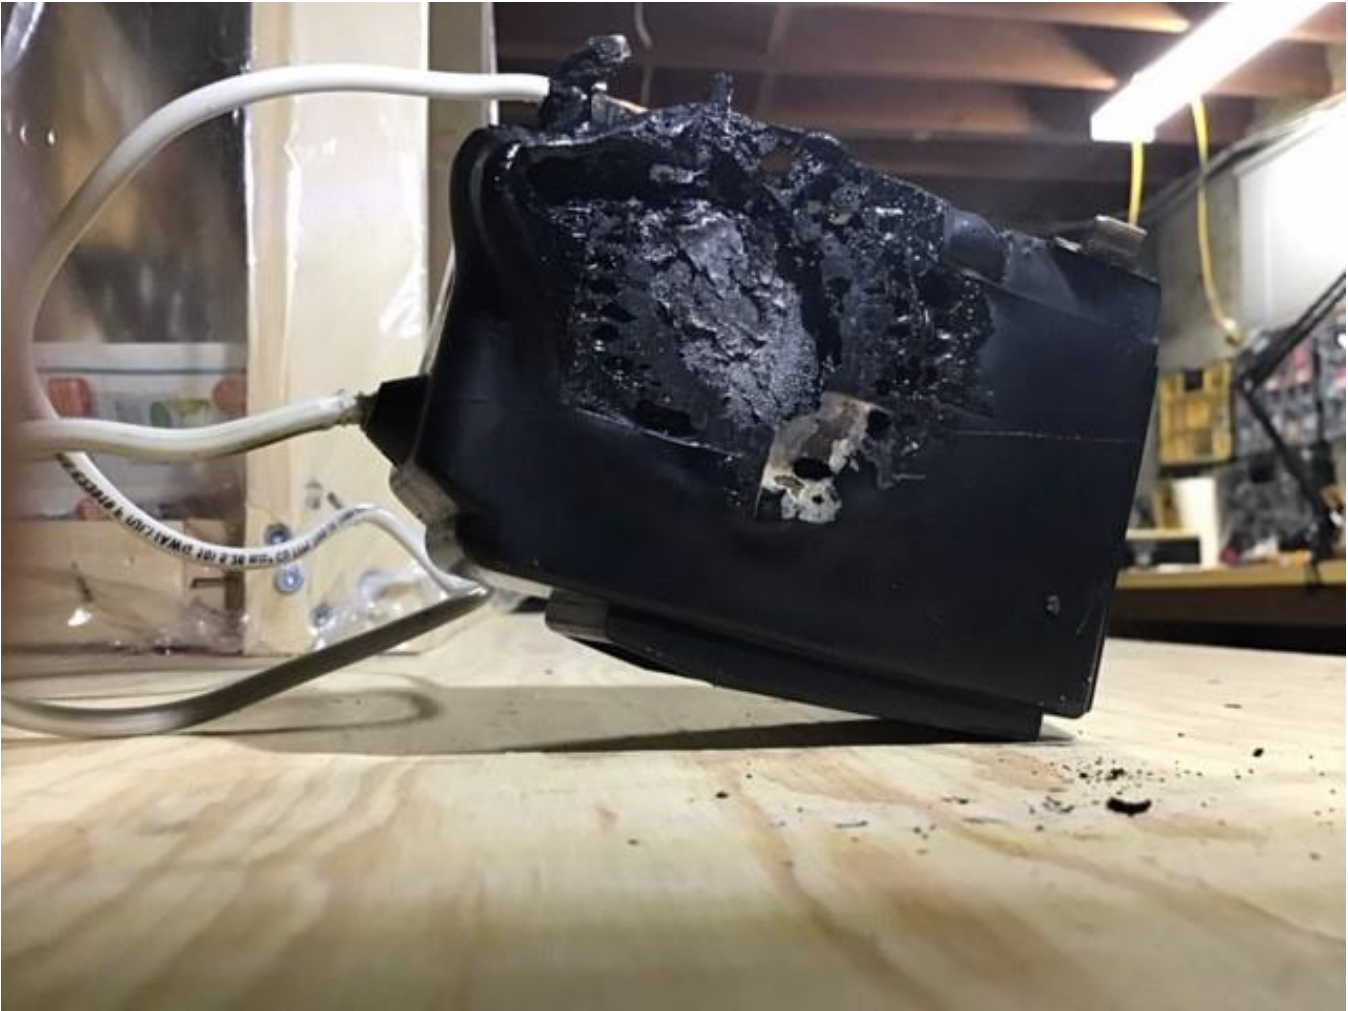
Square D Surgebreaker Suppressor QO2175SB 120/240v 5ka – other side view

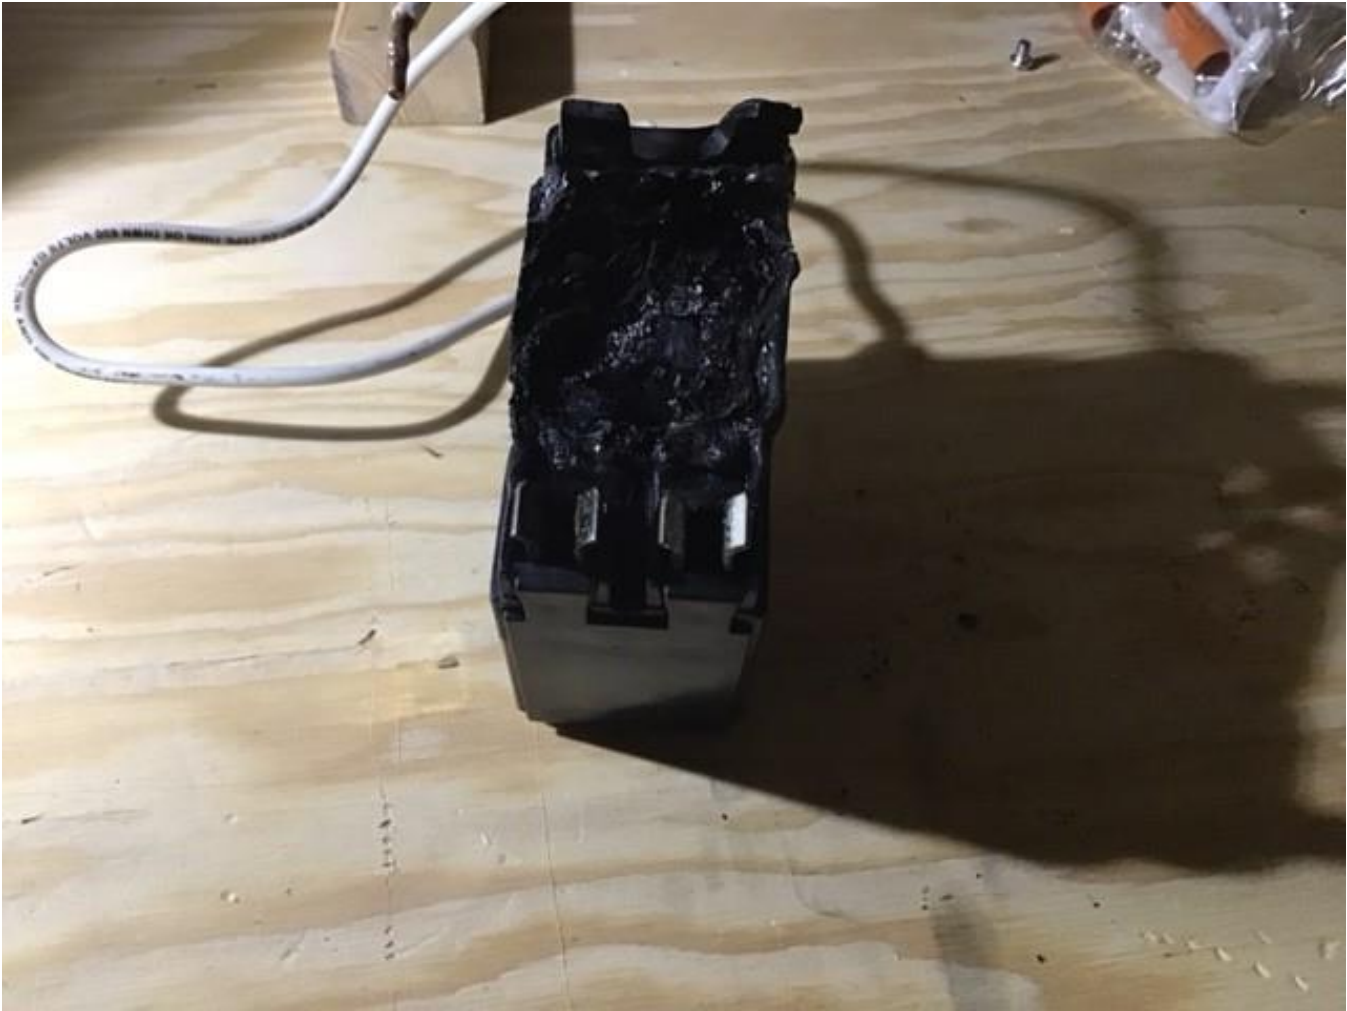
Square D Surgebreaker Suppressor QO2175SB 120/240v 5ka – back view
