Incident Summary #II-1147558-2021 (#20825) (FINAL)

SUPPORTING INFORMATION	Incident Date	February 9, 2021	
	Location	Lower Mainland	
	Regulated industry sector	Boilers, PV & refrigeration - Boiler and pressure vessel system	
	Impact	Qty injuries	0
		Injury description	N/A
		Injury rating	None
	Damage	Damage description	Sour water was released through a pinhole breach of an insulated process pipe.
		Damage rating	Minor
Incident rating	Minor		
Incident overview	Operations detected a leak on an insulated carbon steel horizontal 2" discharge pipe from a pump and immediately responded as per site emergency protocol. A localized possible breach was identified, and the process unit was safely shut down for further investigation. The area was taped off and there were no reported injuries.		
INVESTIGATION CONCLUSIONS	Site, system and components	A 2-inch horizontal section of insulated process piping approximately 3 feet in length. The pipe service was sour water, which is classified as API Class 2 Service.

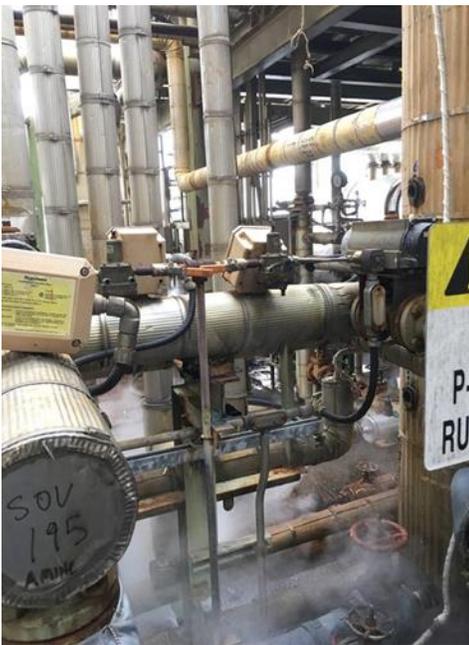
Failure scenario(s)	Corrosion under insulation (CUI) on carbon steel piping resulted in a leak of sour water. The process pipe operated within the CUI temperature range (approximately 100°C) and in a marine environment.	
	Facts and evidence	<p>Upon the removal of the insulation, inspection of the pipe wall verified external thinning of the metal had occurred on the horizontal section, resulting in a pinhole breach.</p> <p>The line remained isolated until it was replaced in kind.</p> <p>This piping is inspected with radiography as part of the site Compliance Program. All CMLs were compliant in their inspection frequency and did not detect CUI as a damage mechanism. The damage occurred on the section of pipe directly between assigned CML points.</p> <p>The damage was consistent with corrosion under insulation (CUI) which is an external damage of metallic components and equipment that are insulated. Damage is caused by moisture ingress through the insulation material. Carbon steel and low-alloy steels corrode in the temperature range between -5°C and 175°C (25°F and 350°F).</p> <p>The facility operates in a Marine environment which increases susceptibility to CUI damage, the location of external damage was aligned with a horizontal broken seal to the insulation jacketing identified in a previous report where moisture would collect.</p> <p>It was confirmed that the facility's inspection strategy meets or exceeds industry standards, and that a dedicated Maintenance team was in place for repairs.</p>

Causes and contributing factors	Cause: There was an insulation breach creating a location of susceptibility to CUI on process piping.

Contributing Factors: Although a minor deficiency was noted on the last inspection report, there was no evidence whether the deficiency had been evaluated at that time or that a work order had been created to address it. In the 5 years since the inspection date, significant improvements to the API 570 reporting process have been implemented including a more robust prioritization methodology for insulation identification.
