Incident Summary #II-1029477-2020 (#18496) (FINAL)

Inci37373737SUPPORTING INFORMATION	Incident Date	June 23, 2020	
	Location	Port Alberni	
	Regulated industry sector	Refrigeration System	
	Impact	Qty injuries	0
		Injury description	N/A
		Injury rating	None
	Damage	Damage description	Loss of containment from an isolation valve to regulator valve flange set due to gasket seal failure.
		Damage rating	Moderate
	Incident rating	Moderate	
	Incident overview	Technical Safety BC was notified due to a release of ammonia within a machine room. Two certified individuals were executing seasonal plant start up activities in an effort to generate ice surface. The ammonia release initiated alarms, equipment shutdown, plant evacuation of staff and emergency services to attend the site. The arena was closed to the public at the time of release.	
INVESTIGATION CONCLUSIONS	Site, system and components	The refrigerant plant is an indirect closed surface system using R717 ammonia as refrigerant. The total nameplate rating of the facilities three compressors is recorded as 120 kw. Direct digital control (DDC) automation is utilized to maintain plant operating conditions.

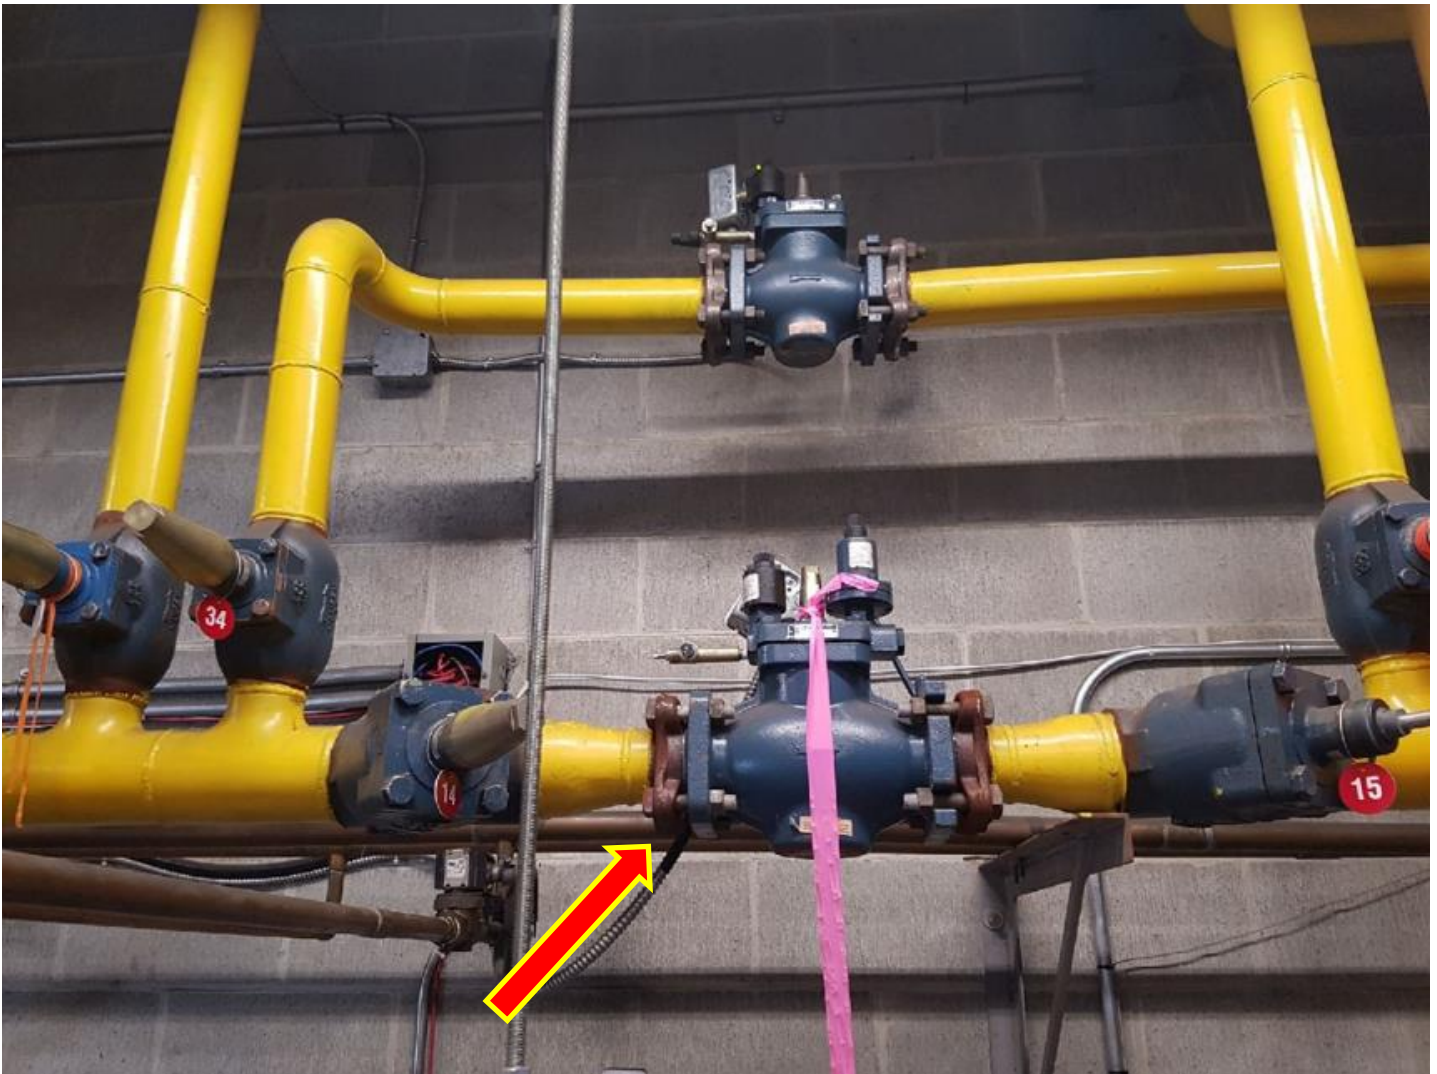
Image 1/1

Failure scenario(s)	While generating ice surface, close frequency pressure excursions likely induced by the rapid opening and closing of a pressure regulating valve located between isolation valve #14 and #15 to the systems outdoor condenser were encountered. At this time a flanged connection upstream of isolation valve #14 and downstream of the regulating valve failed to contain line pressure and ammonia vapor was released into the machine room.	
	Facts and evidence	<p>The plant was being prepared for start-up. The plant seasonal start-up conducted by certified individuals included surface preparation, maintenance activity, commissioning of new equipment and monitoring of the process. A newly installed rooftop condenser was commissioned June 22, 2020. The associated tasks supporting ice generation began June 20, 2020. By June 23, 2020 the refrigeration plant was charged with ammonia and operating.</p> <p>The ammonia release was after 11 am on June 23, 2020. The low level alarm, set at 25 parts per million (ppm), was triggered followed seconds later by the high level alarm set at 200 ppm. The high level alarm stopped sounding at 11:23 am. The detection of ammonia exceeding 200 ppm lasted less than five minutes. Authorized personal were in the refrigeration plant vestibule at the equipment console at the time of alarm.</p> <p>When the audible alarm ceased, ammonia was still detected at 67 ppm within the machine room. With no additional leakage detected authorized personal entered the machine room with personal protective equipment, and used a wrench to tighten the fasteners at the flange location immediately downstream of isolation valve #14. At this time ammonia was detected on location at 41 ppm. The ammonia detection</p>

<p>Causes and contributing factors</p>	<p>The loss of containment at a mechanical flanged joint was likely caused by relaxation of the mechanical fasteners. Fastener relaxation can be expected when utilized in systems experiencing fluctuating thermal conditions, vibration or advanced length of service. Fastener relaxation can be controlled with fastener torque procedures, inspection intervals or eliminating mechanical flanged connections with welded connections.</p> <p>Contributing factors likely include the direct digital control systems logic not updated. A rapidly opening and closing pressure regulating valve. Possible contributing factors include a recent condenser installation.</p> <p>Testing and updating of the DDC system's programming to accommodate plant changes could eliminate undesired plant equipment response.</p>

Pink ribbon identifies regulating valve with actuator components on bonnet. Loss of containment occurred at left side flange connection indicated with red arrow.
