## Incident Summary #II-1035471-2020 (#18692) (FINAL)

SUPPORTING INFORMATION	Incident Date	July 7, 2020	
	Location	Shawnigan Lake, BC.	
	Regulated industry sector	Electrical - Low voltage electrical system (30V to 750V)	
	Impact	Qty injuries	0
		Injury description	No injuries
		Injury rating	None
	Damage	Damage description	Breaker overheated
		Damage rating	Minor
	Incident rating	Minor	
Incident overview	On July 7, 2020 tenants of a dwelling unit located in a multi-family dwelling lost power to their unit. The tenants called an electrician who reset the breaker located in a locked electrical room. When the breaker was reset by the electrician they could smell smoke and could hear a burning noise. The breaker was then immediately turned back off.		
INVESTIGATION CONCLUSIONS	Site, system and components	<p>Main Utility Service is a 600 Amp - 240 Volt fused disconnect located in the electrical room.</p> <p>Sub-distribution consists of 3 meter stacks with 2 pole 90 Amp breakers that feed the units within the multi-family dwelling.</p> <p>125 Amp load centres are located in each dwelling.</p> <p>NMD90 3C/ #2 Aluminum conductors are installed as feeders to each unit.</p>

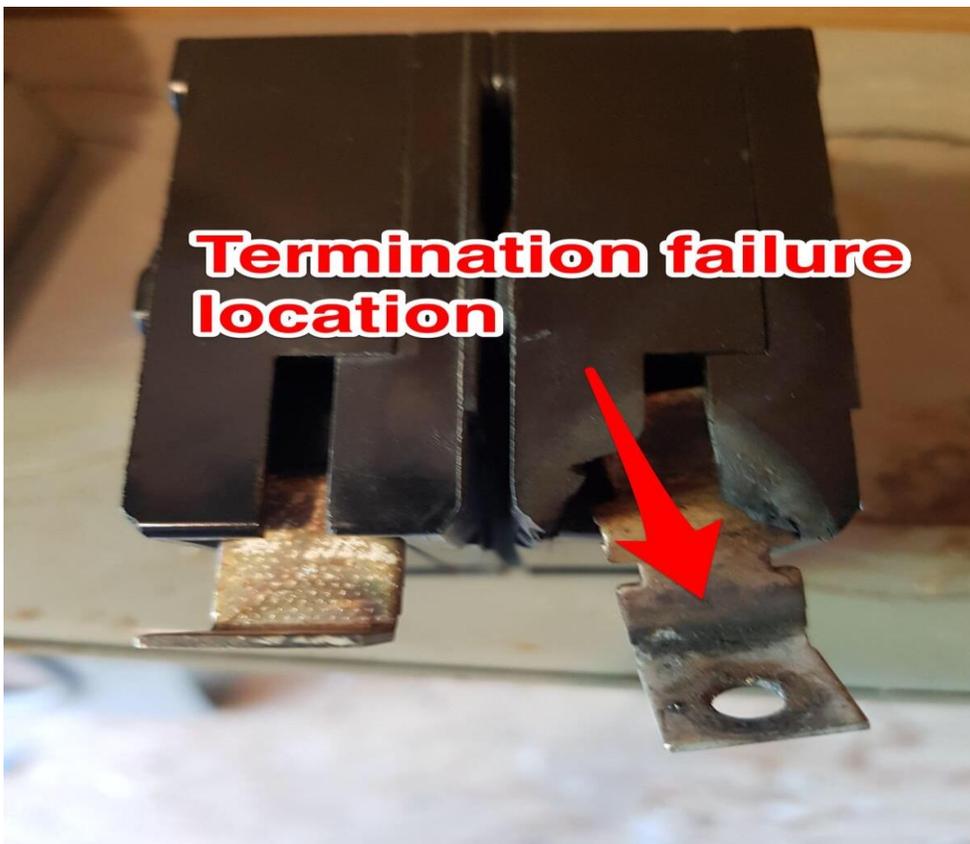
<p>Safety Officer Observations:</p> <ul style="list-style-type: none"><li>- Electrical panel in unit looked original without additional loads as indicated by the panel directory</li><li>- NMD90 3C/#2 AWG conductor showed no signs of damage from heat</li><li>- 2 pole 90 Amp breaker only showed damage on one termination point only</li><li>- Pitting, arcing and discolouration of termination point observed is consistent with a loose termination</li></ul>
<p>Causes and contributing factors</p>	<p>The cause of this incident was very likely due to overheating of a breaker termination. It is likely this termination was not torqued to manufactures specifications at the time of installation. Electrical equipment in the province of BC is required to be maintained in safe and proper working conditions, it is possible this overheating condition may have been identified during regular maintenance by a qualified individual.</p>

2 Pole 90 Amp breaker shows overheating on one side only

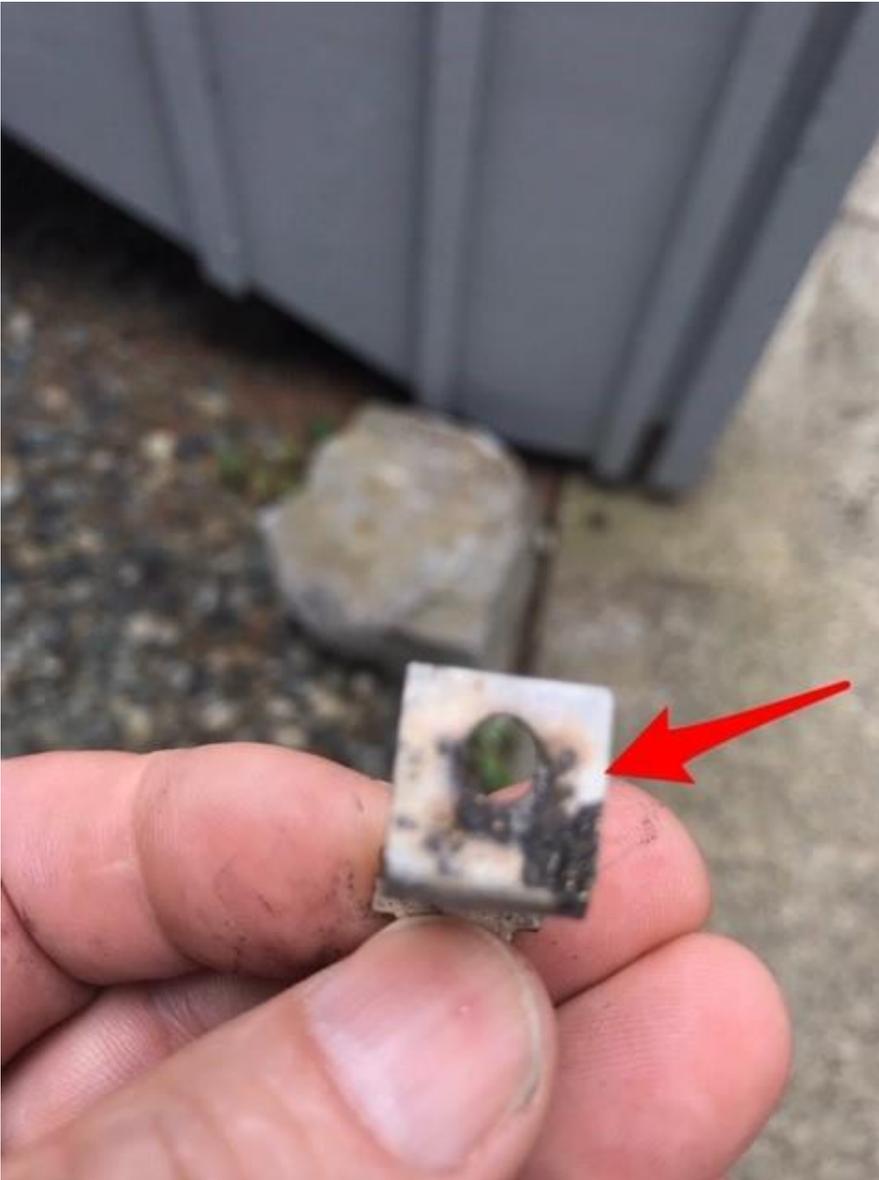
Arcing and pitting on the back of the termination pad

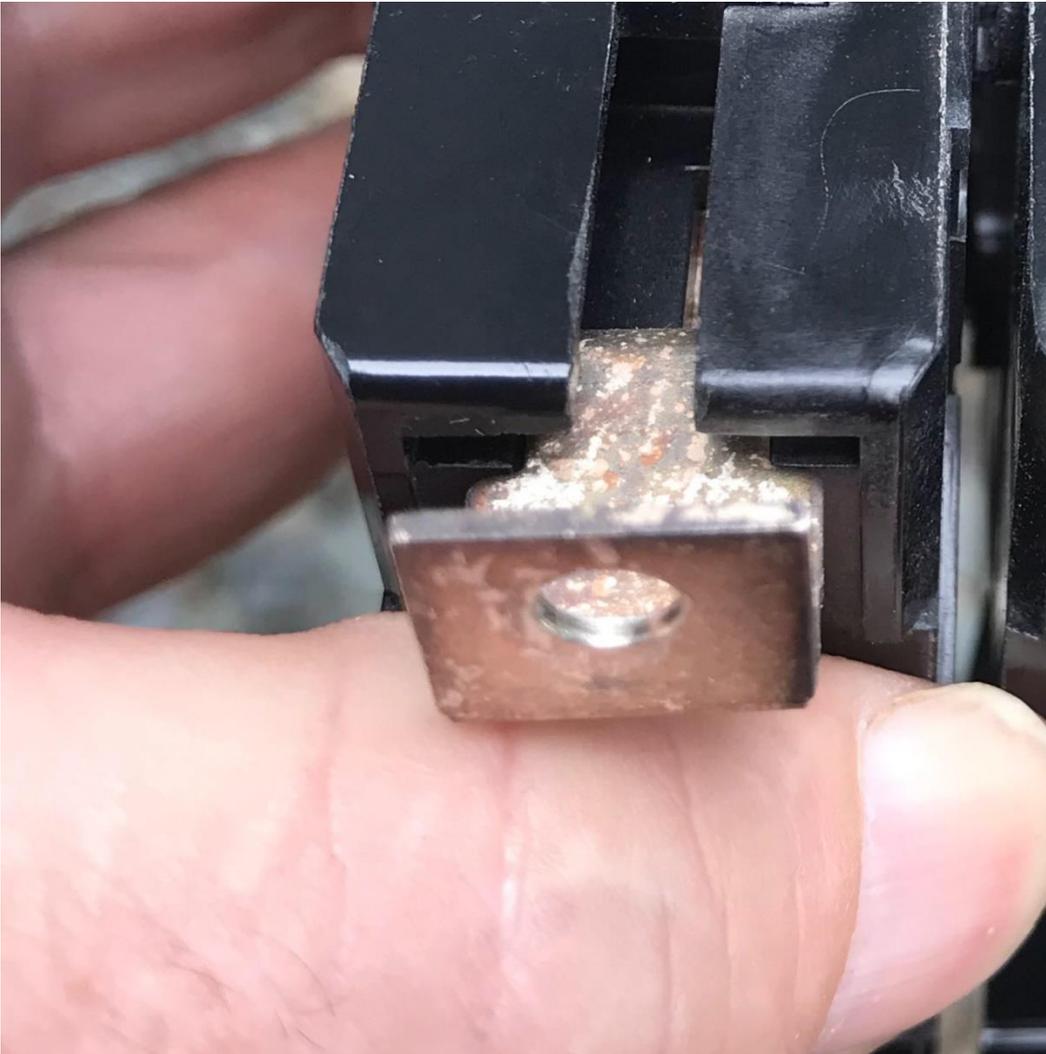
Termination point on the side of the breaker that did not fail. No arcing, pitting or signs of overheating.
