## Incident Summary #II-1216024-2021 (#22613) (FINAL)

SUPPORTING INFORMATION	Incident Date	June 21, 2021	
	Location	Whistler	
	Regulated industry sector	Passenger ropeways - Above surface ropeway	
	Impact	Qty injuries	0
		Injury description	NA
		Injury rating	NA
	Damage	Damage description	Haul rope damage, roughly 40cms long going over 8 strands. On 2 strands there are 6 damaged wires. On the others there are 4-5 damaged wires.
		Damage rating	Minor
Incident rating	Minor		
Incident overview	While conducting line work, maintenance staff were moving the work carrier in reverse from T1 into the return station. The work carrier came to a dead stop as it entered the station while the haul rope was moving. The ropeway was stopped immediately. The damaged section of rope is 40cm in length, going over 8 strands.		
INVESTIGATION CONCLUSIONS	Site, system and components	<p>4 passenger carrier, Detachable Grip (Doppelmayr, DS 104 Grip). This same grip is utilized with the maintenance carrier.</p> <p>Maintenance carrier consists of 2 decks (one deck at a lower and one deck at an upper level).</p> <p>Incident occurred at the bottom return station of the ropeway</p> <p>The grip utilizes an insid

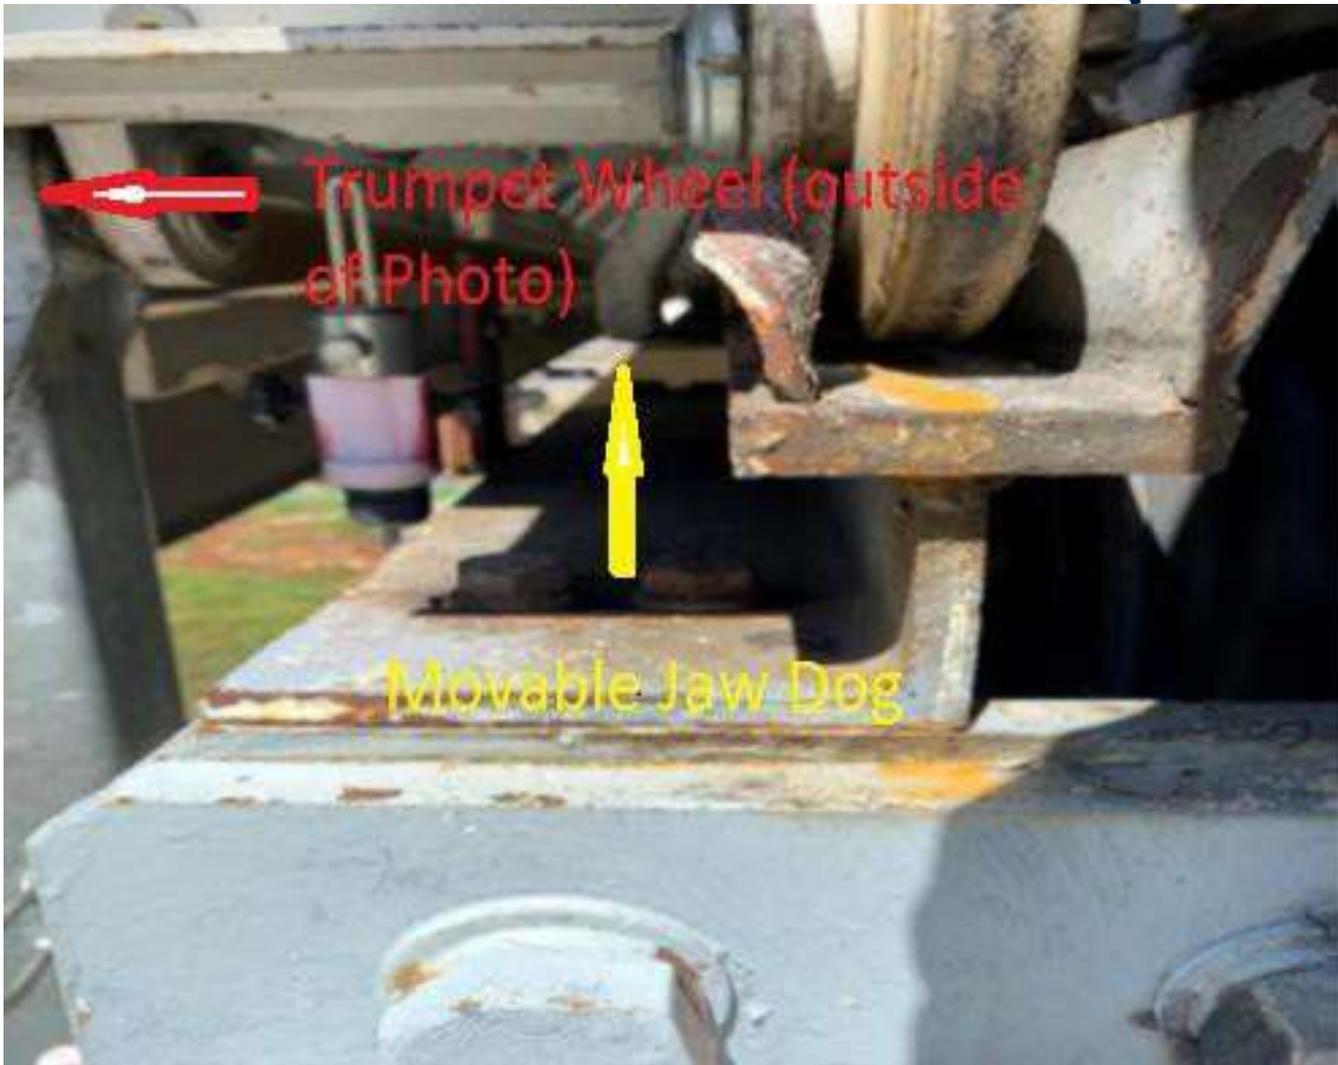
At the far outgoing end of the running wheel rail a deformity (pre-existing condition) was noted to the inside steel upright of the channel (Image 1,2,3).

A witness mark was noted to the dog of the grip movable jaw. Report from the contractor indicates that this was consistent with a scenario where the movable jaw dog made contact with the deformed section of the running wheel rail (Image 1).

The combination of the worn grip trumpet wheel and the deformity noted to the running wheel rail likely could have resulted in the condition where the movable grip jaw dog of the swinging maintenance carrier made contact with the deformed section of running wheel rail. This contact, while the haul rope was running in reverse would likely have caused the sudden stop of the moving maintenance carrier grip.

Image 1 - Deformity to Running Wheel Track Front View with Grip in View

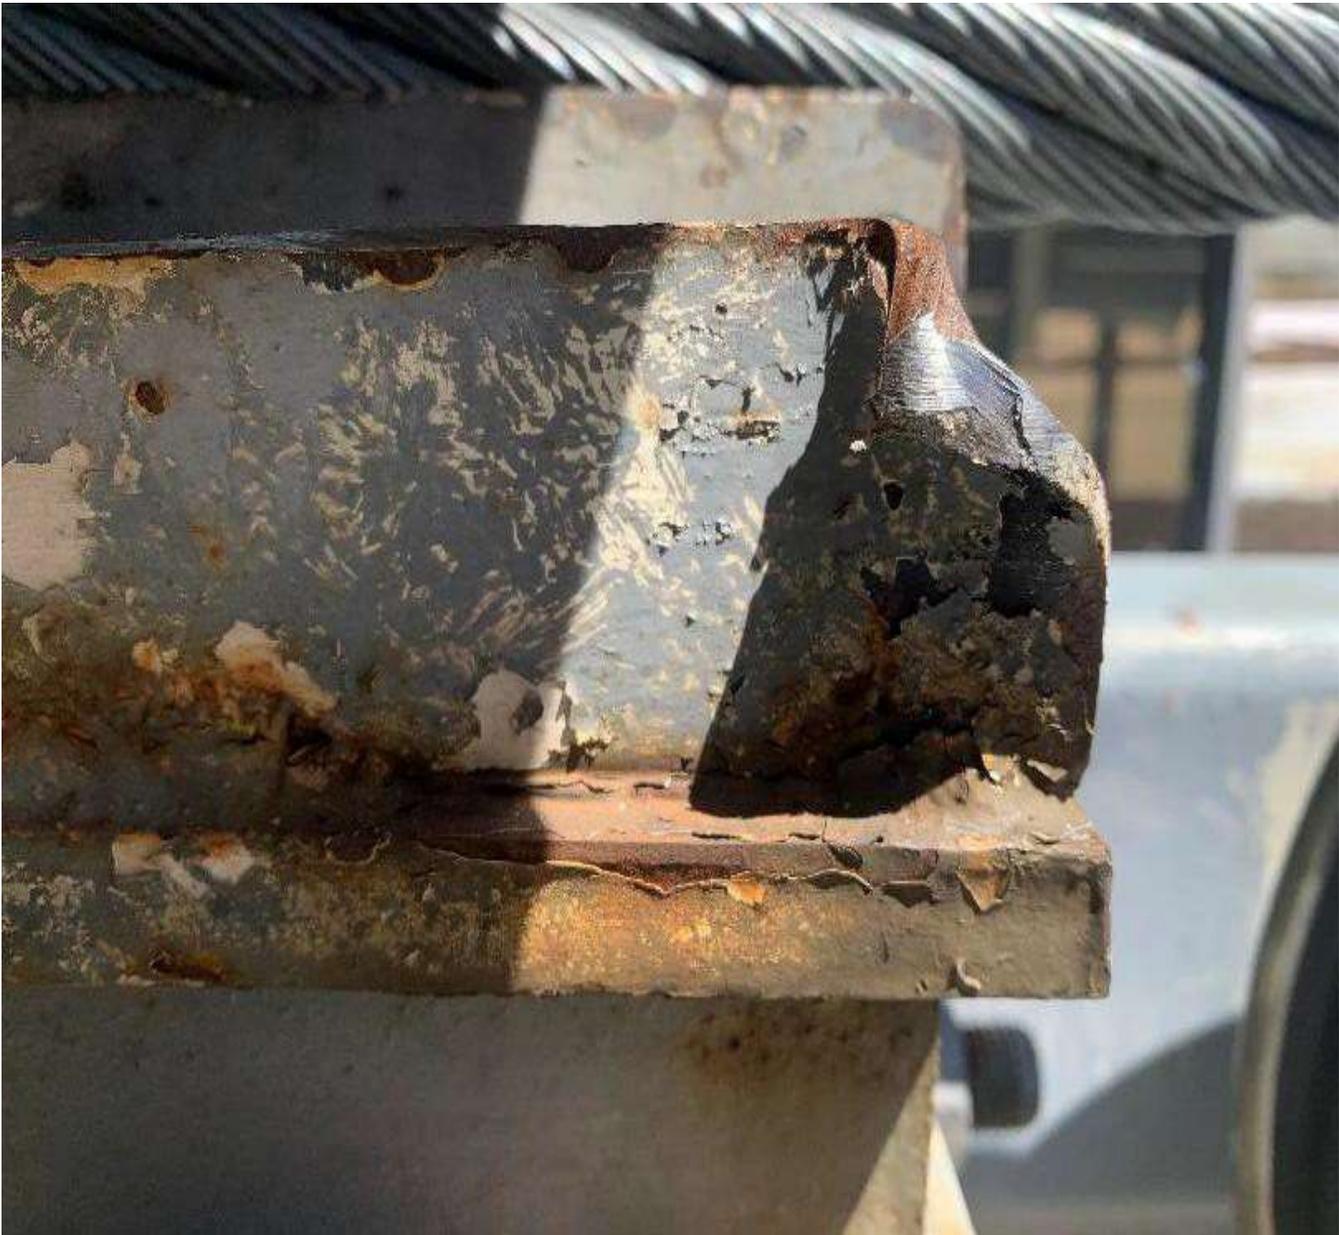
Image 2 - Deformity to Running Wheel Track Side View

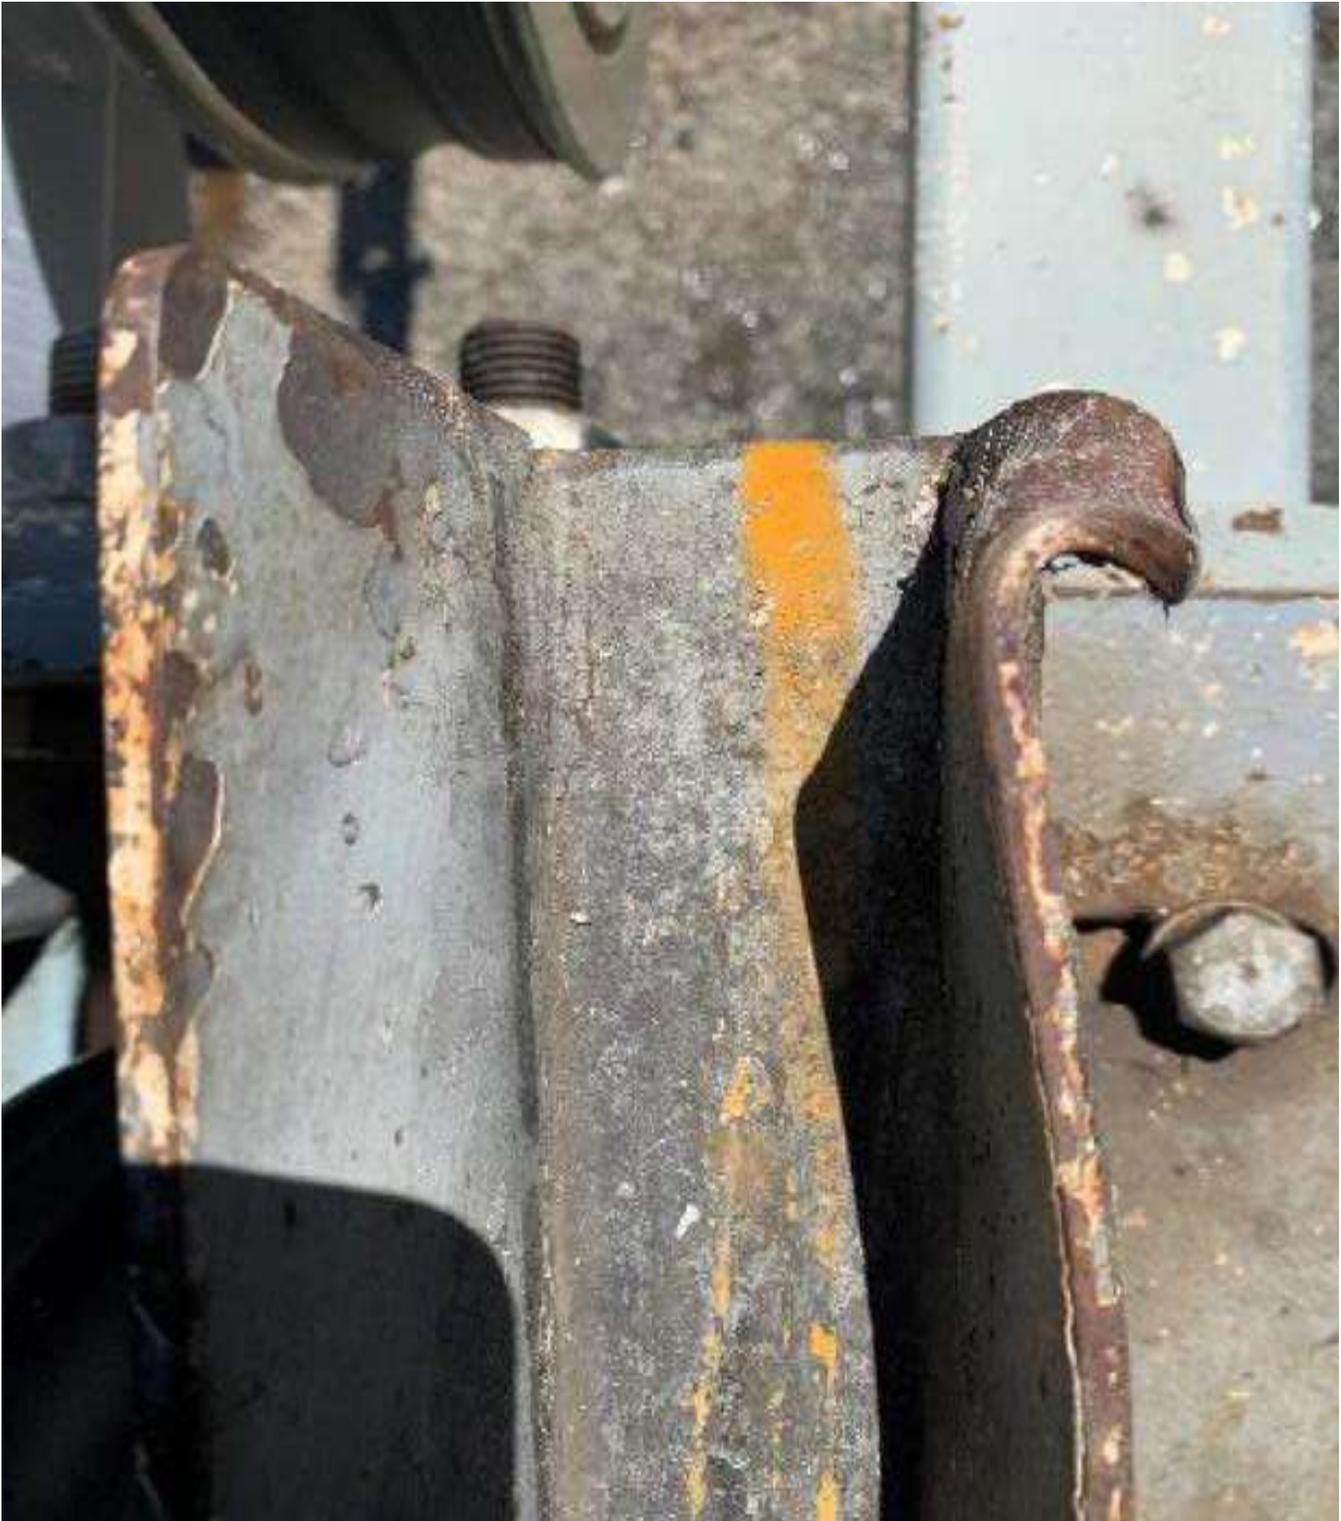
Image 3 - Deformity to Running Wheel Track Top View

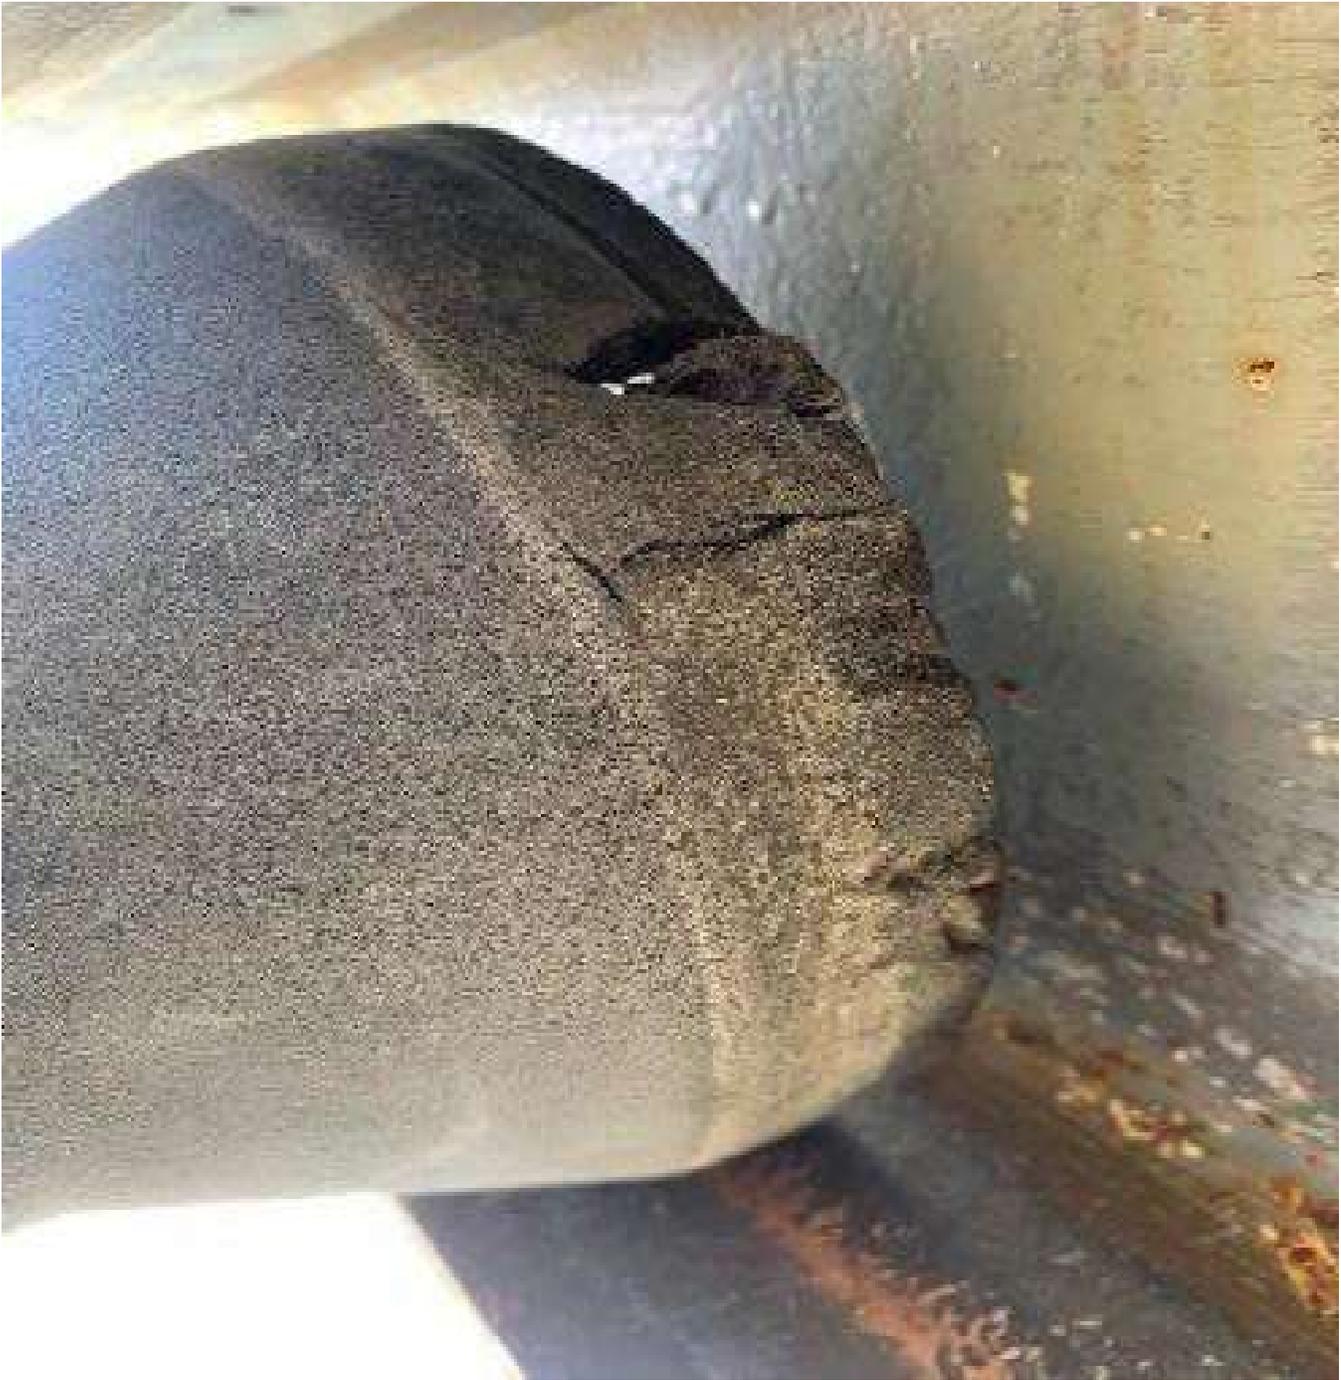
In a report provided by the operator, it was indicated that the grip trumpet wheel was in a less than ideal state. Photo of the trumpet provide evidence that it was significantly worn (multiple cracks with flattened and partially separated sections) (Image 4).

Image 4 - Grip Trumpet Wheel
