Incident Summary #II-1313279-2022 (#25769) (FINAL)

SUPPORTING INFORMATION	Incident Date	January 5, 2022	
	Location	Duncan, BC.	
	Regulated industry sector	Electrical - Low voltage electrical system (30V to 750V)	
	Impact	Qty injuries	0
		Injury description	None
			Injury rating
	Damage	Damage description	Electrical arcing caused smoke and melting damage to electrical metering equipment.
		Damage rating	Minor
	Incident rating	Minor	
Incident overview	An individual was installing a seven-jaw meter into a meter module located in a new electrical three phase meter centre. As the meter module was incorrectly installed, it pivoted in the meter centre causing a phase to ground arcing fault. Fault occurred within the meter centre and was contained within the enclosure.		
INVESTIGATION CONCLUSIONS	Site, system and components	<p>New commercial building with self contained electrical room located in the southwest corner of the building. 1200 Amp underground service and metering equipment is installed in this room.</p> <p>Components:</p> <ul style="list-style-type: none"> • Main 1200 Amp 208 Volt circuit breaker • 1200 Amp tap box • 3 X 800 Amp meter centre • 7 jaw meter socket module with a

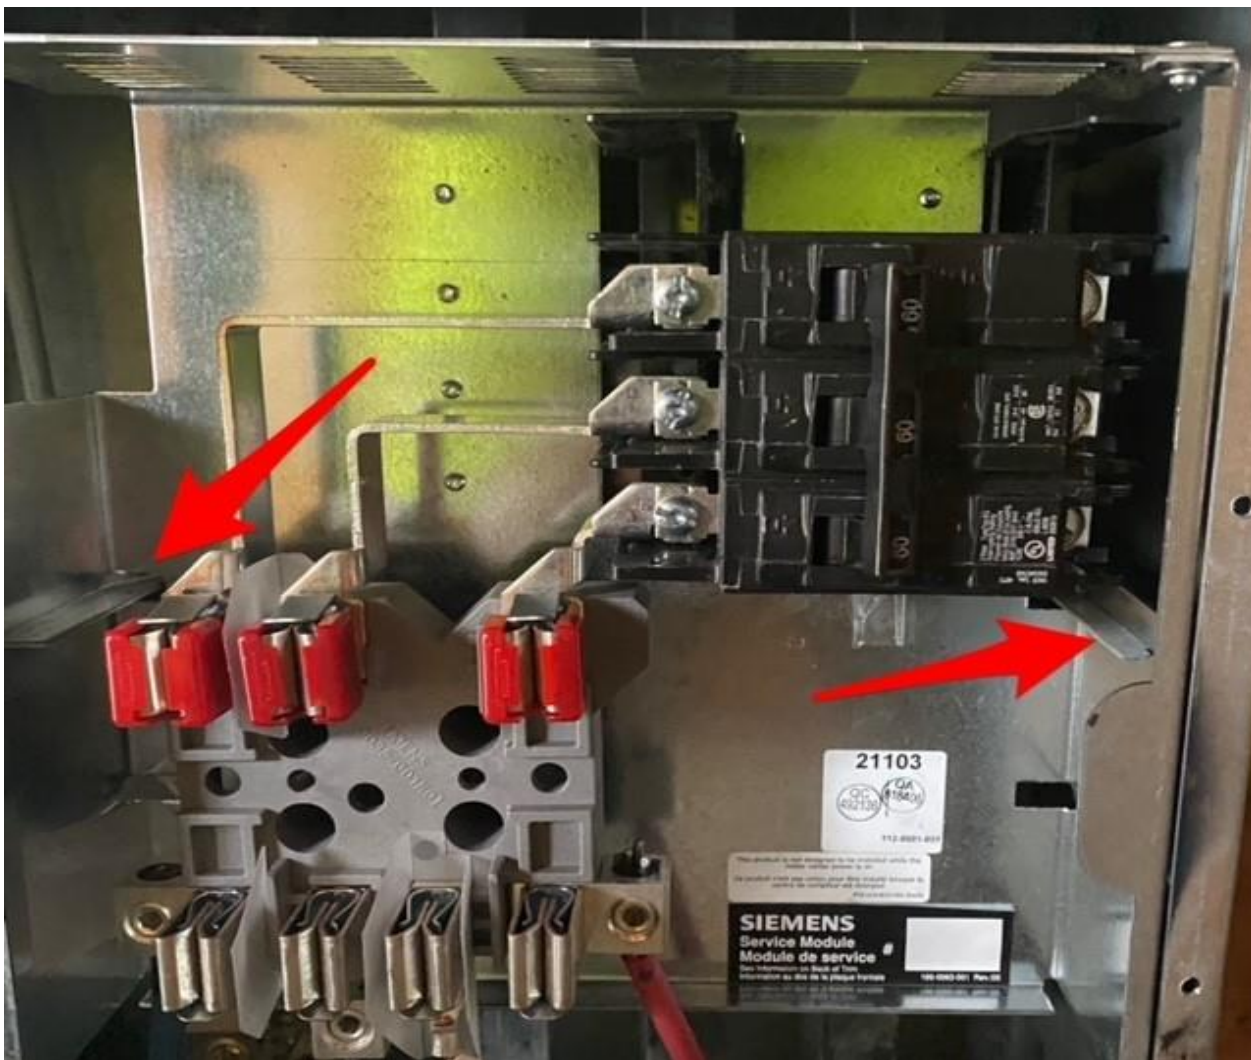
Image 1.

Three phase 100 Amp meter module correctly installed.

Red arrows indicate mounting fins in meter centre aligned with mounting slots in meter module

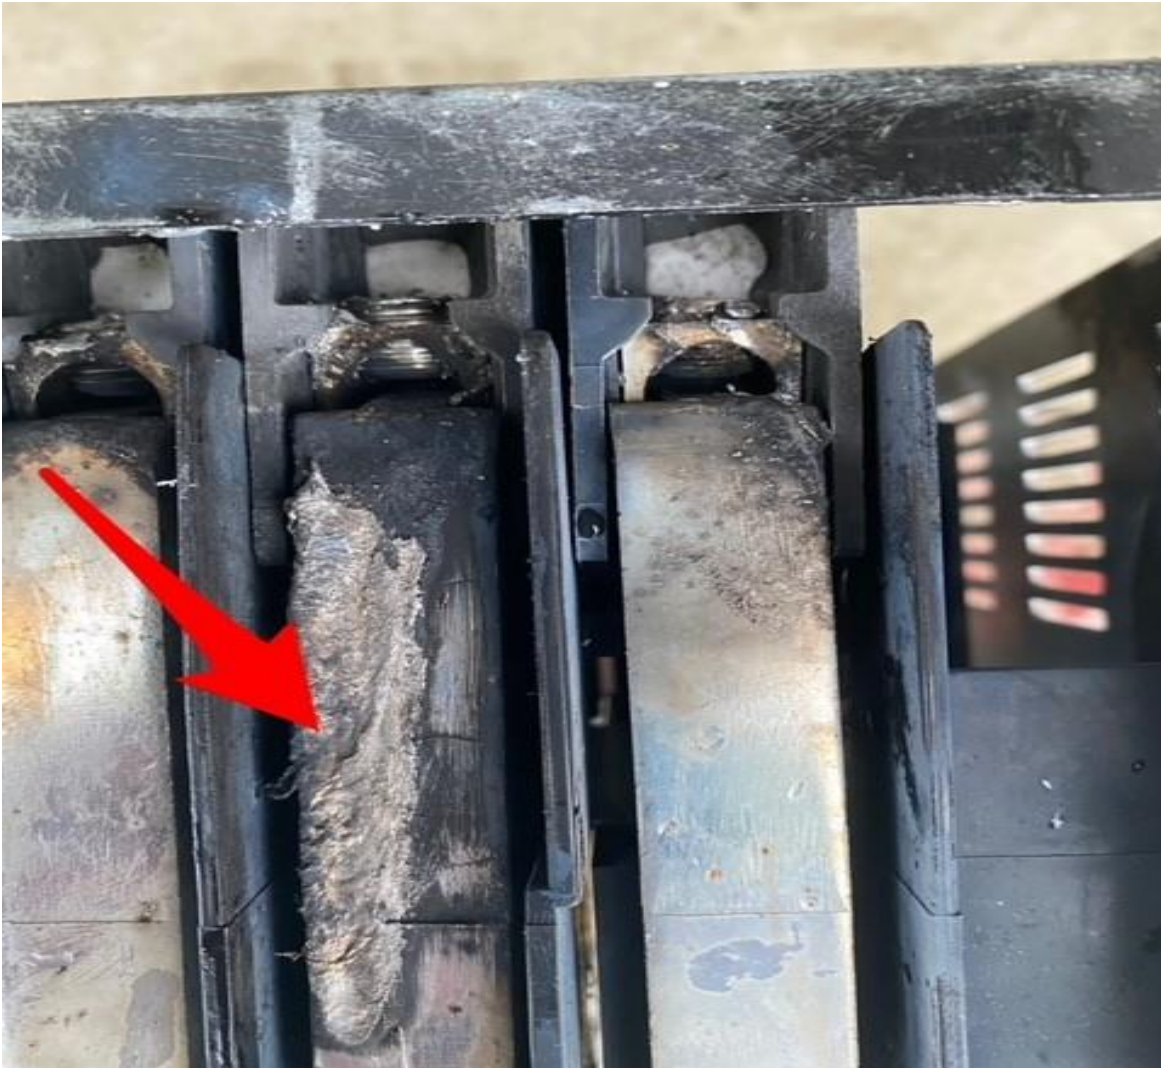
Image 2.

<p>Failure scenario(s)</p>	<p>A seven-jaw meter module was installed within the meter centre enclosure in a location that was not approved for that specific type of module. The module was installed at approximately 890 mm from the bottom of the meter centre to the centre of the meter socket. The manufacture specifies this 7 jaw meter socket module to be installed at either 661mm or 999mm. The incorrect installation of the meter module allowed the module to shift to the right contacting the mounting fins within the enclosure (Image 4). The module was installed prior to the system being energized by the supply authority. The main service was energized with the meter module overcurrent device de-energized. As the meter was being pressed into position. The module not being properly supported, the meter socket module was able to pivot and or flex causing an arcing fault between the module's energized buss system the meter centre enclosure. (Images 2,3,4)</p>

B phase meter module buss (close up)

Red arrow indicates location of arcing fault

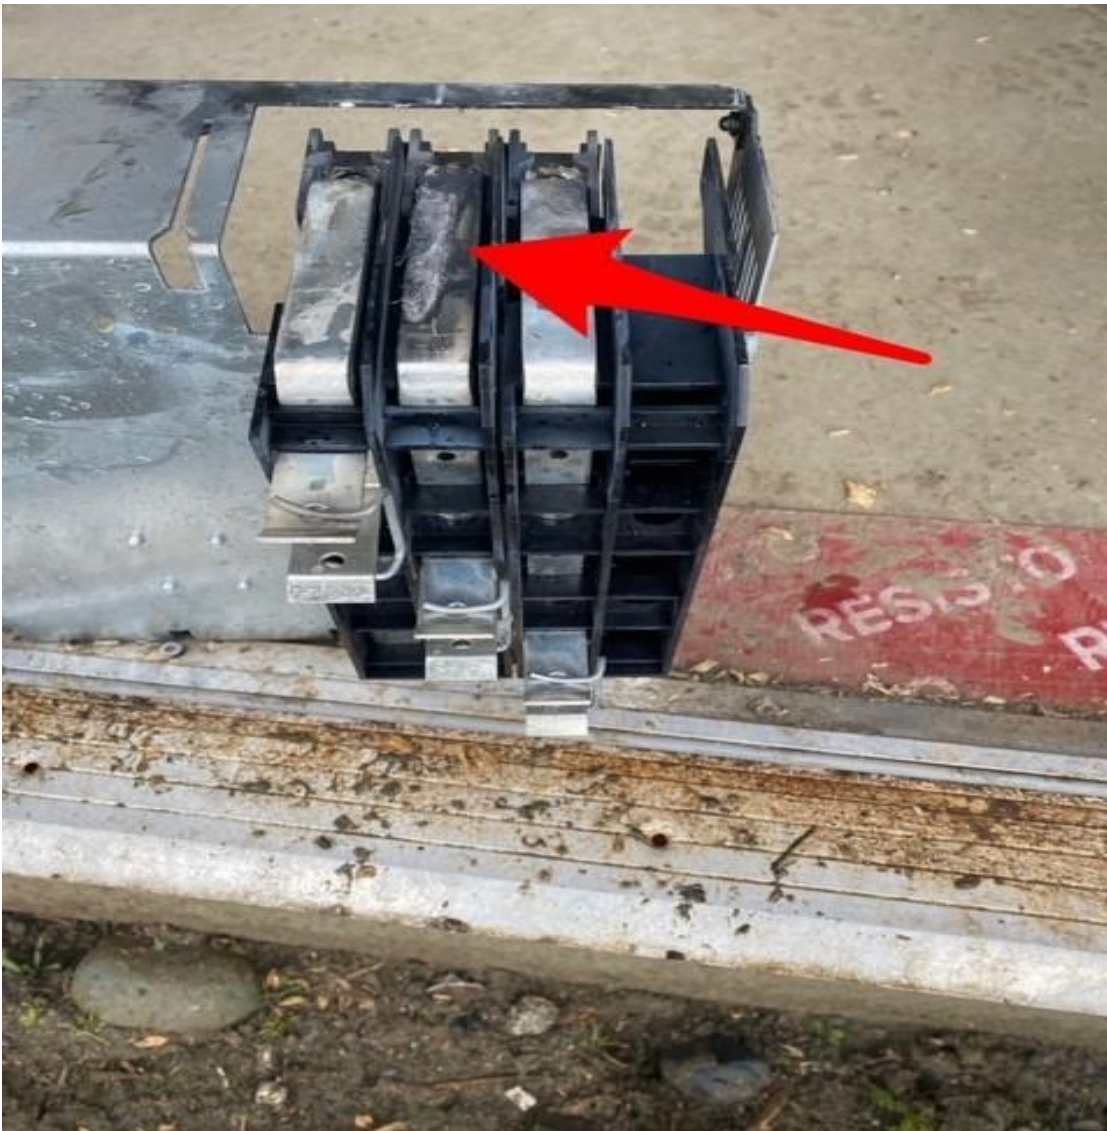
Image 3.

Three phase meter module red arrow indicates location of arcing fault

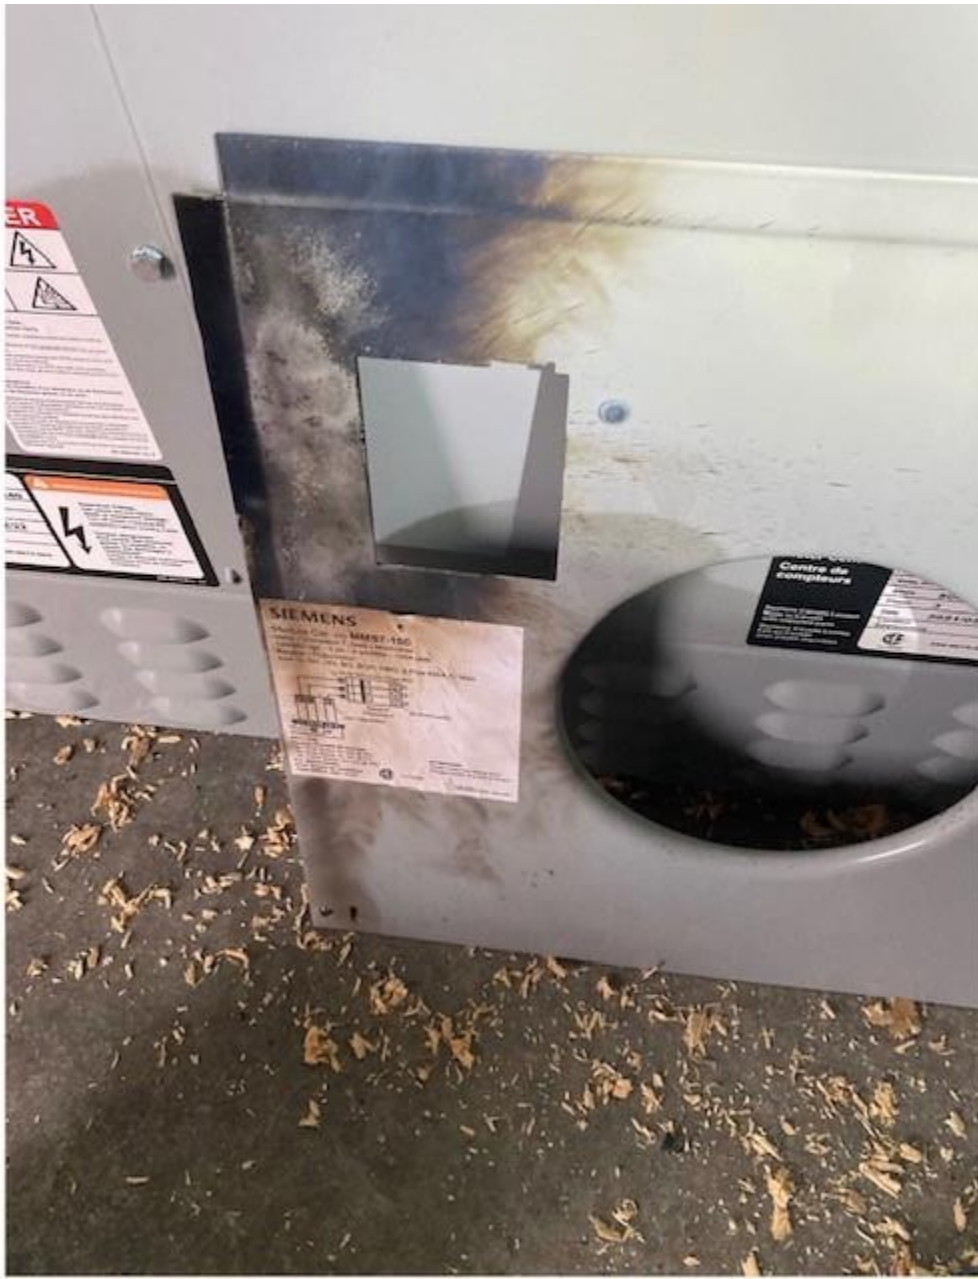
Image 4. Back side of meter cover

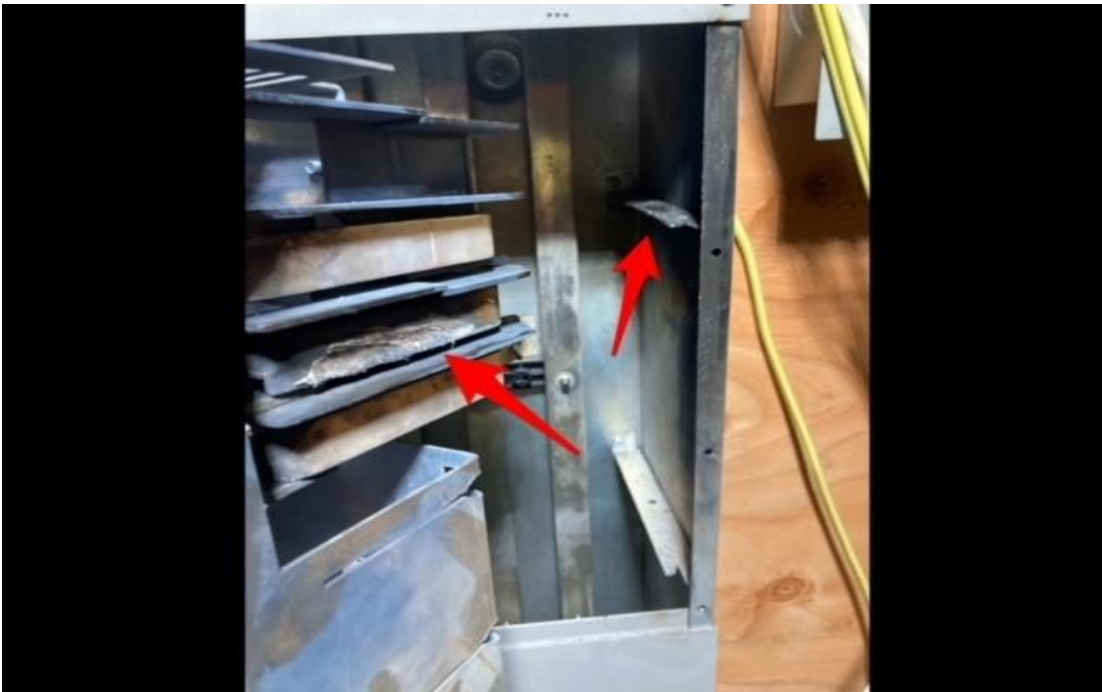
Image 5.

<p>Causes and contributing factors</p>	<p>The cause of this incident was very likely due to the 7 jaw 3 phase meter module being installed in the incorrect location. This location allowed the energized parts of the meter module to have contacted the meter centre enclosure.</p> <p>It is very likely because the module installed has four support slots (two on left side and two on the right) these slots align with horizontal support fins located left and right side within the meter centre enclosure. When the module is installed in the correct location the support fins align with slots supporting the module on both sides</p>

(image 1). This prevents pivoting or movement of the module and ensures correct clearances around energized electrical equipment. The module was installed at approximately 890 mm from the bottom of the meter centre to the centre of the meter socket. The manufacture specifies this 7 jaw meter socket module to be installed at either 661mm or 999mm (image 6). The incorrect installation of the meter module allowed the module to shift to the right making contact with the energized 'B' phase buss of the meter module and the arcing fault to occur.

Meter module located in incorrect position. Red arrows indicate B phase buss on meter module and mounting fin on meter centre

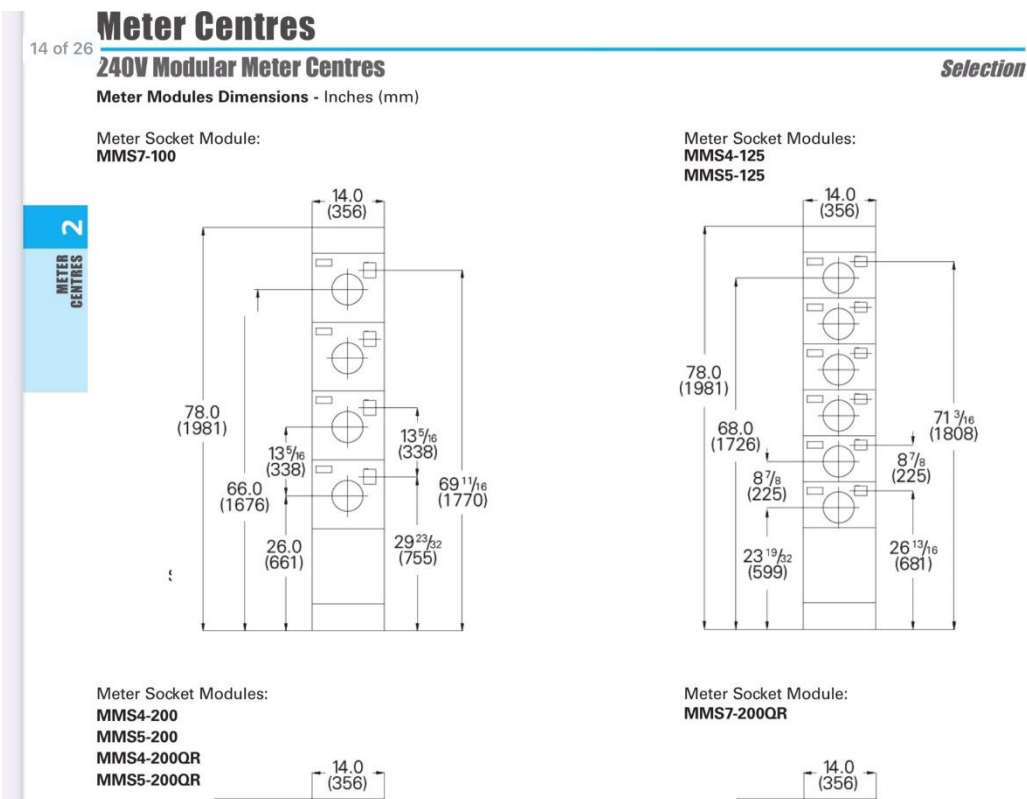
<p>Facts and evidence</p>	<p>Witness statement:</p> <ul style="list-style-type: none"> • An Individual was installing a seven jaw meter and had de-energized the meter base with the breaker as per procedure. As individual was pressing on the meter to seat the meter into the jaws a short circuit and arc fault occurred in the cabinet. No injuries sustained as crew had on appropriate arc flash protection. <p>Electrical contractor interview:</p> <ul style="list-style-type: none"> • Contractor indicated to the Safety Officer the location of the meter module in the meter centre where it was installed at the time of the incident • Contractor stated they had installed three meter stack fillers two below the meter module and one above • Contractor indicated where the meter module energized buss had contacted the meter centre enclosure <p>Safety Officer observation:</p> <ul style="list-style-type: none"> • Meter module 'B' phase buss system melted • Meter module 100 Amp 3 phase overcurrent device damaged • Meter module (images 2,3,5) and meter enclosure cover (Image 4) with smoke damage, molten metal and pitting directly beside the overcurrent device location. • Documentation from the manufacture of the electrical equipment installed showing exact location heights of each type of meter module to be installed within the meter centre enclosure. (Image 6) • All electrical equipment installed was approved for use in BC.

Image 6. Manufacturers installation specification sheet (MMS7-100 installed)
