SAFETY ORDER

No: SO-P4 091002 1

DOPPELMAYR CTEC SAFETY ALERT BULLETIN SA-08-021 WOLFURT KD08003E

Title: **Tower Failure Due to Water Intrusion**

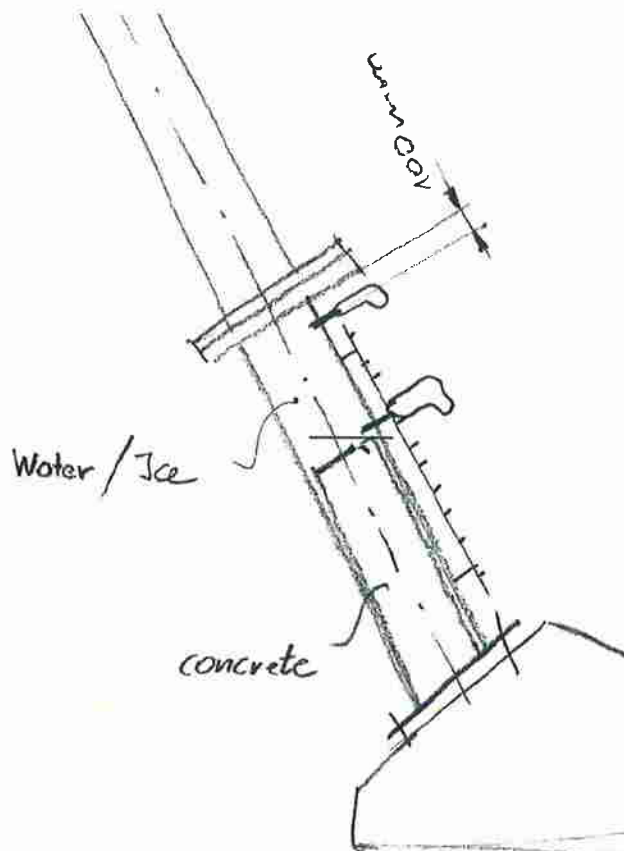
For tower shaft sections partially filled with concrete through the top plate, check the tower section with the hammer method as described previously. If water/ice is suspected, drill a small hole 3/8" - 1/2" (10 - 12 mm) approx. 2 inches (50 mm) below the top plate on the uphill side of the tower (behind the ladder). Tower shafts with a cover for concrete fill on the outside of the shaft already have a drain hole and the cover can be removed for inspection purposes. **If ice is found in this section, this shall be cause for immediate and continued closure of the lift to public transportation** and must be reported to the nearest Doppelmayr representation office for review and recommended repair procedures.

A small drain hole 3/8" - 1/2" (10 - 12 mm) is required to eliminate the water above the concrete level. See illustration below.

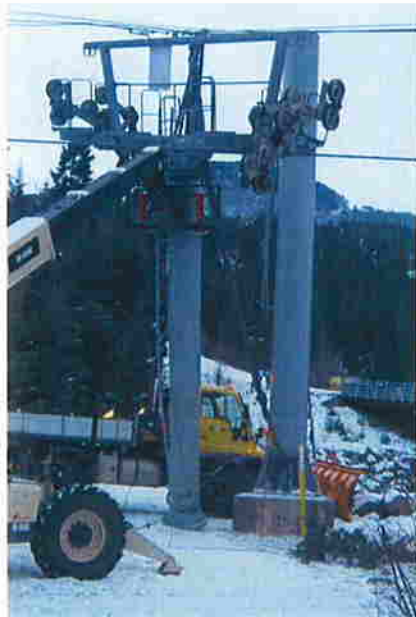
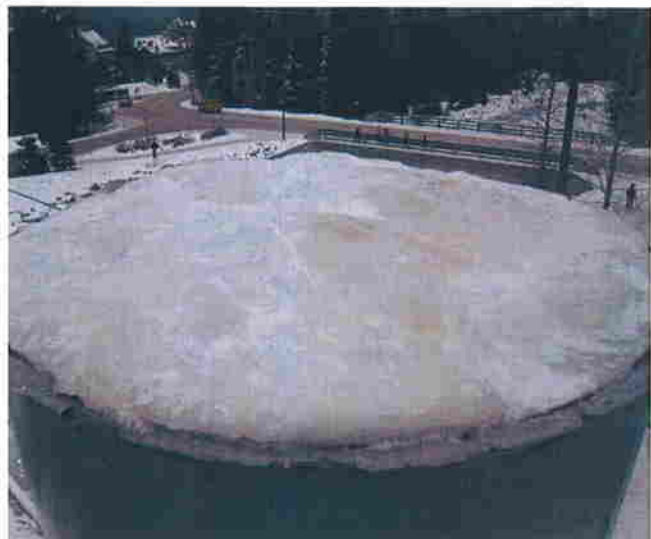
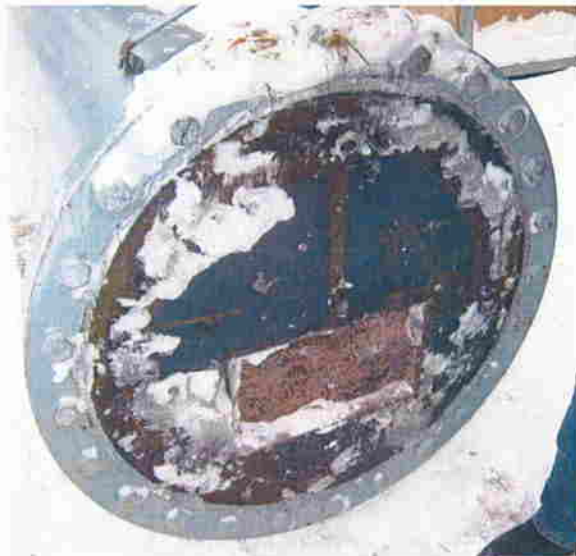
Tower with 2 x 6T/2FR assemblies;
16,7m tall; 9,7m of 30" tube spliced
to 7m of 24" tube.

Lower tower section filled approx.
5m with concrete, the remainder
with ice.

Temperature approx. -12°C/10°F.

Bottom tower section top flange
plate was pushed off the shaft by
ice and caused top tower section to
separate and fall.

The comm. line and the haul ropes
supported the tower head so the
upper section came to rest in a
more or less vertical position on the
ground.
