## Incident Summary ( File # 5623112) (Final)

SUPPORTING INFORMATION	Incident Date	<i>October 16, 2017</i>	
	Location	<i>Coquitlam</i>	
	Regulated industry sector	<i>Elevating Devices- Escalator</i>	
	Impact	Qty injuries	<i>1</i>
		Injury description	<i>One person sustained minor scrapes, cuts and bruising to their left ankle.</i>
		Injury rating	<i>Minor</i>
	Damage	Damage description	<i>Escalator skirt panel crumpled. Sections of escalator step cast metal edge cracked and broken.</i>
		Damage rating	<i>Minor</i>
	Incident rating	<i>Minor</i>	
Incident overview	<i>One person riding an escalator had their boot caught between the moving step and the escalator skirt panel. The escalator skirt panel was caught by the moving escalator step causing skirt panel and escalator step damage.</i>		
INVESTIGATION CONCLUSIONS	Site, system and components	<i>Escalators have cast metal steps that move passengers up or down the escalator. Escalator skirts are stationary vertical panels that close the gaps on either side of the escalator steps to prevent passengers appendages and objects from being caught between the moving steps and stationary structure of the escalator. The escalator skirt consis

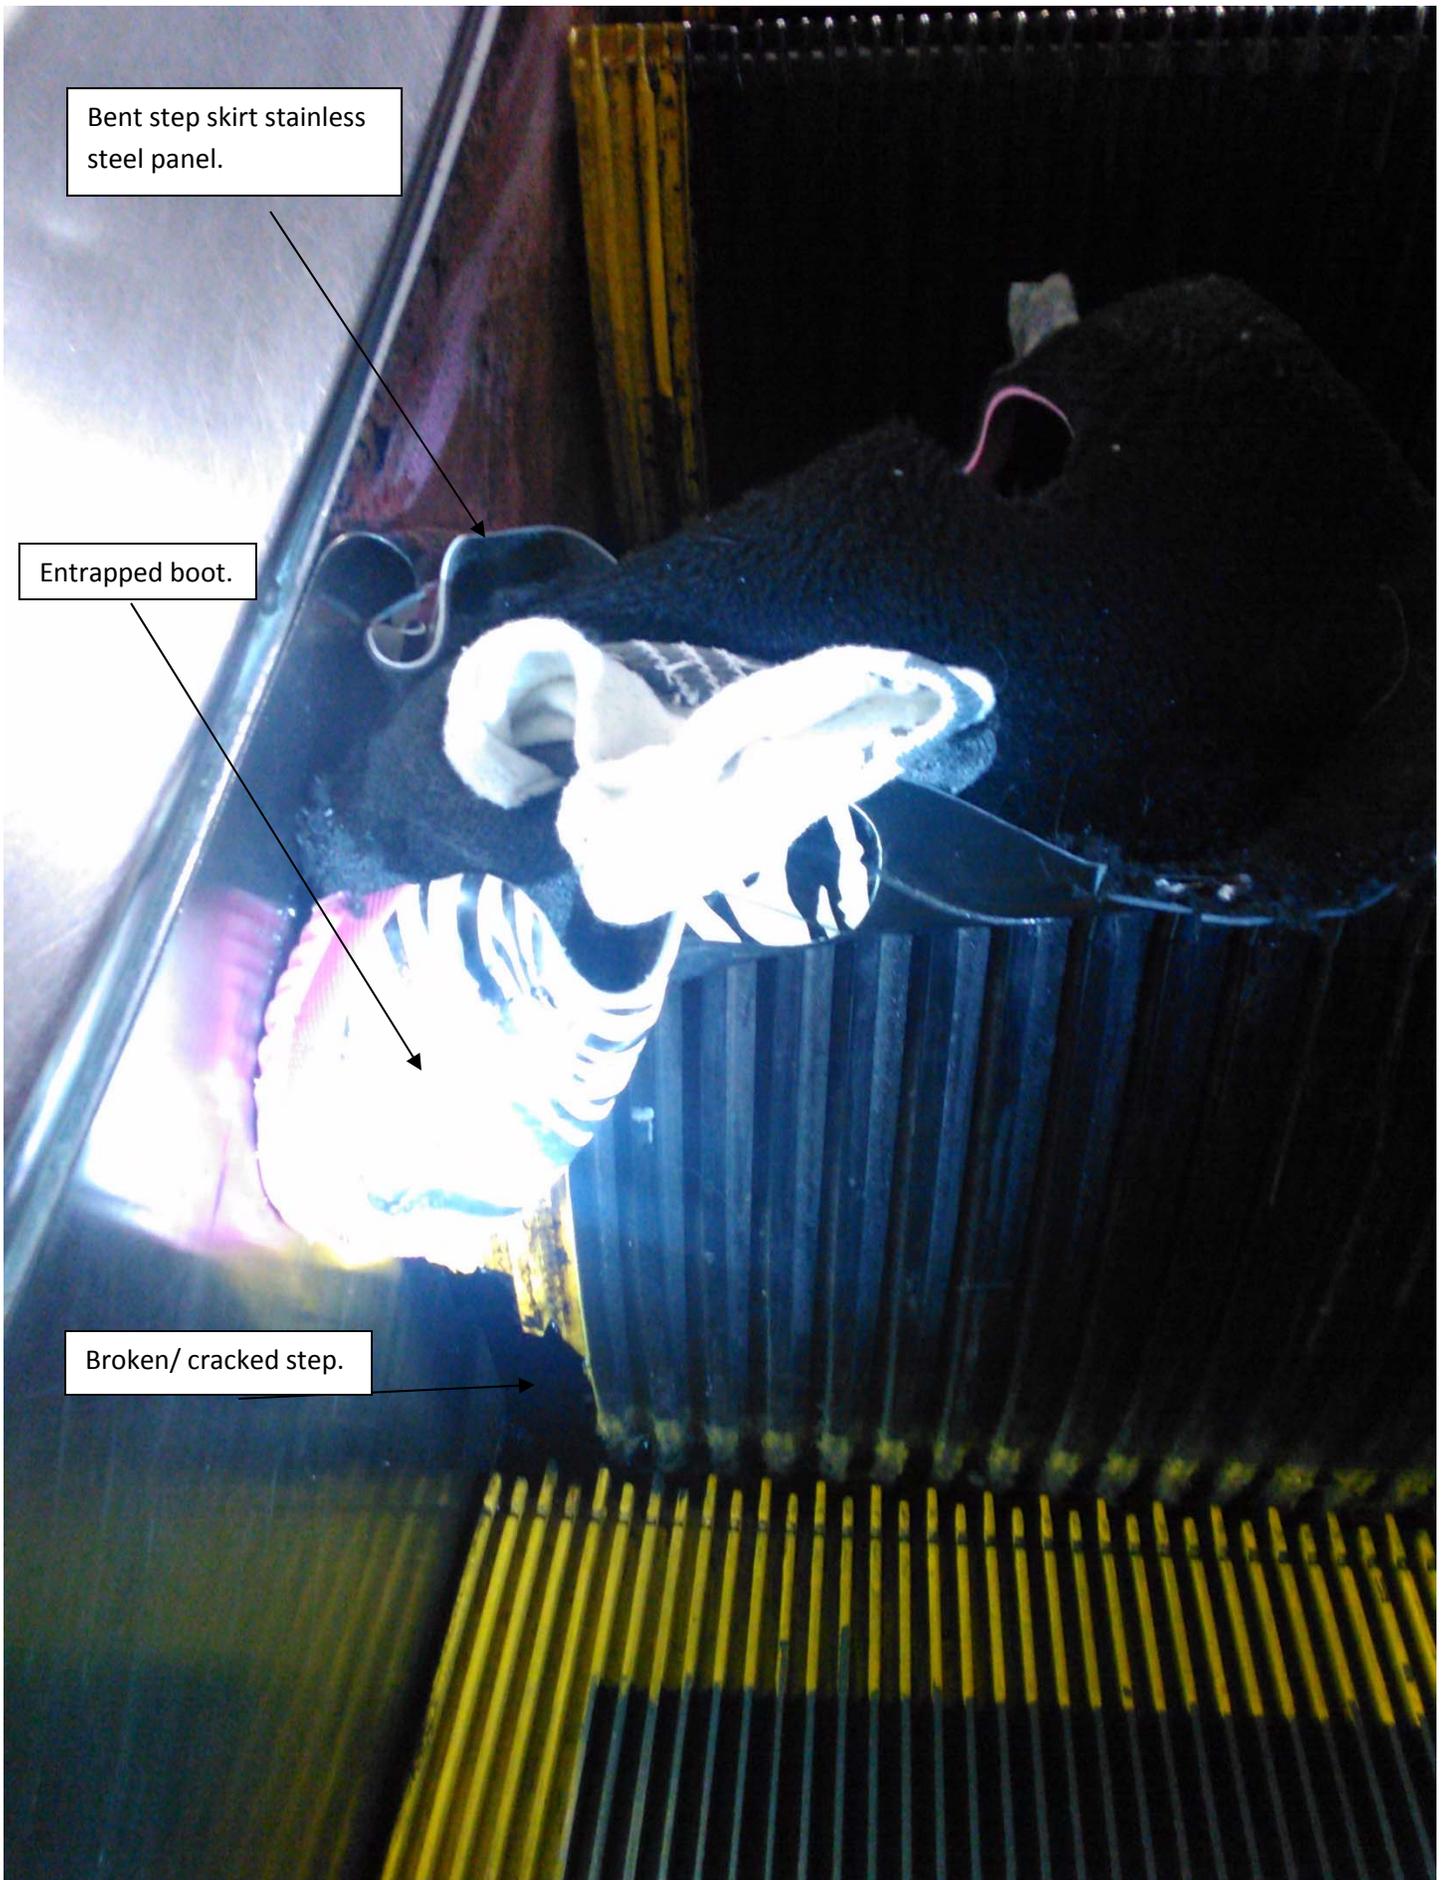
Bent step skirt stainless steel panel.

Entrapped boot.

Broken/ cracked step.

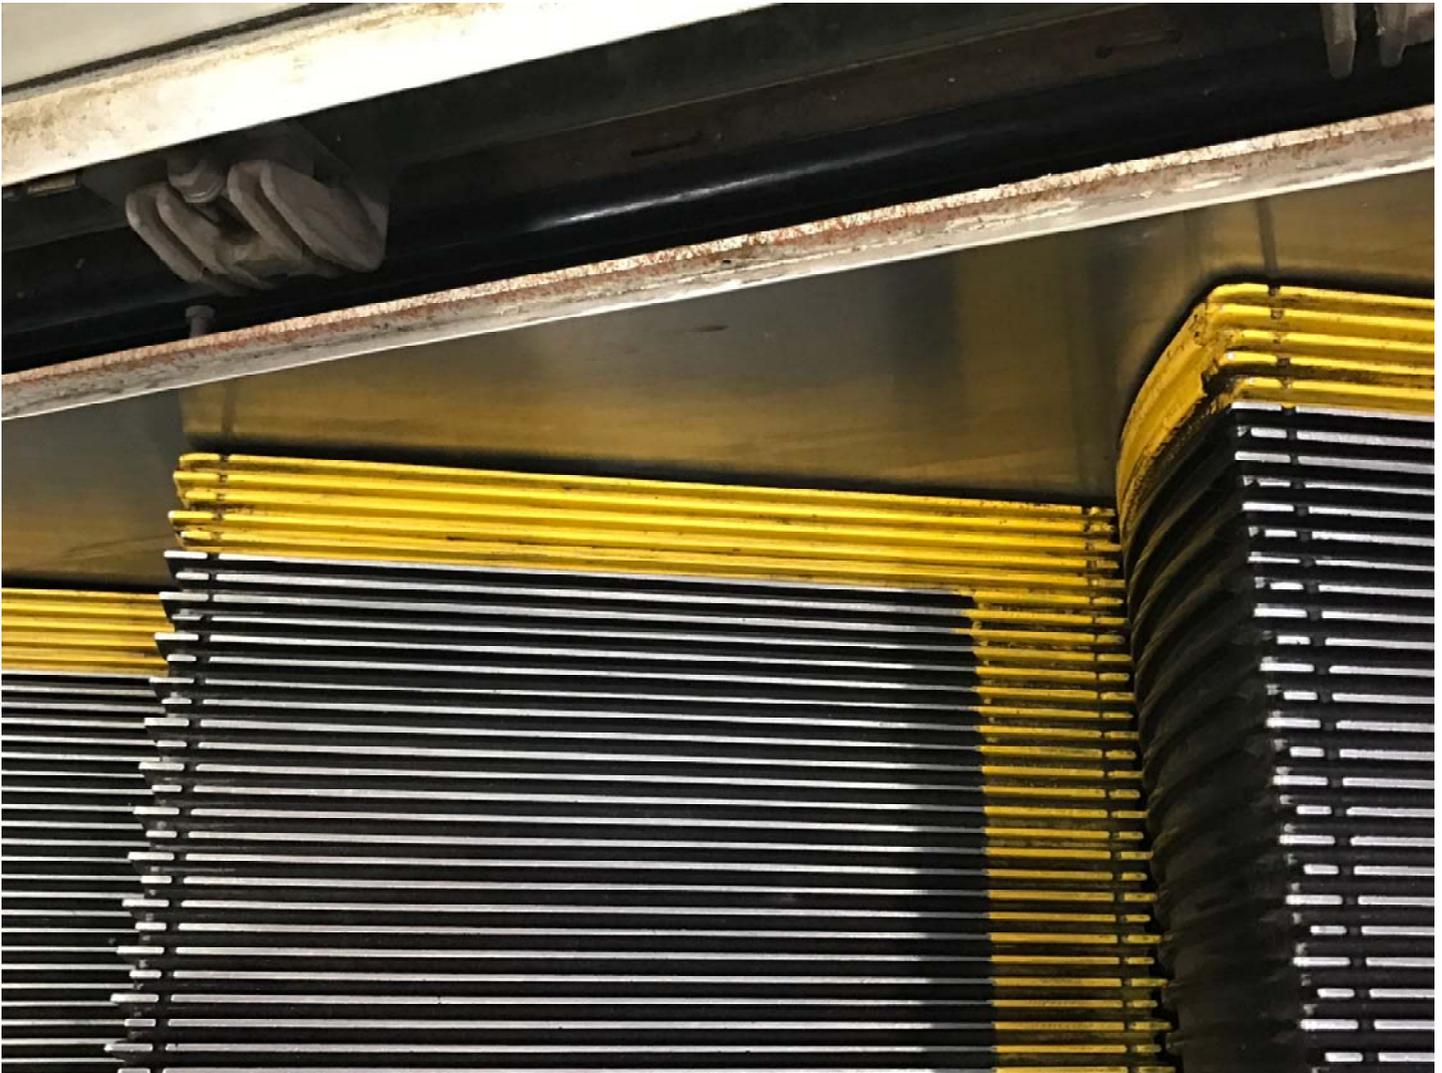
Photo showing gap between the escalator step and the vertical escalator step skirt.

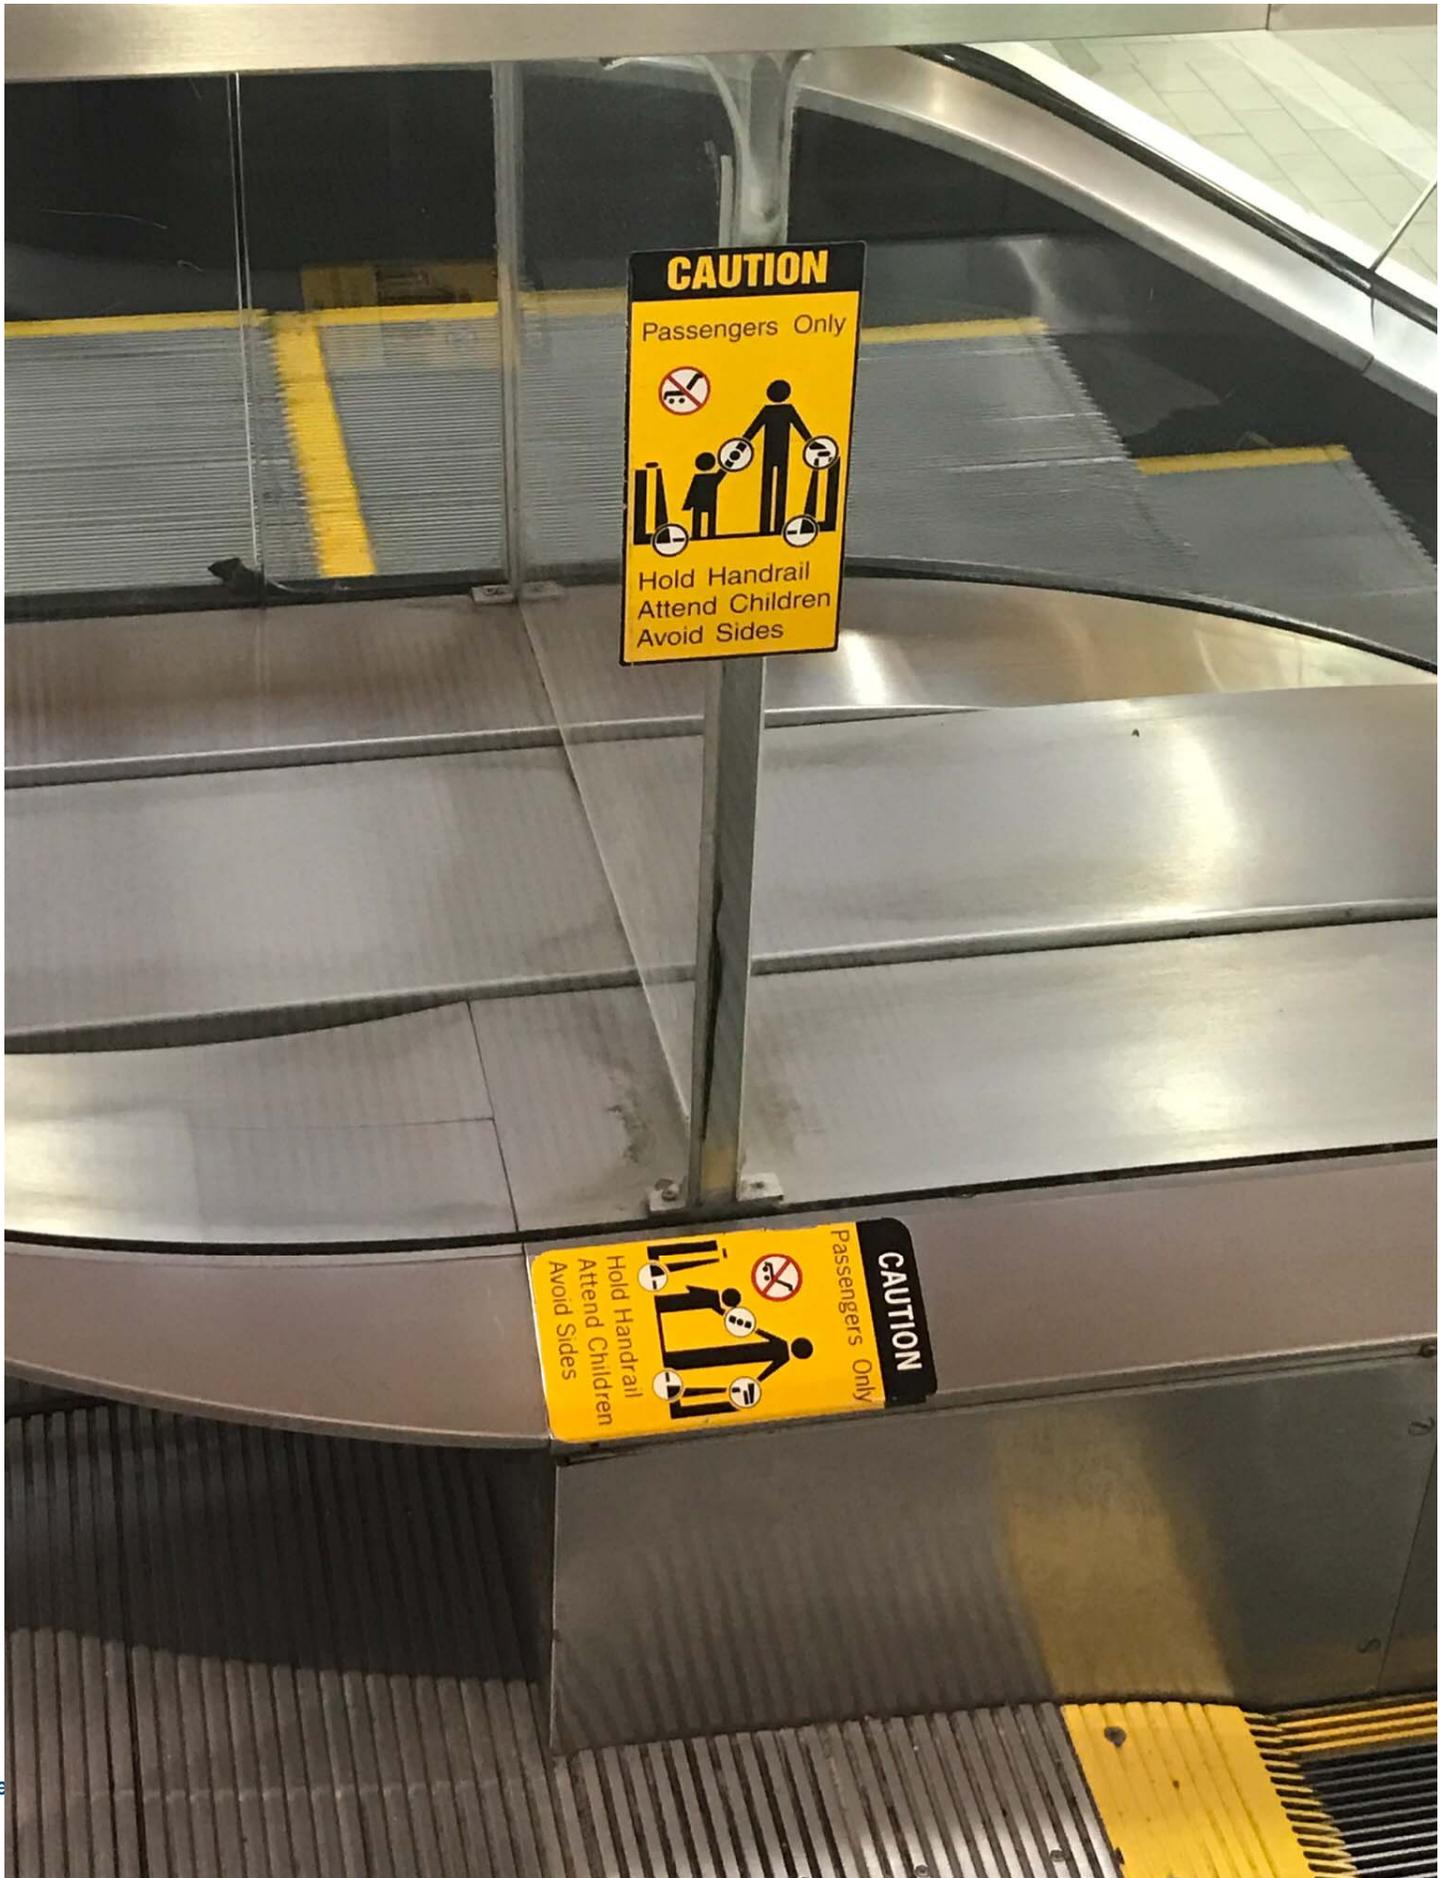
Pictogram showing proper rider rules.
