Incident Summary (Reference # II 607002-2017)

SUPPORTING INFORMATION	Incident Date	October 24, 2017	
	Location	Port Coquitlam	
	Regulated industry sector	Refrigeration system	
	Impact	Qty injuries	None
		Injury description	None
		Injury rating	None
	Damage	Damage description	A suction regulator O-ring was blown out and this allowed approximately 2 pounds of ammonia to leak in to the boning department..
		Damage rating	Insignificant
Incident rating	Minor		
Incident overview	The suction regulator O-ring on an ammonia refrigerant system failed and allowed ammonia gas to leak into the boning room where production workers were present. The supervisor of the boning room noticed a faint smell of ammonia and evacuated the production workers as a precaution.		
INVESTIGATION CONCLUSIONS	Site, system and components	<i>The equipment that failed is located in the boning room that is part of a poultry processing plant. The boning room process is mainly taking the poultry by-product and cooling this product to near 2 Celsius by passing it through a heat exchanger that is fitted with a surge drum. The heat exchanger and a portion of the surge drum are filled with liquid ammonia and as the by-prod

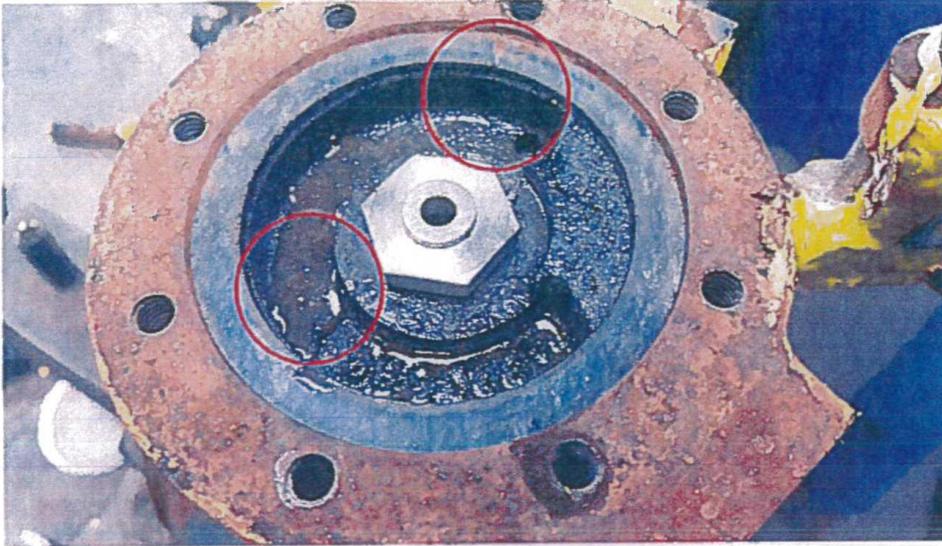
<p>reached 25 ppm and the alarm was triggered by the leak detection system. Full plant evacuation was initiated as a precaution.</p> <ul style="list-style-type: none"> • The ventilation fans were switched on for the boning department area. • The ammonia levels as indicated on a panel outside the maintenance department indicated 29 ppm for the boning department and 0 ppm for the rest of the plant. The refrigeration mechanic who was called in by the maintenance department arrived on scene and isolated the suction regulator by way of isolation valves that are located outside the boning department. • The highest level the leak detection system reached was 41 ppm of ammonia in the boning department and it took approximately 2 hours before the leak detection system indicated 0 ppm. • The suction regulator is subjected to the daily sanitizing wash and was found to be corroded and had internal moisture and rust.

Corroded suction regulator and moisture present

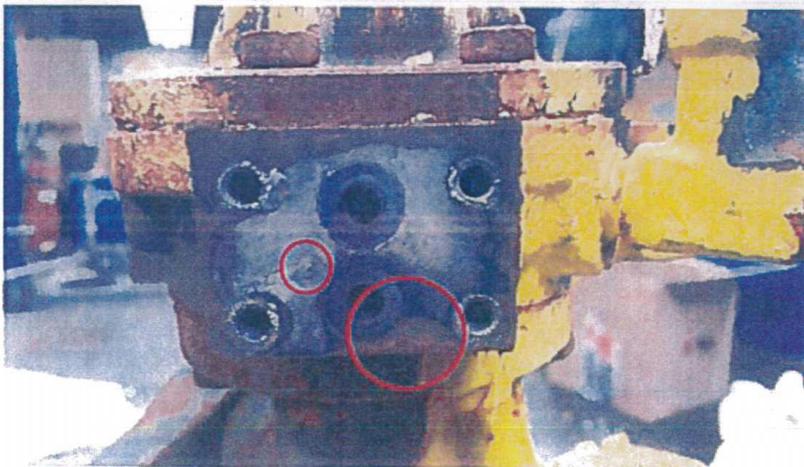
Failure scenario(s)	One of the O-rings in the suction regulator failed and allowed ammonia gas to leak into the boning room. <ol style="list-style-type: none"> 1. O-ring failure due to the age and lack of maintenance 2. The O-rings are subjected to varying pressure and temperature changes throughout the day depending on the operating mode such as cooling or defrost cycle. 	
	Facts and evidence	<ul style="list-style-type: none"> • The boning room supervisor detected a faint smell of ammonia in the boning department but there was no audible ammonia leak detection alarm at this point. • The leak detection system will activate an alarm when the level of ammonia reaches 25 ppm. • The boning department supervisor called the maintenance department to investigate and evacuated all the employees from the boning department area. Eventually the ammonia concentration level in the boning department

<p>Causes and contributing factors</p>	<p>The suction regulator bottom O-ring was found to be blown out and this allowed the ammonia gas to leak in to the room. It is likely the O-ring was subjected to varying temperatures and pressures throughout the day and over time the mechanical properties of the material declines.</p>

Suction regulator – bottom "O" ring is blown out and the seat face has a dimple in it
