Incident Summary (Reference #5263) (Final)

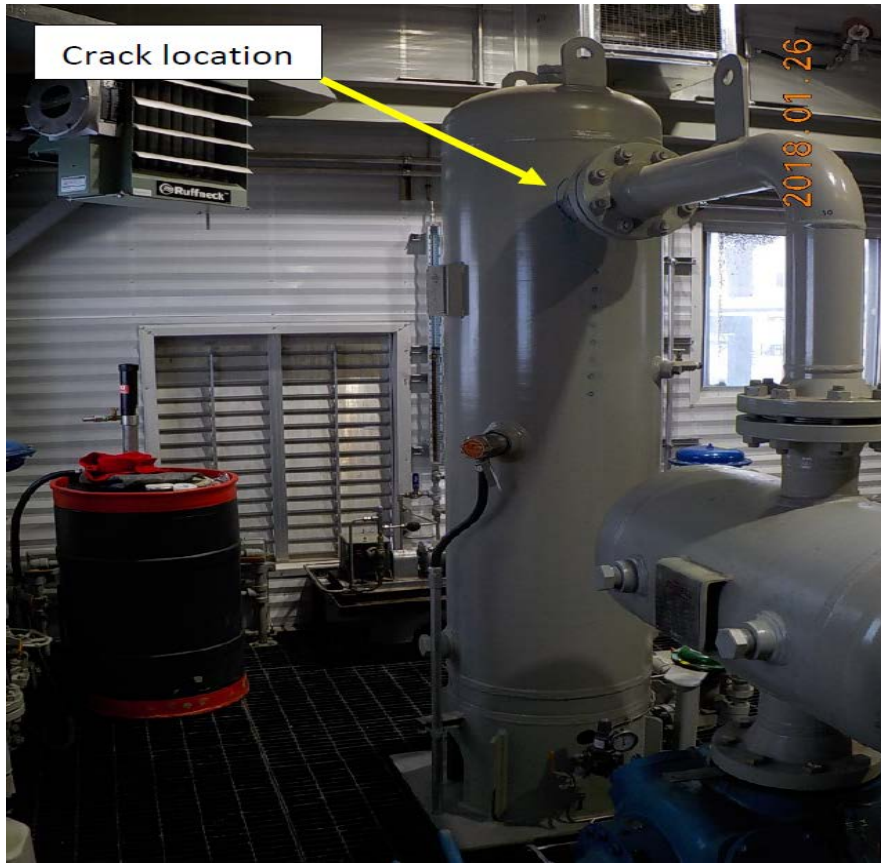
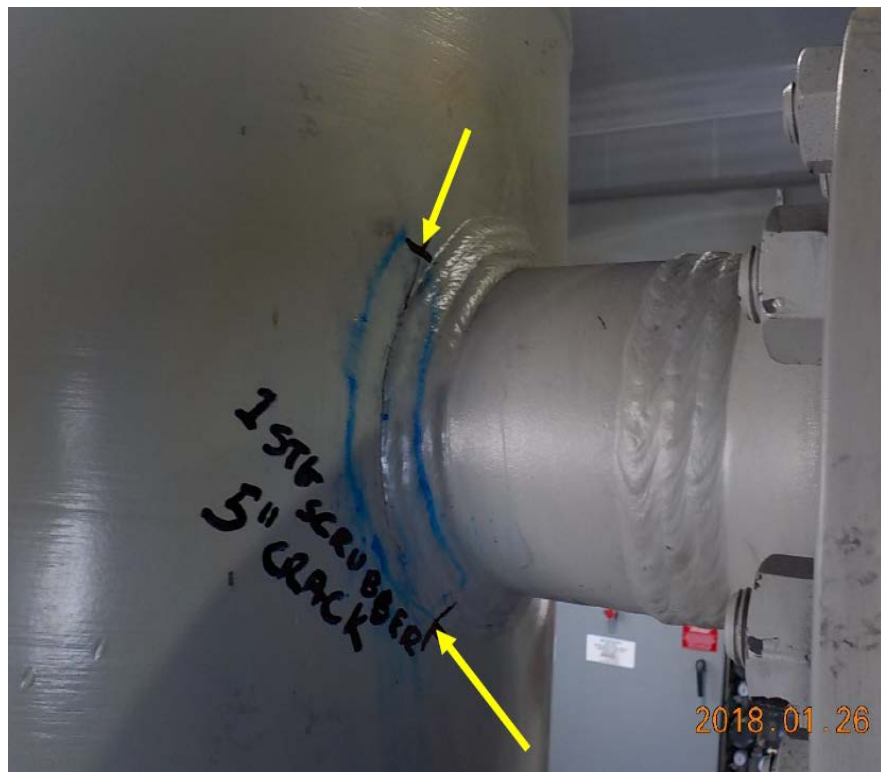
SUPPORTING INFORMATION	Incident Date	January 25, 2018	
	Location	Dawson Creek	
	Regulated industry sector	Boiler and Pressure Vessel	
	Impact	Qty injuries	None
		Injury description	None
		Injury rating	None
	Damage	Damage description	An outlet nozzle weld on a suction scrubber (A vertical pressure vessel) cracked.
		Damage rating	Moderate
	Incident rating	Moderate	
Incident overview	Nozzle weld failure on 1 st Stage Suction scrubber(A vertical pressure vessel) resulting in gas leaking through weld. Gas detection within the building alerted operator and compressor was shut down and depressurized.		
INVESTIGATION CONCLUSIONS	Site, system and components	This site is a remote industrial gas facility. Under normal circumstances, this type of vessel removes traces of liquid droplets from gas streams to protect downstream equipment from damage and failure.	
	Failure scenario(s)	-Vibration transmitted from the equipment associated with this vessel. - Weight of the piping assembly connected to equipment adding to outlet nozzle stress.

Facts and evidence	-Equipment connected to this scrubber transmits vibration to the scrubber. - The connected piping bears on the outlet nozzle - It is not independently supported..	
	Causes and contributing factors	Vibration and mechanical design may have caused the nozzle weld failure.
