## Incident Summary #II-692974-2018 (#7309) (FINAL)

SUPPORTING INFORMATION	Incident Date	May 19, 2018	
	Location	Vancouver, BC	
	Regulated industry sector	Amusement Devices - Amusement ride	
	Impact	Qty injuries	0
		Injury description	None
		Injury rating	None
	Damage	Damage description	Failure of a passenger shoulder restraint system on a roller coaster.
		Damage rating	Moderate
	Incident rating	Moderate	
	Incident overview	On May 19, 2018 a passenger shoulder restraint system failed while the ride was in motion, such that the rider was not secured. The passenger completed the ride with no physical injury.	
INVESTIGATION CONCLUSIONS	Site, system and components	The ride was approximately 32 years old on the date of incident. The ride is generally known as a corkscrew roller coaster, given the helical shape of the track. Passengers are secured in their seat by a pair of padded bars that cover the shoulders and front torso. The passenger shoulder restraint is held in place with an assembly that includes a threaded trunnion bolt (“trunnion bolt”) fastened into the top of a ratchet shaft, Appendix A. The trunnion bolt is fastened by a threaded connection and secured into the ratchet s

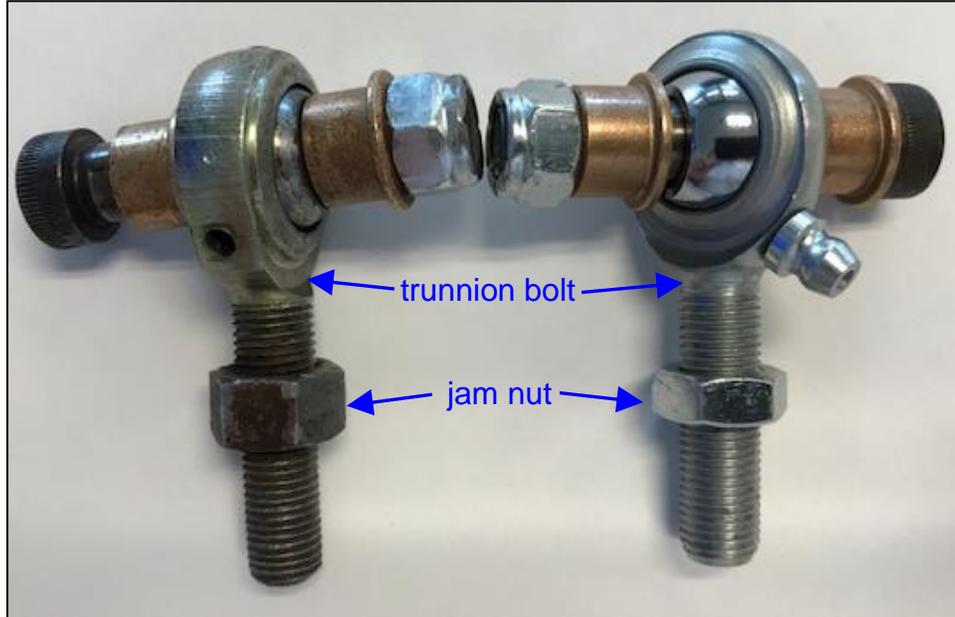
Figure 1: Incident trunnion bolt (left) compared to new part from the original manufacturer (right)

<p>the ratchet shaft was made of hardened steel whereas the trunnion bolt was mild steel.</p> <p>Testing found mechanical properties of the incident trunnion bolt to be similar to the OEM bolt. The jam nut used on the incident bolt had 25% less strength and hardness than the original. The OEM had specified that a Grade 8 bolt be used, the incident nut and bolt were found to be a lower strength Grade 2.</p> <p>The corrosion resistant coating had been worn off of the incident jam nut. This jam nut was found to be seized onto the bolt due to oxidation (rust), Figure 4. It may not have been possible to turn the nut to tighten the fastener during routine maintenance checks. It is evident that the trunnion bolt was not in serviceable condition at the time of failure.</p> <p>The bolt threads located above the jam nut were in good condition but heavily worn below the nut, Figure 5. The excessive wear in the lower threads was due to movement of the mild steel bolt against the hardened steel ratchet shaft during ride operation. This movement caused the shaft to abrade the bolt until the crowns of the bolt threads were worn down to the point that the trunnion bolt was no longer securely fastened in the ratchet shaft.</p> <p>Given that the bolt was seized, a torque check may not have detected that that the fastener was loose because the jam nut would feel tight (due to being seized onto bolt). Records show that 12 new trunnion bolts had been purchased in January 2013, enough to replace one quarter (25%) of the 48 seats on the two trains for the corkscrew roller coaster. No further trunnion bolts had been purchased up to the date of the incident.</p> <p>In order for threaded fasteners to remain secure a specific pre-load (torque) must be applied to the bolt and jam nut during installation and must be maintained during the service life of the equipment. Verifying the shoulder restraint bolt tightness should be part of a routine maintenance program for the roller coaster as per the applicable standards. The applicable standard in effect at the time of the incident was <i>CAN/CSA-Z267 Safety Code for Amusement Rides and Devices</i>. This standard requires that the ride manufacturer provide torque requirements for fasteners and that the owner/operator inspect, test and maintain the equipment, including preventive maintenance to prevent equipment failure.</p> <p>Following the incident, an investigation was conducted by an engineering firm and a report was issued, dated May 24, 2018. The report recommended replacement of the affected ride hardware with new parts supplied by the manufacturer.</p>

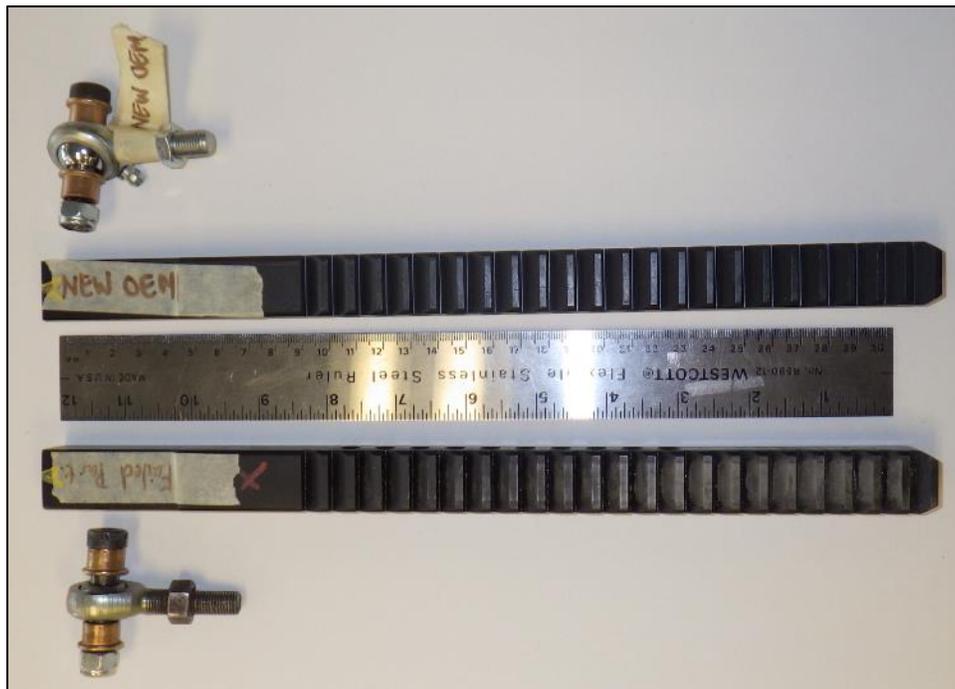
Figure 2: Trunnion bolts and ratchet shafts, incident (below) and new OEM samples (above).

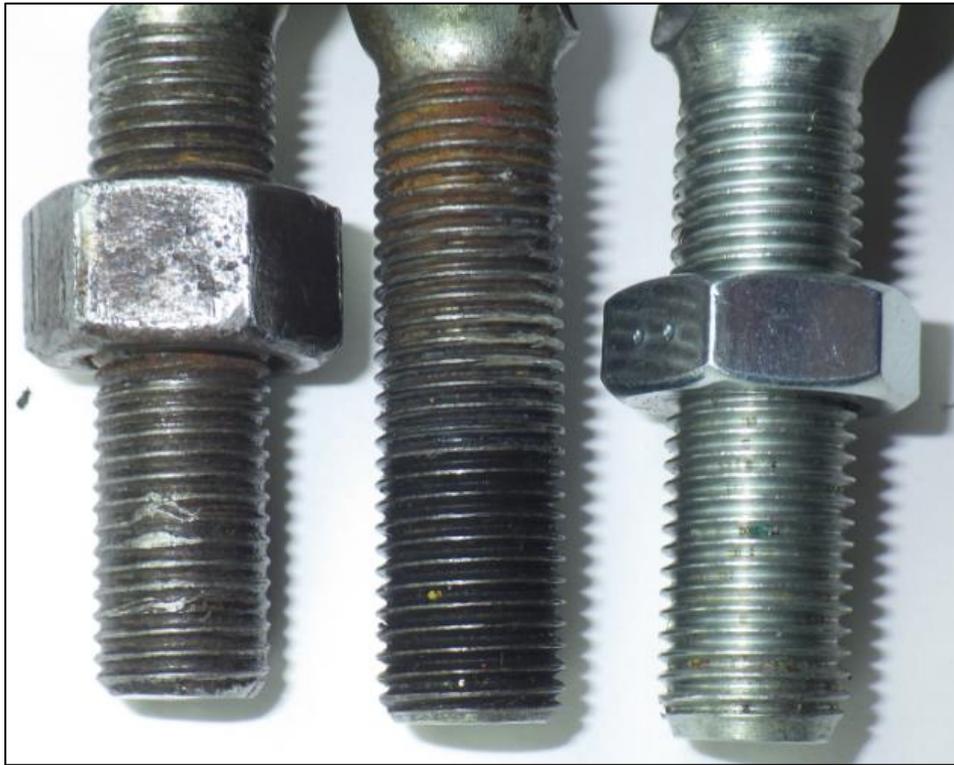
<p>Causes and contributing factors</p>	<p>The incident trunnion bolt failed due to the bolt threads being worn down over time during operation to the point where it was no longer in serviceable condition. The heavily worn bolt threads no longer provided enough contact with the mating threads in the ratchet shaft to resist being pulled out due to normal forces experienced during ride operation. It is likely that the trunnion bolt became loose because the jam nut had seized to the bolt due to oxidation (rust) and could no longer be tightened to keep the bolt securely fastened into the ratchet shaft. A possible contributing factor was the lack of routine preventive maintenance to detect that the bolt had seized and was no longer in serviceable condition.</p>

Figure 3: Damaged threads on incident bolt (left), compared to a new bolt (right) and used OEM bolt (centre).

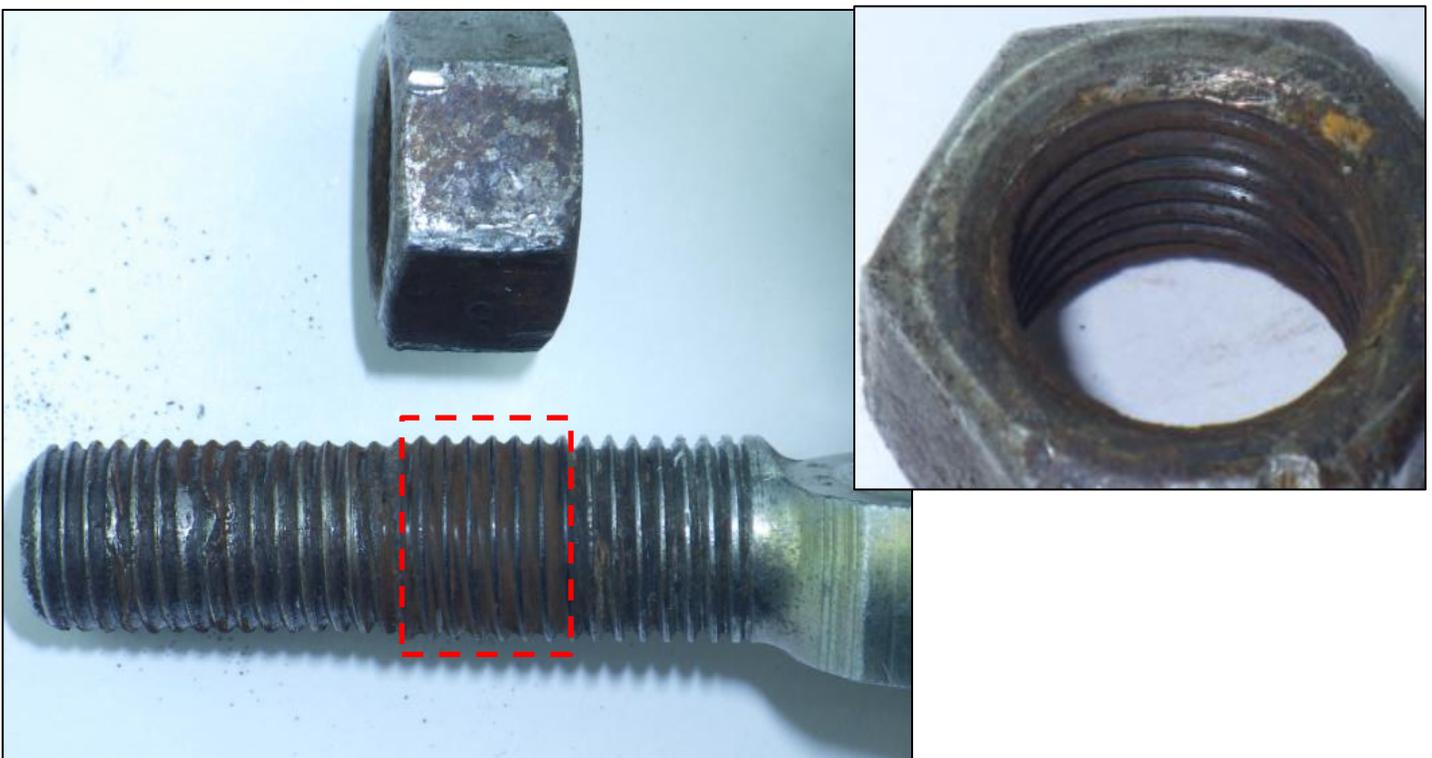
Figure 4: Nut removed showing rust on bolt and nut threads where they were seized together.

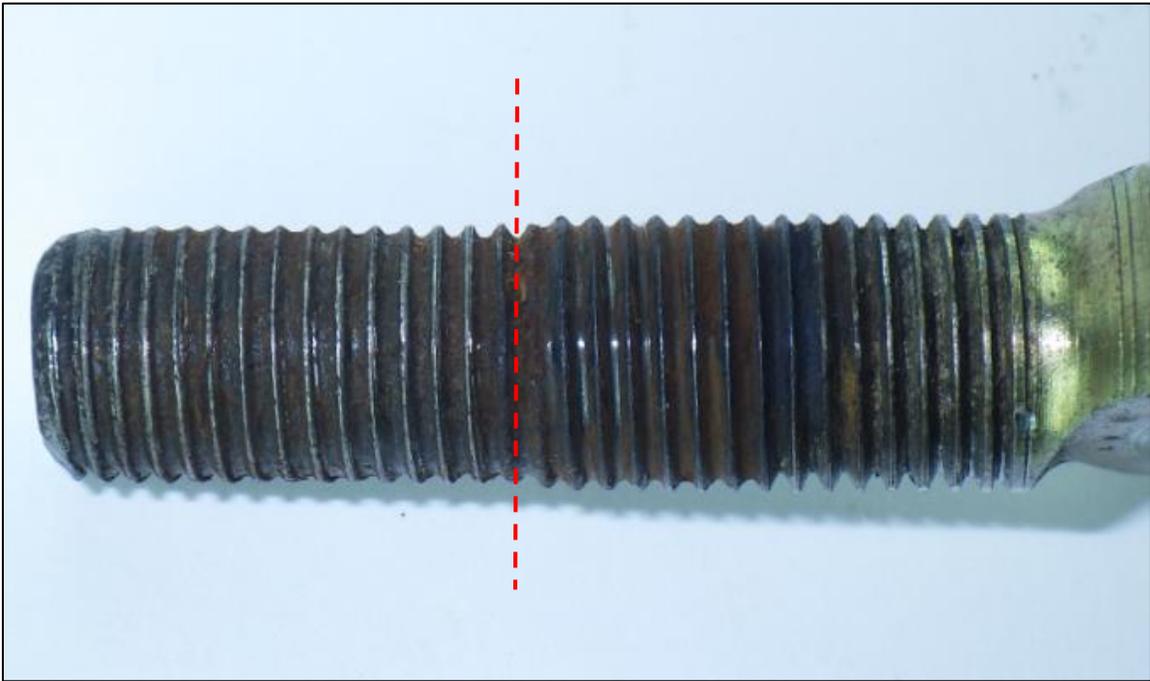
Figure 5: Bolt threads heavily worn, narrowing the bolt diameter below nut position (left of red line)
