Incident Summary Report II-663369-2018 (6287) (Final)

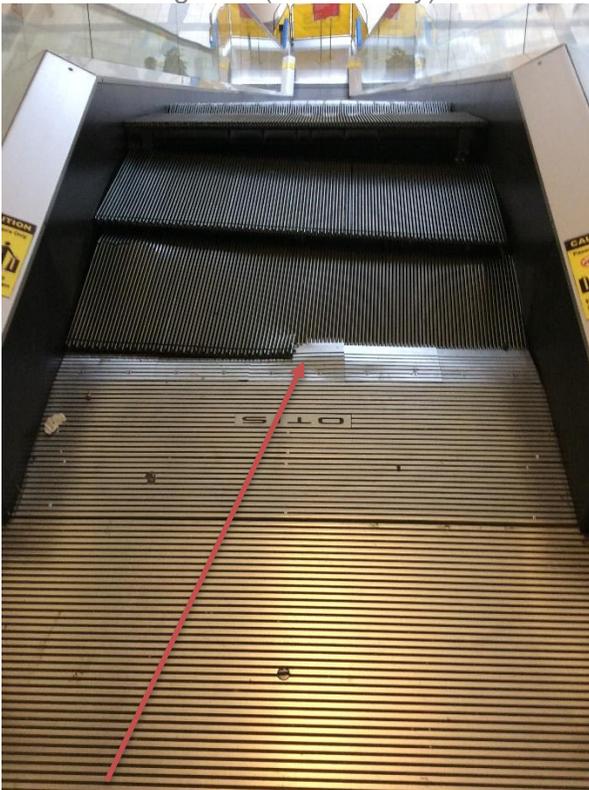
Steps piled up into upper combplates.

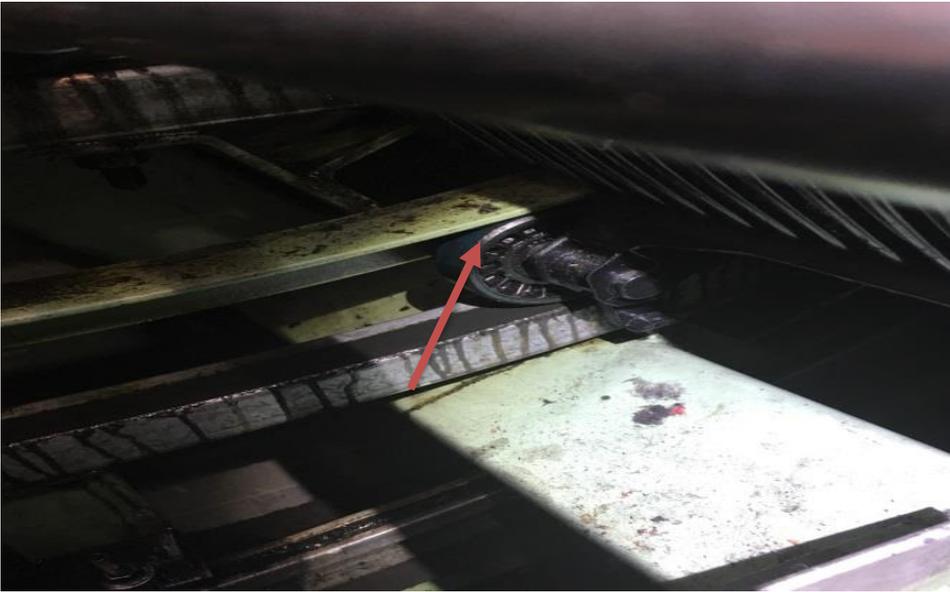
Example of a properly adjusted upthrust track, showing the correct clearance.

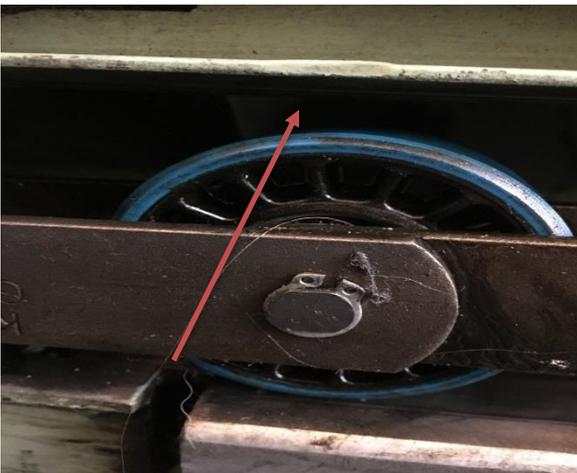
Failure scenario(s)	<p>Licensed contractor failed to provide field mechanics with specifications and tolerances for the Otis 506 escalators.</p> <p>Upthrust track was not set to the correct specification which allowed the step rollers to ride higher or out of alignment prior to entering into the upper combplates.</p> <p>The hold down track was not set to correct specifications, which allowed the step to rise more than 1mm. The ability for the step to rise lead to the step and track to come into contact.</p>	
	Facts and evidence	<p>Onsite investigation observations:</p> <ul style="list-style-type: none"> The proper adjustment for the upthrust track is 1mm. This escalator the upthrust track was set to 6mm. (5mm above maximum allowance) The hold down track was allowing the steps to rise 4mm. (3mm above maximum allowance)

Upthrust track as found. This is showing the clearance beyond 1mm.

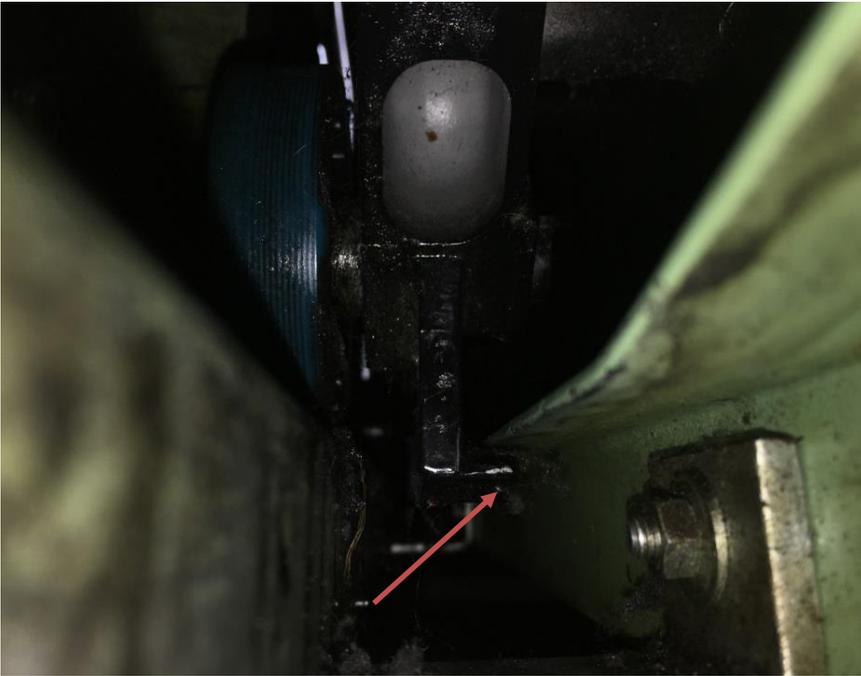
Step hold down track and step up lift tab.

This helps keep the step in alignment as it rotates in the upper end. Proper setting of 1mm clearance being shown here. During incident it was found at 4mm.
