Incident Summary #II-899455-2019 (#14987) (FINAL)

Failure scenario(s)	While train was travelling through a curved section of the track the locomotive's rear truck wheels derailed.

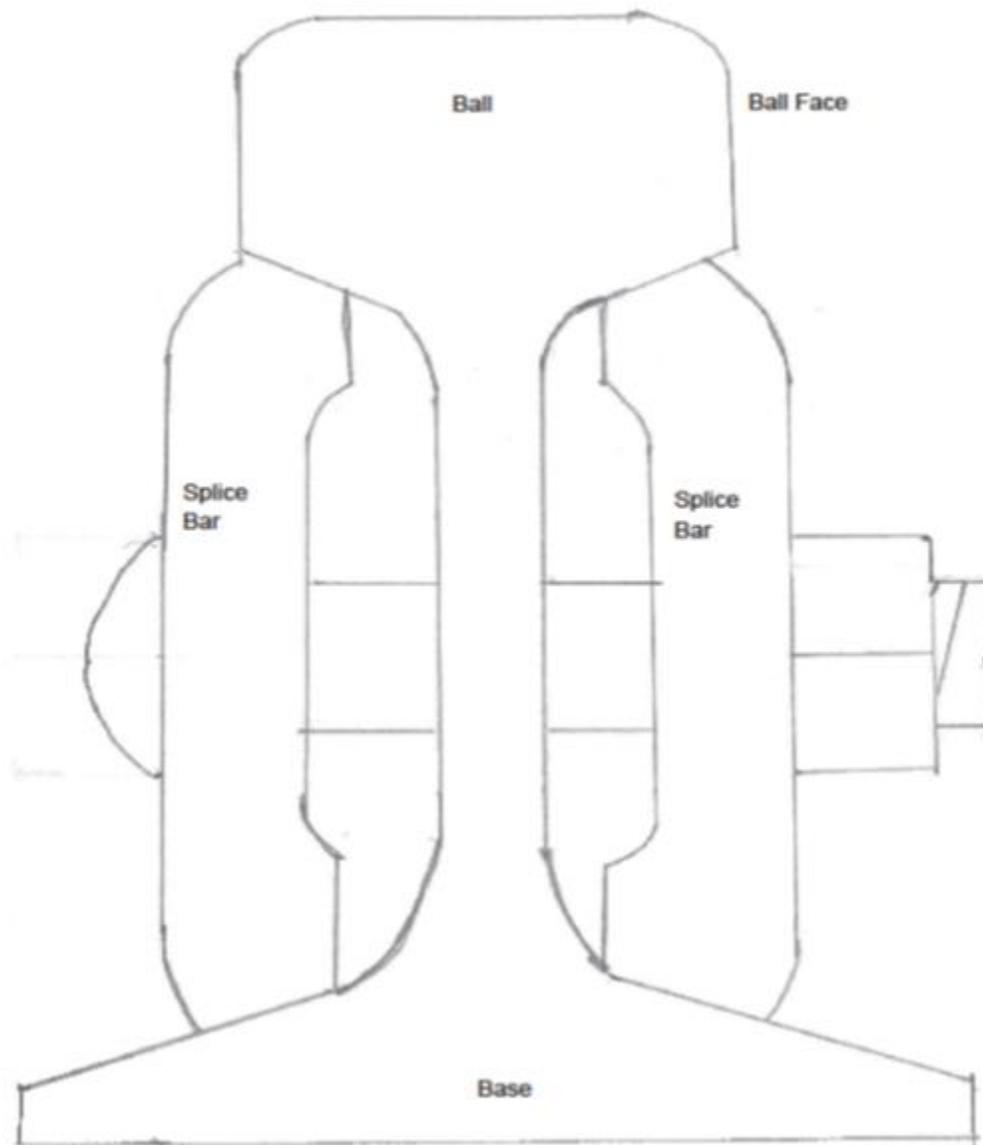
Diagram 1

<p>Causes and contributing factors</p>	<p>An impact to the leading wheel of the truck was the very likely cause of the bent axle. It is not certain if the cause of the impact was due to a hard impact with the line rail gauge side splice bar or a resulting impact of the derailment.</p> <p>Speed was very likely not a contributing factor as the operators policy regarding max speed was significantly lower than that of the manufacturer's specified maximum speed.</p> <p>A contributing factor to the derailment may have been due to the wear of the line rail, gauge side ball face. This wear may have resulted in a condition that the splice bar was situated proud in relation to the ball face.</p>

Cross Section of ASCE Rail with Splice Bars, Bolt and Nut

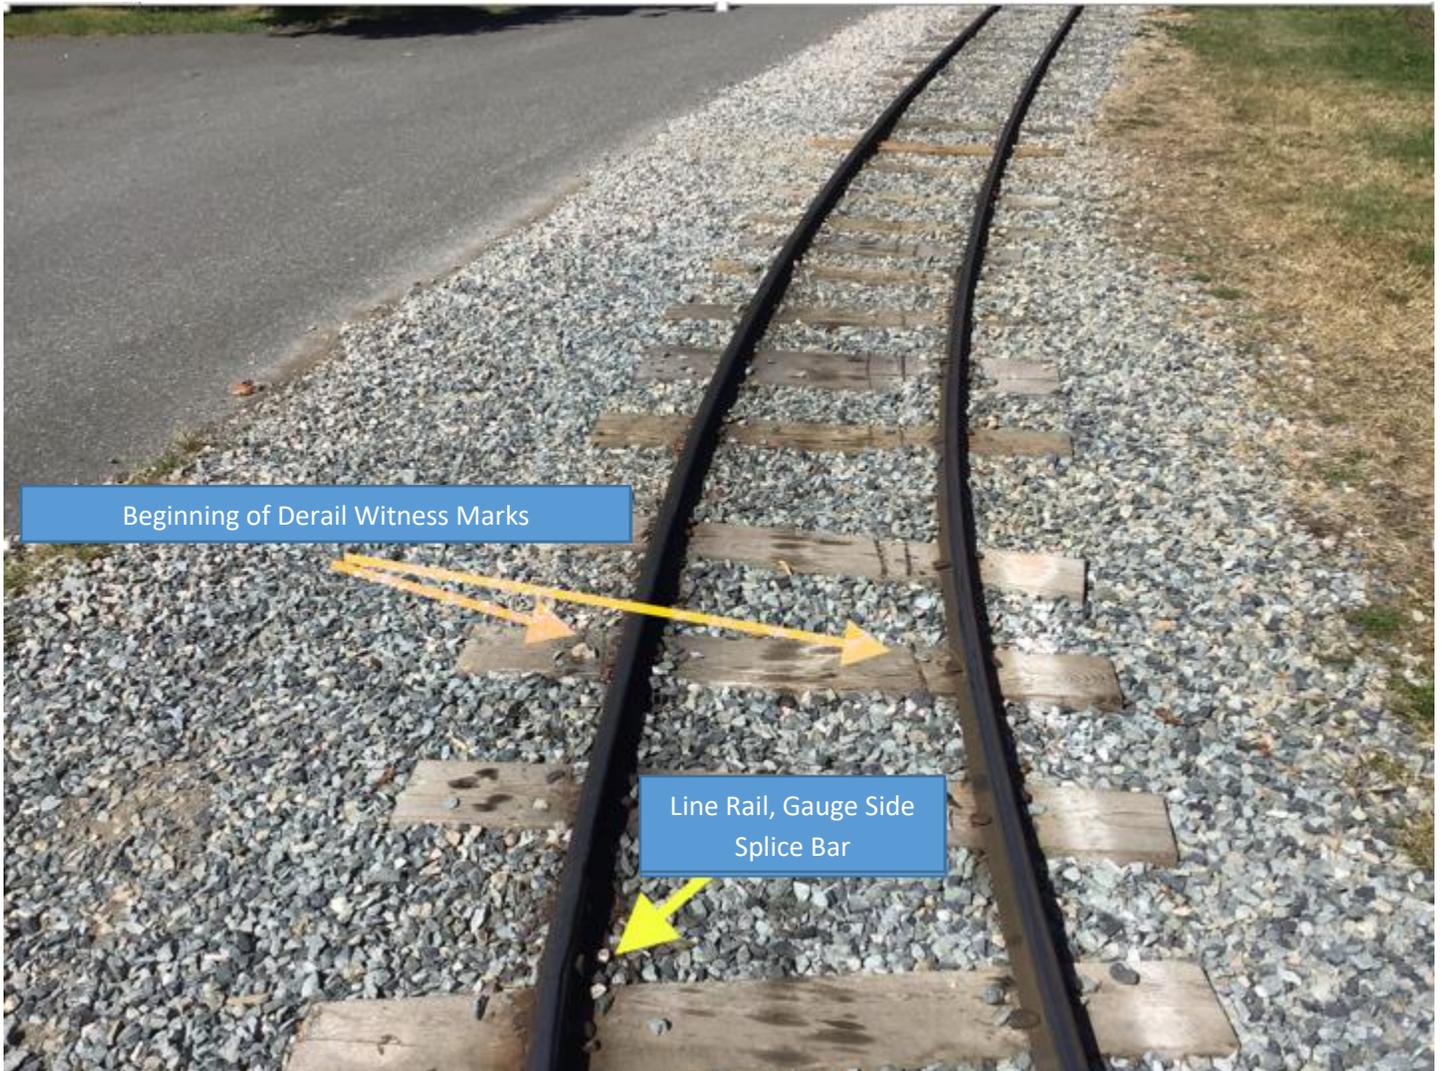
Photo 1

<p>Facts and evidence</p>	<p>Manufacturer's specified maximum speed is 12 mi/h or 19.3 km/h. The operator's training and operations manual indicates maximum speed of 6 km/h or 3.7 mi/h</p> <p>Narrative of events based on reports provide by the operating contractor:</p> <ul style="list-style-type: none"> The locomotive was progressing slowly through the curve when the locomotive began to shake. The operator stopped the train to investigate cause and observed that a derailment had occurred. After the incident occurred the train was moved back from original location of derailment. <p>Onsite incident inspection observations:</p> <ul style="list-style-type: none"> Observed witness marks (gouging) in the railway ties. These appear to be consistent with the impression that a derailed wheel would cause. (see photo 1) At the curve, wear was noticed on the line rail (outside rail) gauge side (inside of rail) of the ball face. (see diagram and photo 2) A gauge side splice bar in the line rail, located approximately .75 m before (direction of travel of the train) the first rail tie derail witness marks, was observed to have a significant impact marking on its leading and top edge. Impact marking appeared fairly recent (no oxidization of steel at impact marking). It was also observed that the splice bar was significantly proud of the ball face in comparison to other splices located along the track. (see photo 1 and 2) Observed that the locomotive's left side wheel axle of the rear truck was bent.

End View of Rail Cross Section
