Incident Summary II-655223-2018 (5985) FINAL

SUPPORTING INFORMATION	Incident Date	February 28, 2018	
	Location	Lytton	
	Regulated industry sector	Above-surface ropeway	
	Impact	Qty injuries	None
		Injury description	N/A
		Injury rating	None
	Damage	Damage description	Indications of damage to gondola cabin, gondola carriage, materials crane attachment, and the lower terminal loading platform.
		Damage rating	Moderate
Incident rating	Moderate		
Incident overview	<p>As a part of daily pre-operational checks, the gondola cabin/carriage and attached crane/carriage, were run without load to ensure that operations were running normally.</p> <p>On reversal of the gondola run, the operator situated at the upper terminal, witnessed the hauling rope jerk violently, which was not normal.</p> <p>The operator immediately shut down the system and proceeded to investigate the cause.</p>		
INVESTIGATION CONCLUSIONS	Site, system and components	<ul style="list-style-type: none"> Fixed cable crane used for material and passenger transport, installed to construct and service an industrial site. System consists of fixed track ropes, situated side by side, anchored at the top and bottom terminals. A hau

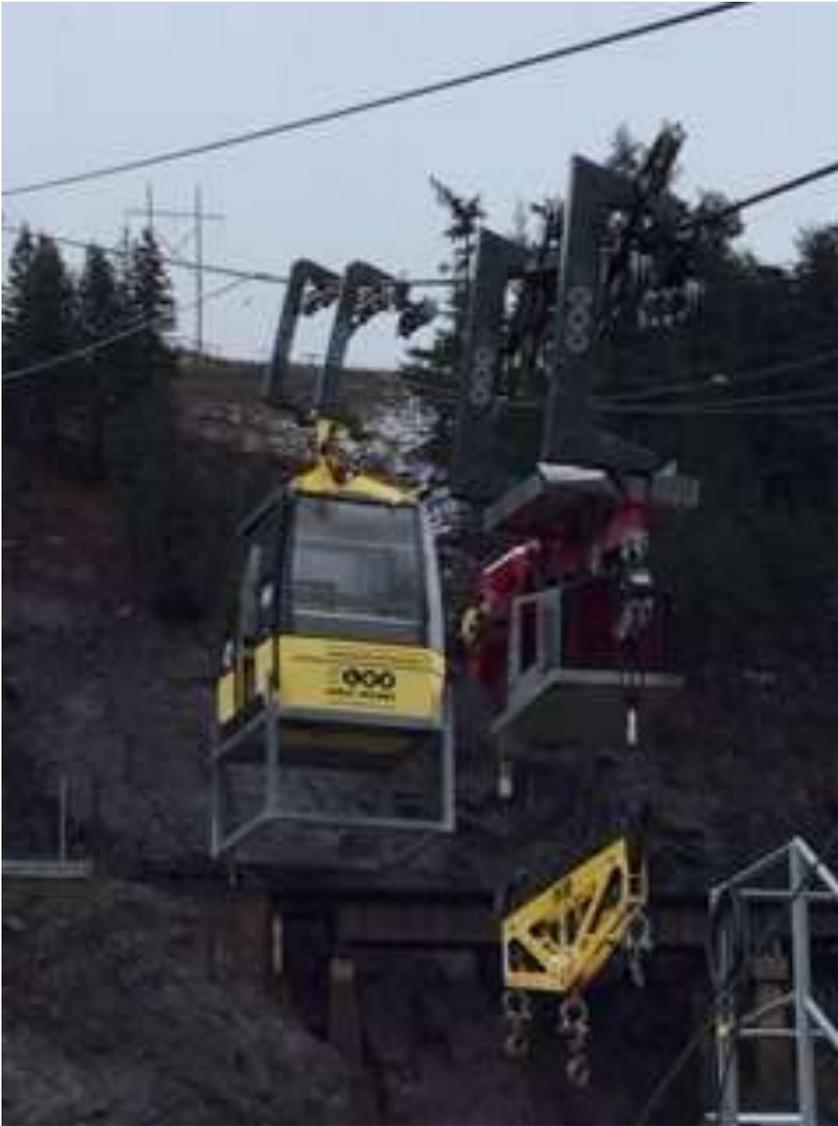
This photo shows the Gondola/carriage(yellow) and Crane/carriage(red), including the underhanging spreader bar and its attachments, as they were found after the incident.

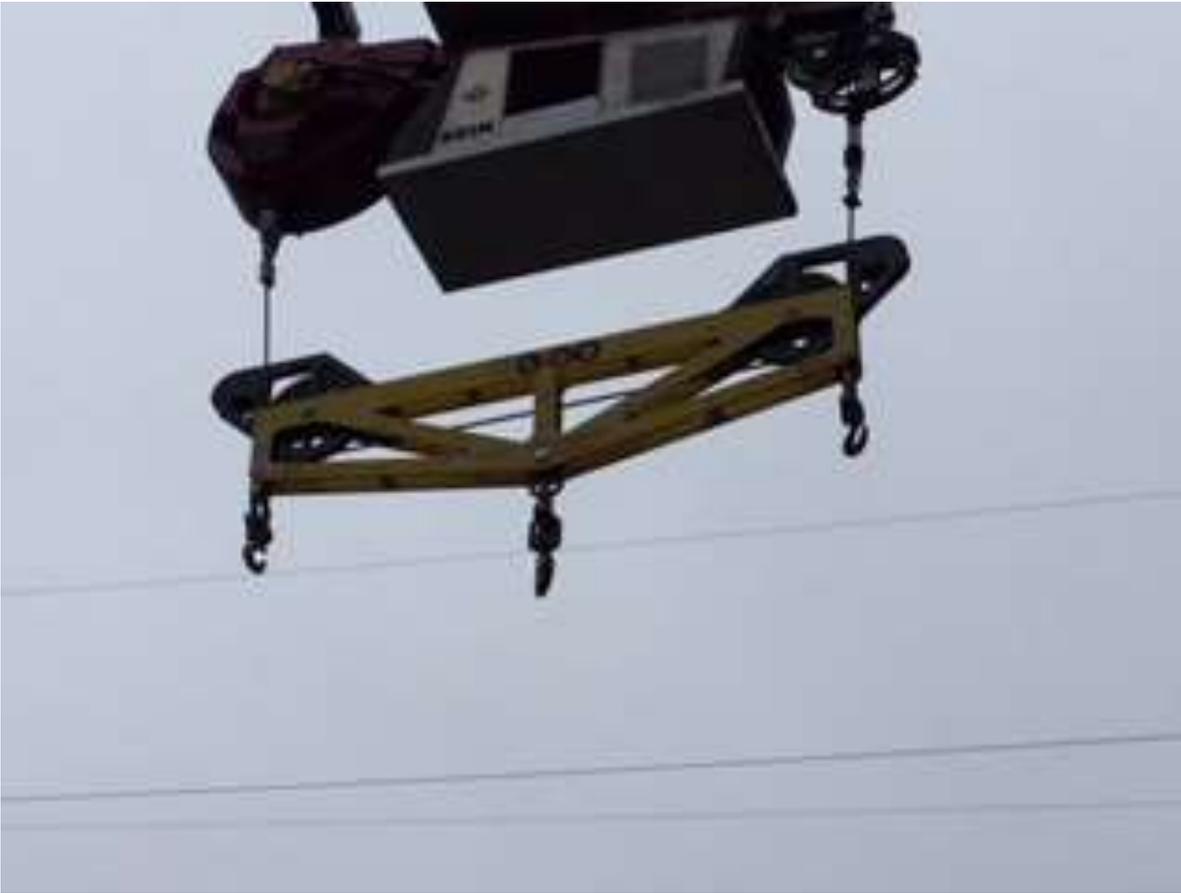
<p>Causes and contributing factors</p>	<ul style="list-style-type: none"> • It is likely the spreader bar located beneath the crane/carriage, was in too low a vertical position to maintain safe clearances at the lower terminal loading/unloading platform gondola cabin guides. • It is very likely, the 20ton snap hook, located on the most uphill connection of the spreader bar, became attached to the structural I-beam of the passenger loading/unloading platform, gondola cabin guides, at the lower terminal.

This photo shows the spreader bar and its attachments, hanging underneath the Crane/carriage. The uppermost 20ton Snap Hook gate shows indications of stress or impact, as the gate is deformed in the open position.

(far left hook in picture)

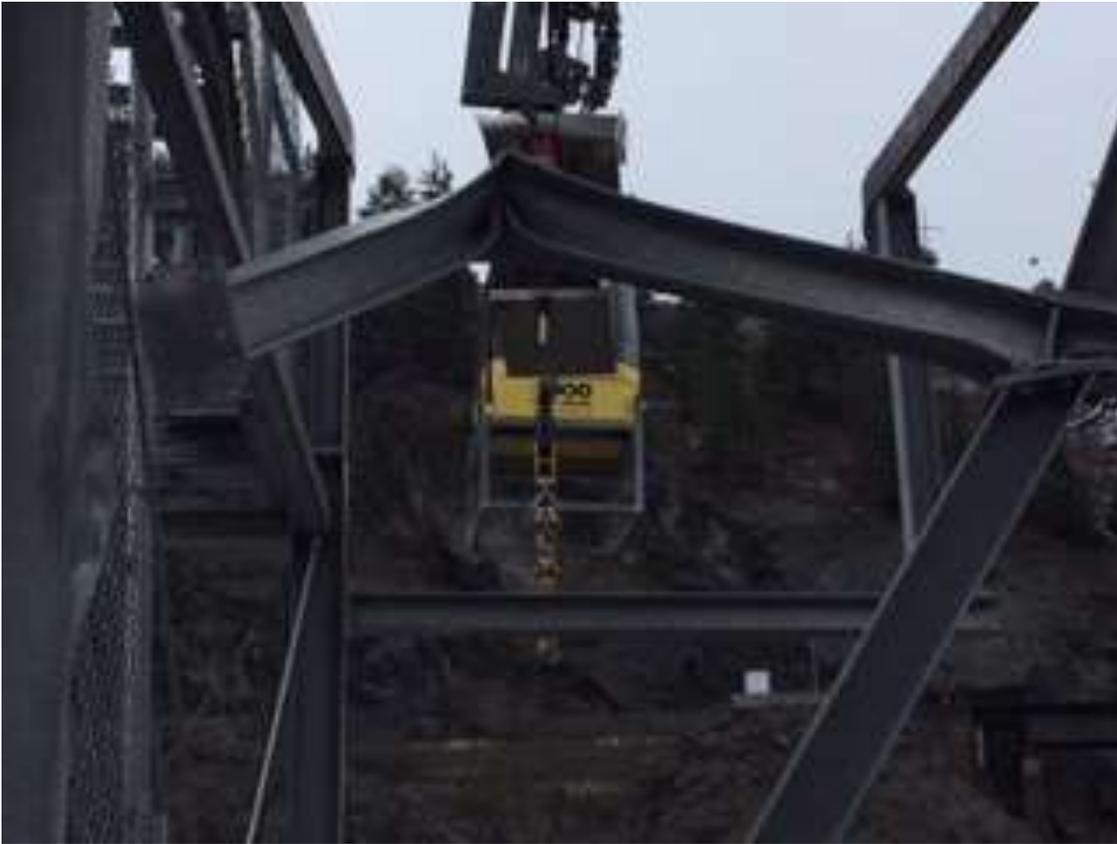
This photo shows the deformed I-beam in the foreground and the Crane/carrriage spreader bar in the background
