Incident Summary (#6212) II-662243-2018 (Final)

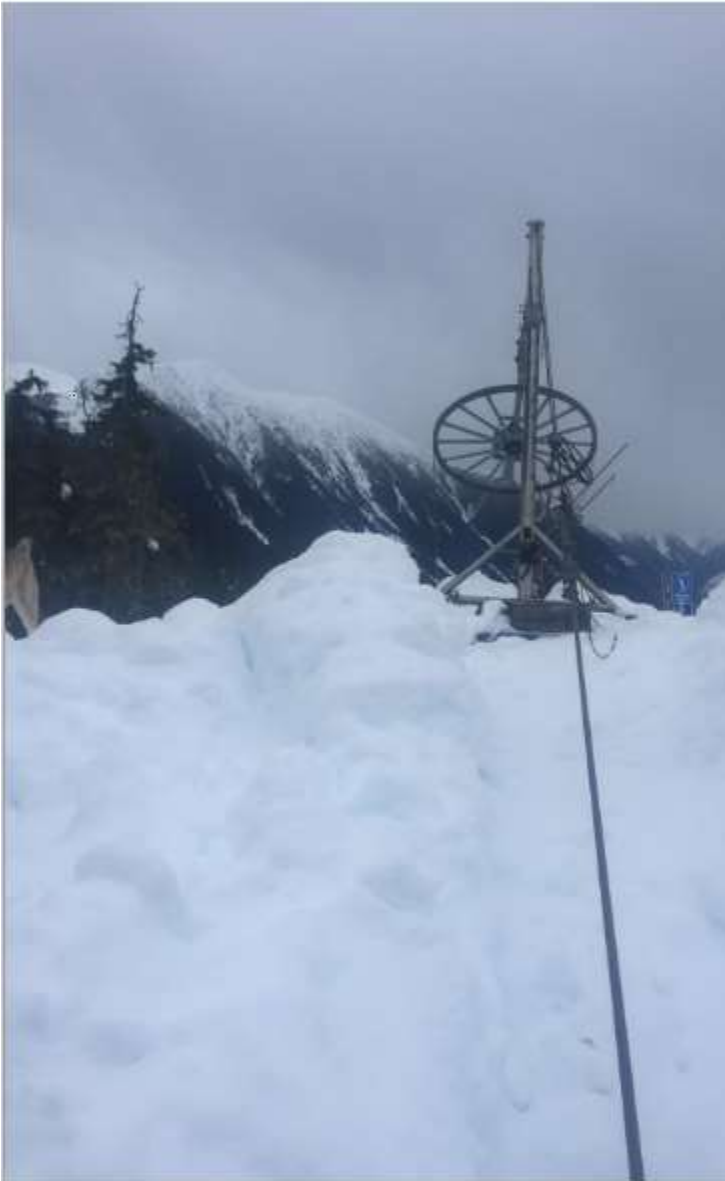
Causes and contributing factors	<p><i>The loss of hauling rope tension is the direct result and outcome of the tension system anchor failure.</i></p> <p>It is highly likely that the organic anchor (log/timber) decomposed to a point where it could no longer maintain the forces applied to it. The inability of the Anchor to be visually inspected may have been a contributing factor.</p>

Station tilted forward due to anchor failure

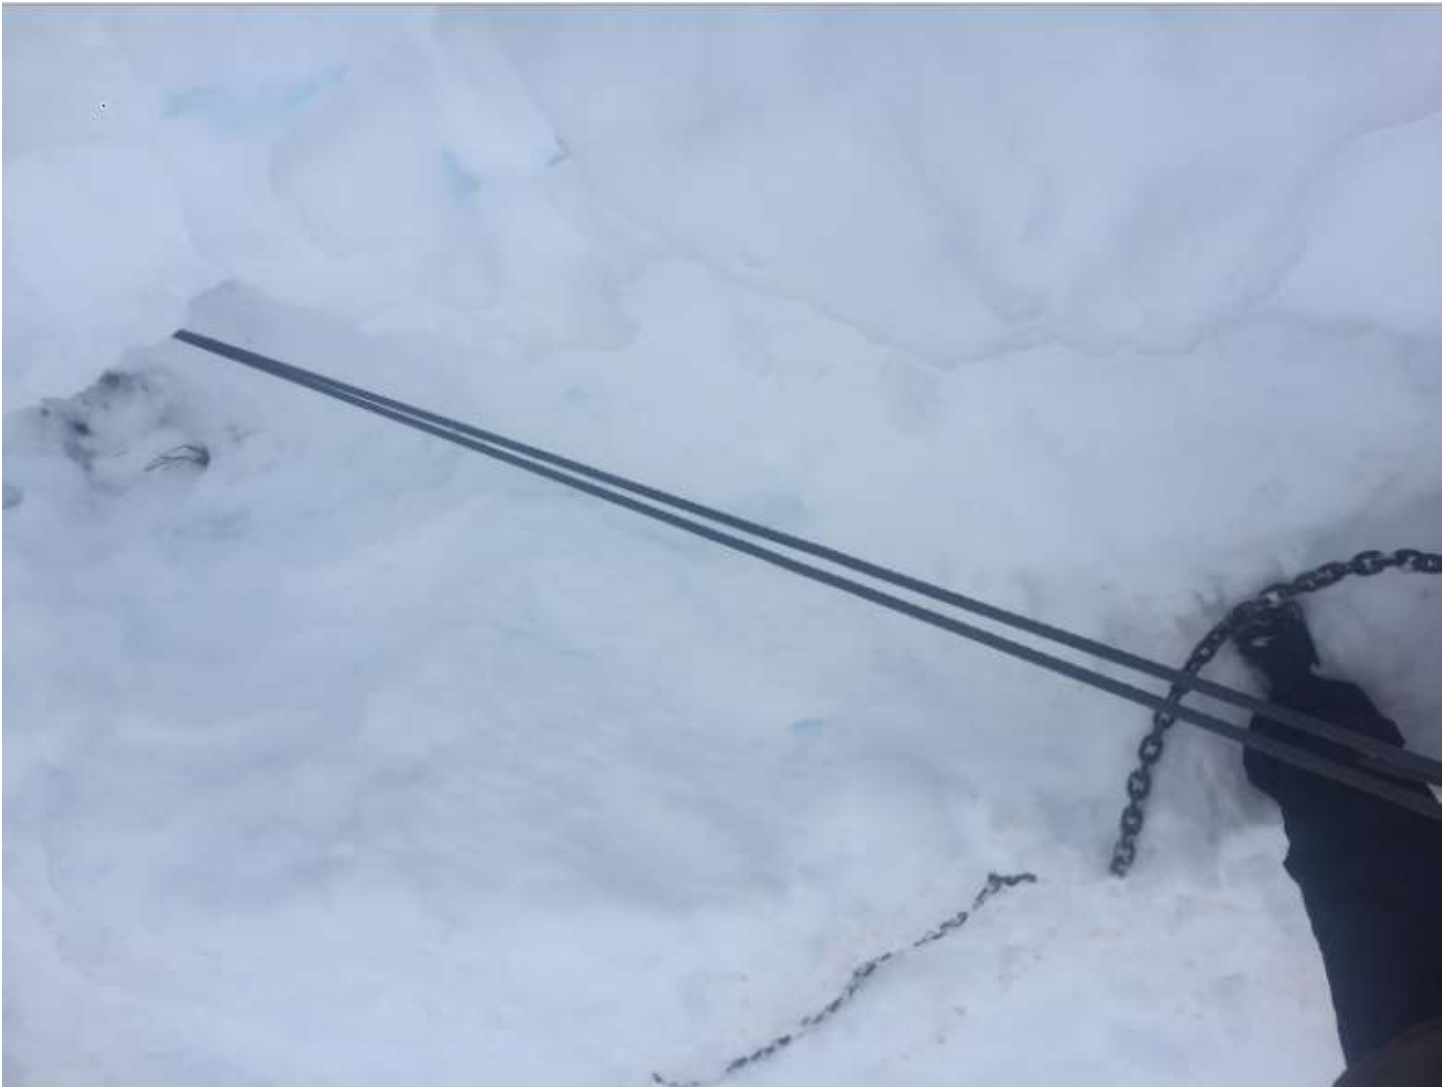
Tension Cable submerging into snow/earth connecting to buried anchor.
