Incident Summary #II-941214-2019 (#15927) (FINAL)

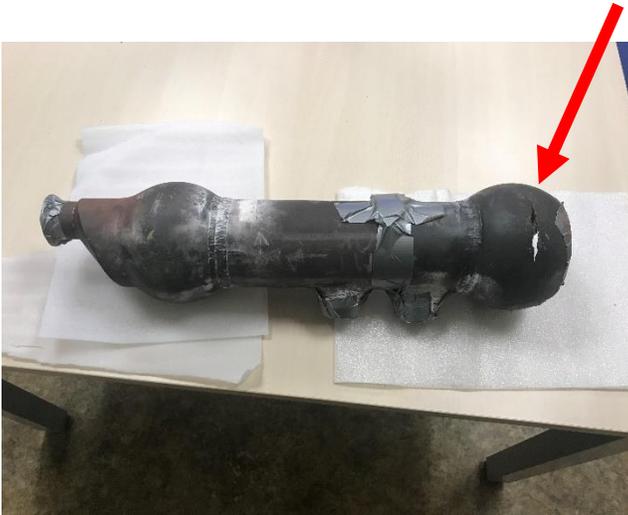
Facts and evidence	A third party failure analysis, which determines probable cause of failure, was performed determining that both the ruptured fitting and the opposite reducer fitting were the incorrect material (plain carbon steel) from the specified material on the construction drawings (chrome-molybdenum alloy). Although material tracking paperwork provided by the owner and contractor identified the correct pressure fittings were in place, the incorrect material was installed in the system.	
	Causes and contributing factors	It's likely that poor material handling and traceability practices were the contributing cause of the failure of the ruptured fitting. It's very likely this fitting failed due to a creep failure, (which is where metal components continuously deform under load which may eventually lead to a rupture). Carbon steel materials have significantly lower creep resistance than the specified material and are not suitable for use under pressure in moderate to high temperature service.

Rupture close-up

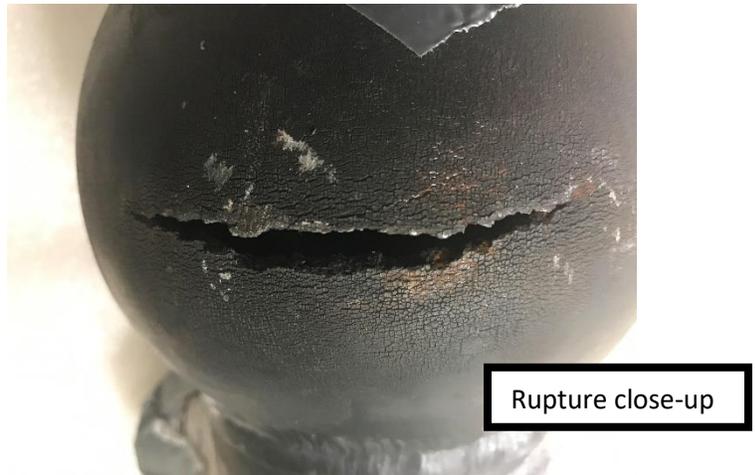
Overview of failed pressure piping section removed. Arrow indicates ruptured fitting.

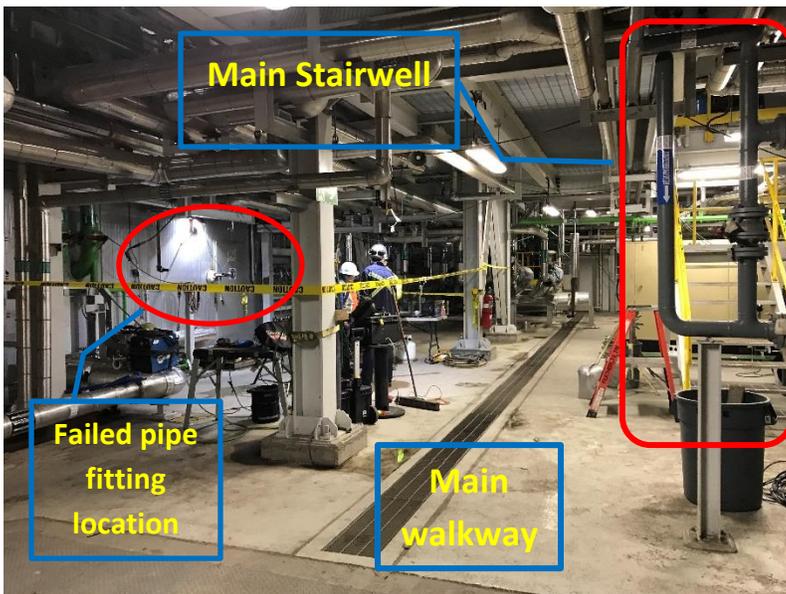
Overview of frequently used walkway and stairwell.

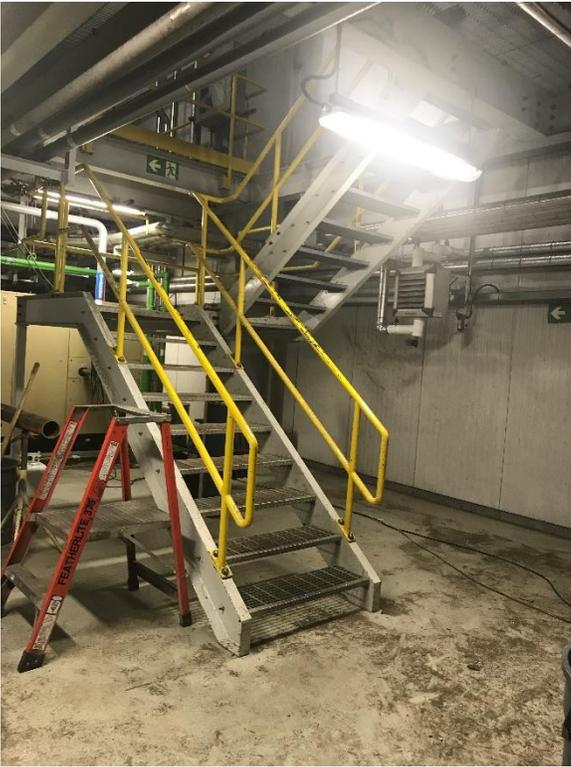
Main stairway is the only egress down from upper floors (directly across from failure area).

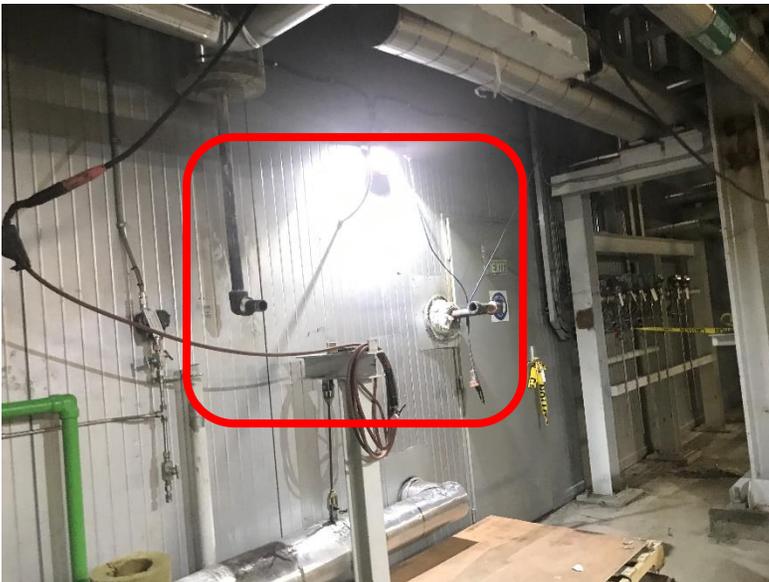
Area overview of failed fitting and associated piping location. (Removed from service)
