Incident Summary #II-763515-2018 (#8646) (FINAL)

| SUPPORTING INFORMATION | Incident Date | September 19, 2018 | |
| | Regulated industry sector | Elevating devices - Elevator | |

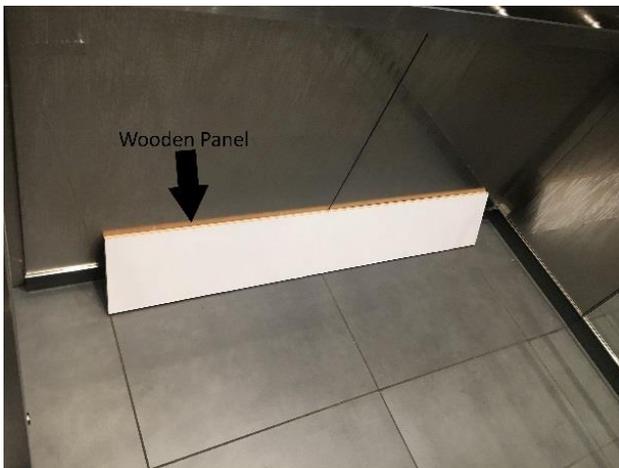
| | Facts and evidence | <p>During investigation it was found:</p> <ul style="list-style-type: none"> The wooden panel that had fallen down was not located. A photograph was provided below to show missing panel (Photo 1) Location of the missing panel could be seen from inside the cab. (Photo 2) Inspection of the area where the panel fell from and of other panels indicated adhesive was used to fasten panels. | |

Photo 1: Wooden panel that had fallen from the ceiling

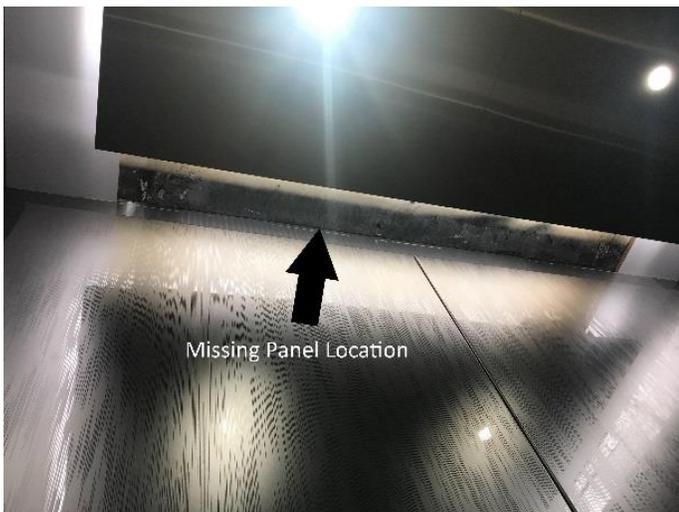
| | Failure scenario(s) | The wooden ceiling panel was attached to the ceiling shell of the elevator cab with an adhesive. Through time and constant vibration the adhesive no longer held the wooden panel to the ceiling, allowing it to become loose and fall to the ground. | |
| | Causes and contributing factors | The wooden panel falling was likely due to the fastening method used or the type/amount of adhesive used was not suitable for this type of installation resulting in the adhesive becoming loose over time and contributing to the panel falling. | |

Photo 2: Location on the ceiling where the panel had fallen out of

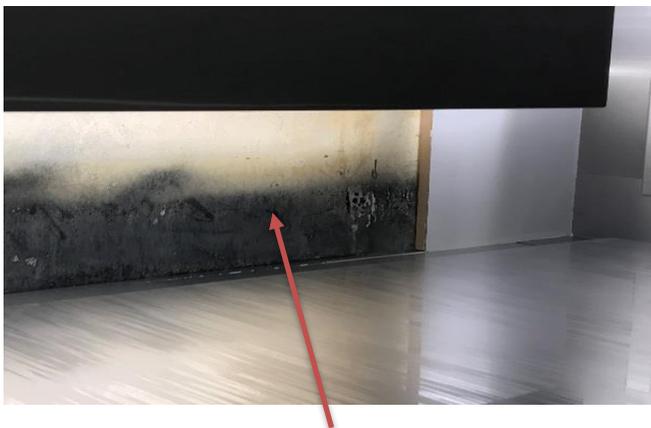
Photo 3: Close up view of where the panel had fallen out
