Incident Summary (Reference #II-693957-2018)

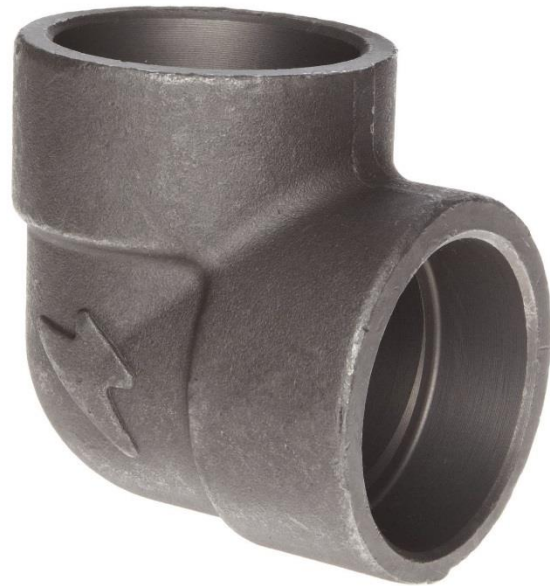
Typical 2" -
90° Steel
Elbow

SUPPORTING INFORMATION	Incident Date	May 7, 2018	
	Location	Burnaby	
	Regulated industry sector	Boiler and pressure vessel system	
	Impact	Qty injuries	None
		Injury description	None
		Injury rating	None
	Damage	Damage description	Gas leak in pipe line fitting.
		Damage rating	None
Incident rating	Insignificant		
Incident overview	A fuel gas pipe line fitting developed a pinhole leak allowing fuel gas to escape.		
INVESTIGATION CONCLUSIONS	Site, system and components	<i>The oil refinery fuel gas pipe line conveys high pressure fuel gas to various processes throughout the plant. The high pressure fuel gas pipe and associated fittings are generally made of steel to withstand the high fuel gas pressure. The pipe fittings are typical 90° elbows, couplings, tees, valves etc. that are used to join various sections of pipe together.</i>	
	Failure scenario(s)	One of the fittings (2" - 90° elbow) on the fuel gas pipe developed a pinhole leak allowing fuel gas to leak to the atmosphere.

Facts and evidence	<ul style="list-style-type: none"> Refinery process operator noticed a hissing sound in the vicinity of the 90° elbow when performing his unit rounds. The refinery personnel implemented a temporary leak repair by enclosing the leaking elbow. Gas leak testing was used to verify that the leak had been contained – photo attached. 	
	Causes and contributing factors	It is likely that the cause of the pinhole leak may be due to certain components in the fuel gas that contributed to under deposit corrosion and possibly this under deposit corrosion eventually developed into a pinhole leak.

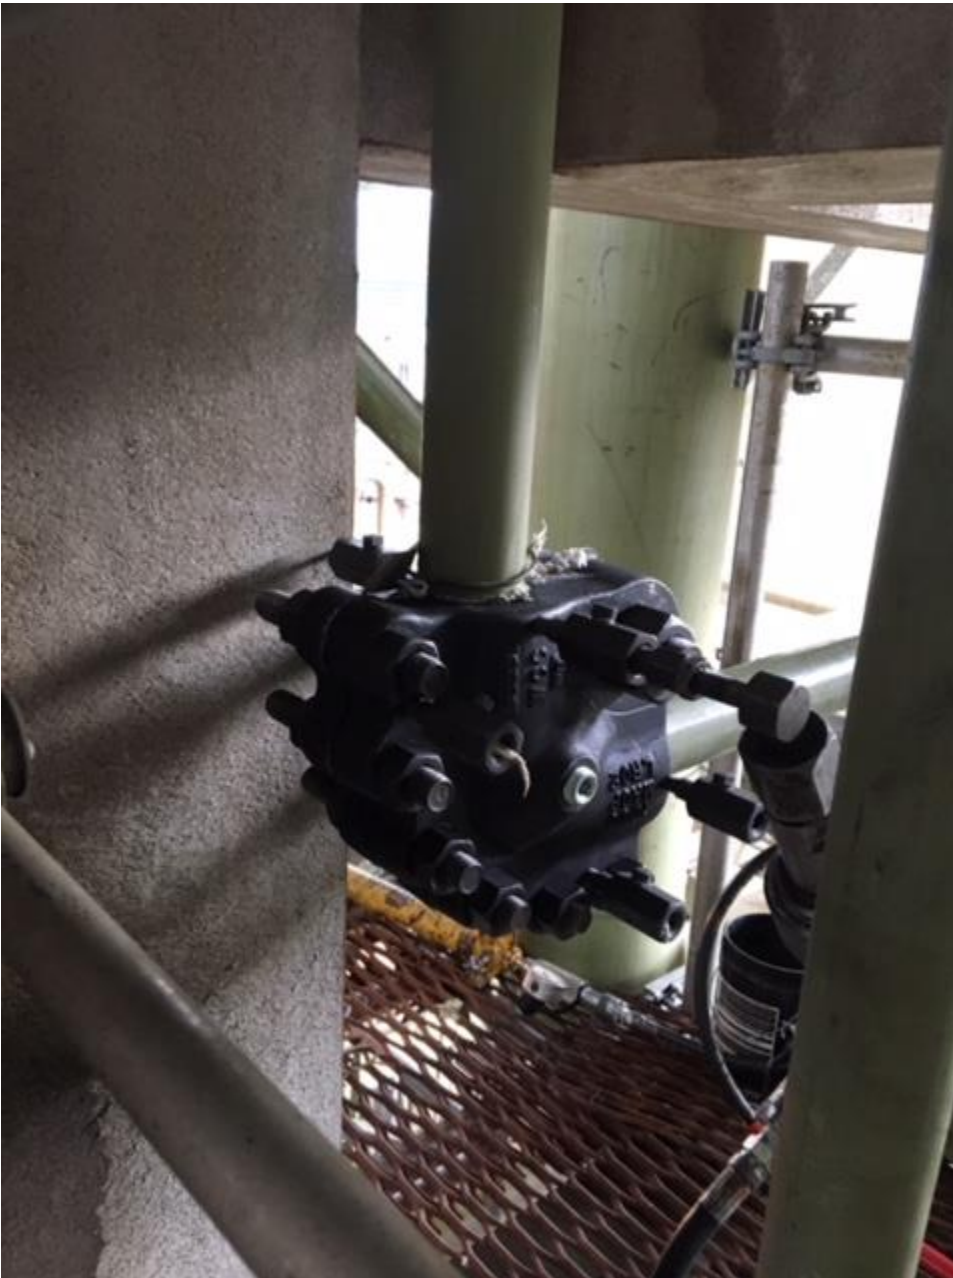
The 2" - 90° steel elbow with pinhole leak has been enclosed in a metal casing. A sealant is injected into the metal casing to seal the leak.
