## Incident Summary #II-700086-2018 (#BPVII-1141825) (FINAL)

SUPPORTING INFORMATION	Incident Date	6/11/2018	
	Location	Vancouver	
	Regulated industry sector	Boilers, PV & refrigeration - Refrigeration system	
	Impact	Qty injuries	1
		Injury description	Person appeared disoriented, had watery eyes and flushed face.
		Injury rating	Moderate
	Damage	Damage description	Ammonia wafted when handhole cover was opened slightly.
		Damage rating	None
	Incident rating	Moderate	
Incident overview	During planned maintenance technician slightly opened handhole cover for the ammonia compressor crankcase and inhaled waft of ammonia.		
INVESTIGATION CONCLUSIONS	Site, system and components	The Ammonia compressor is part of a refrigeration plant in a public assembly site-ice rink. The compressor compresses low pressure ammonia vapour to high pressure vapour. Compressor crankcase houses the crankshaft of the compressor and act as lubricating oil sump. Handhole cover is a bolted cover for compressor crankcase access opening and opened to gain access to compressor crankcase for maintenance and inspection.

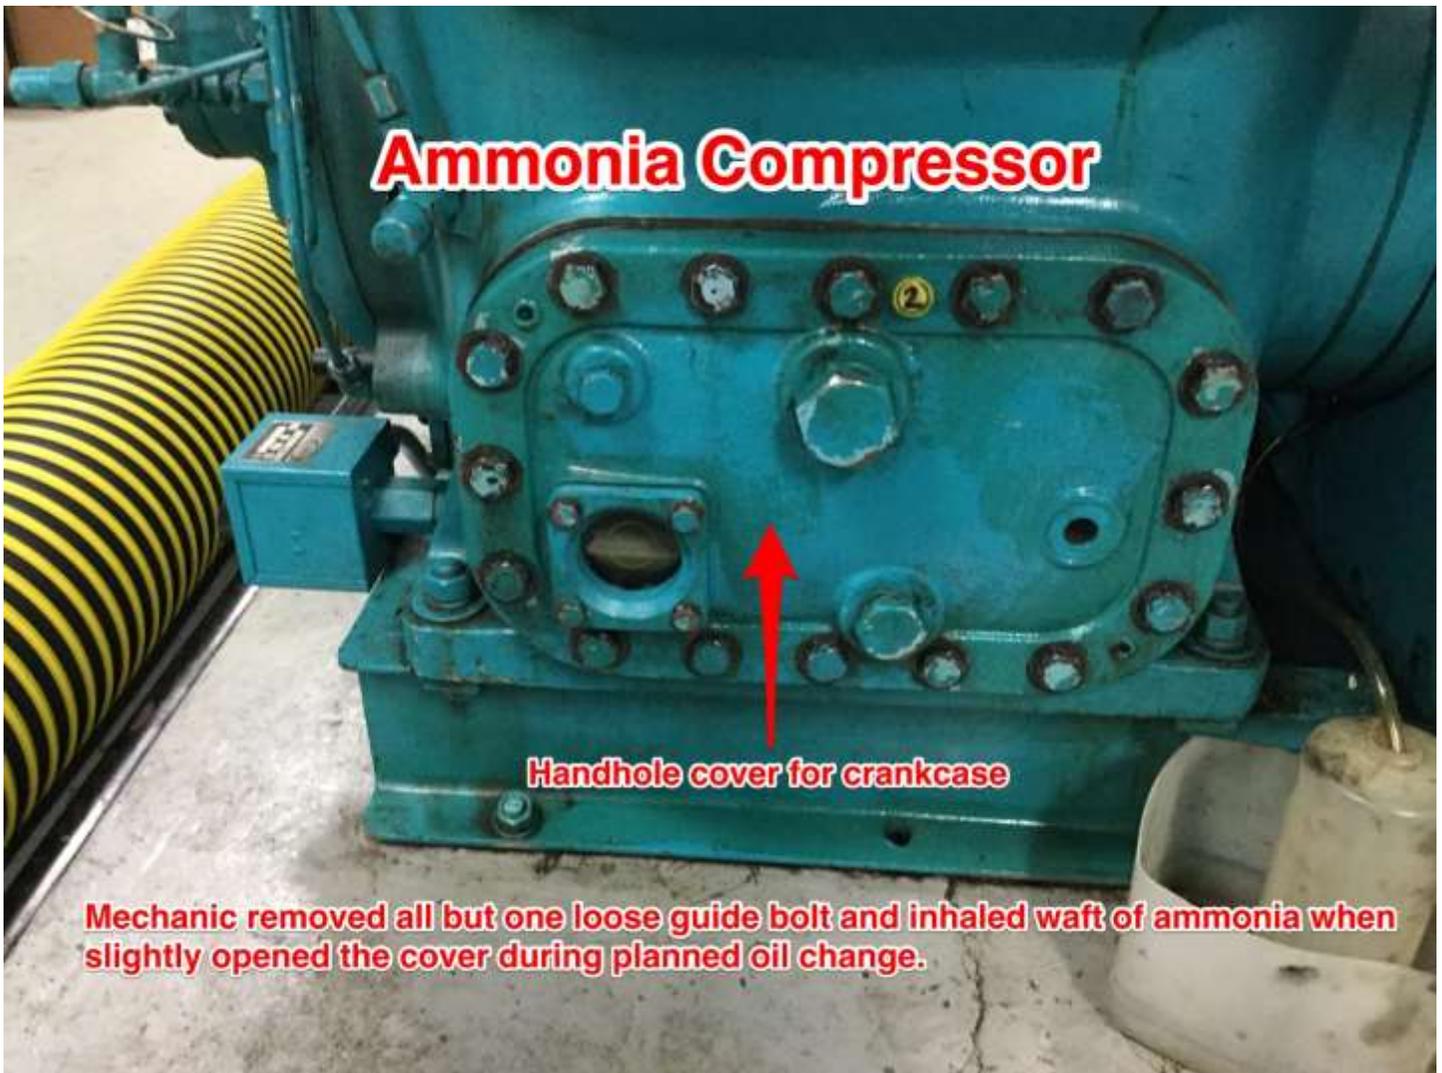
Photos or diagrams (if necessary)

Failure scenario(s)	During planned maintenance, the mechanic removed all but one loose guide bolt and opened cover slightly once he felt oil was below the cover level. Evaporating ammonia from remaining oil wafted from crankcase and inhaled by the mechanic.	
	Facts and evidence	<p>There were two witness accounts.</p> <ul style="list-style-type: none"> <li>• First was certified refrigeration mechanic from licensed refrigeration company. Upon arrival on site at about 12:30pm, he went to machine room with his portable detector, bite block and tools. He purged compressor to Opsig after isolating compressor. Upon completion of purging, he connected hose to compressor oil drain line and started draining oil. Once he felt oil level was below cover level, he removed all but one loose guide bolt and opened cover slightly. He inhaled strong waft of ammonia and left machine room immediately to get attention and met one of the plant operators.</li> <li>• Second account was certified operator. He was approached by the mechanic outside the machine room at about 2:25 and observed that the mechanic was disoriented and had watery eyes, flushed face. He sent him to first aid with another employee. He went to vestibule of machine room</li> </ul>

<p>and found machine room detector reading 0ppm. He went inside machine room and his personal detector read 17ppm near the compressor where the mechanic was working.</p> <p>Communication with licensed contractor responsible for maintenance at this plant confirmed that wearing ammonia mask was not part of the standard working procedure for compressor oil change up to the time of incident.</p>
<p>Causes and contributing factors</p>	<p>It is highly probable that ammonia concentration in waft inhaled by mechanic was strong enough for him to call for attention (Oil remaining in the crankcase exudes ammonia until all ammonia in oil is evaporated and evaporated ammonia accumulates above oil in crankcase and escapes outside when cover is opened) .</p>
