Incident Summary #II-760614-2018 (#9226) (FINAL)

SUPPORTING INFORMATION	Incident Date	October 19, 2018	
	Location	Duncan	
	Regulated industry sector	Electrical - Low voltage electrical system (30V to 750V)	
	Impact	Qty injuries	0
		Injury description	N/A
		Injury rating	None
	Damage	Damage description	3 Phase 400 Amp load centre buss and associated over current devices disintegrated. Fire damage in and around electrical distribution panel. Smoke damage in electrical room.
		Damage rating	Major
	Incident rating	Major	
	Incident overview	A qualified individual working for a licensed electrical contractor was entering an armoured cable into an energized electrical panel when arcing and sparking occurred, causing an electrical fire in the load centre. The fire damaged the load centre and the wall and ceiling adjacent to the panel.	
INVESTIGATION CONCLUSIONS	Site, system and components	The system is a 120/208 Volt 3 Phase overhead service. The main disconnect is fused at 600 Amps. From a 600 Amp splitter parallel raceways enter in to a 3 Phase 400 Amp disconnect. This disconnect has 300 Amp fuses installed. Conductors from the disconnect enter a metering cabinet, conductors from the me

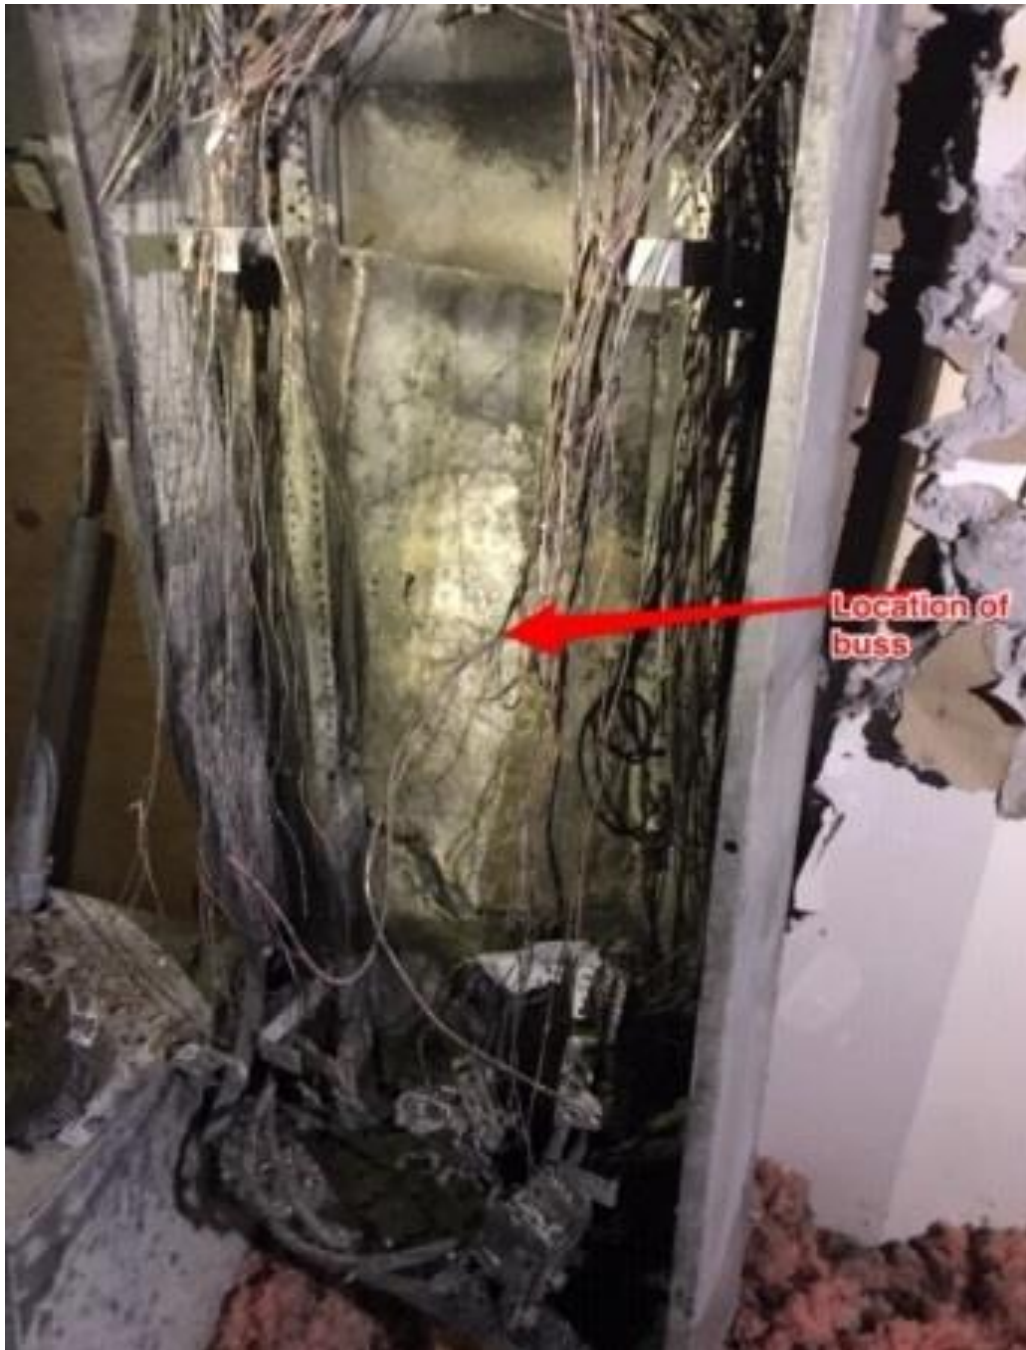
Photograph 1. Showing buss location

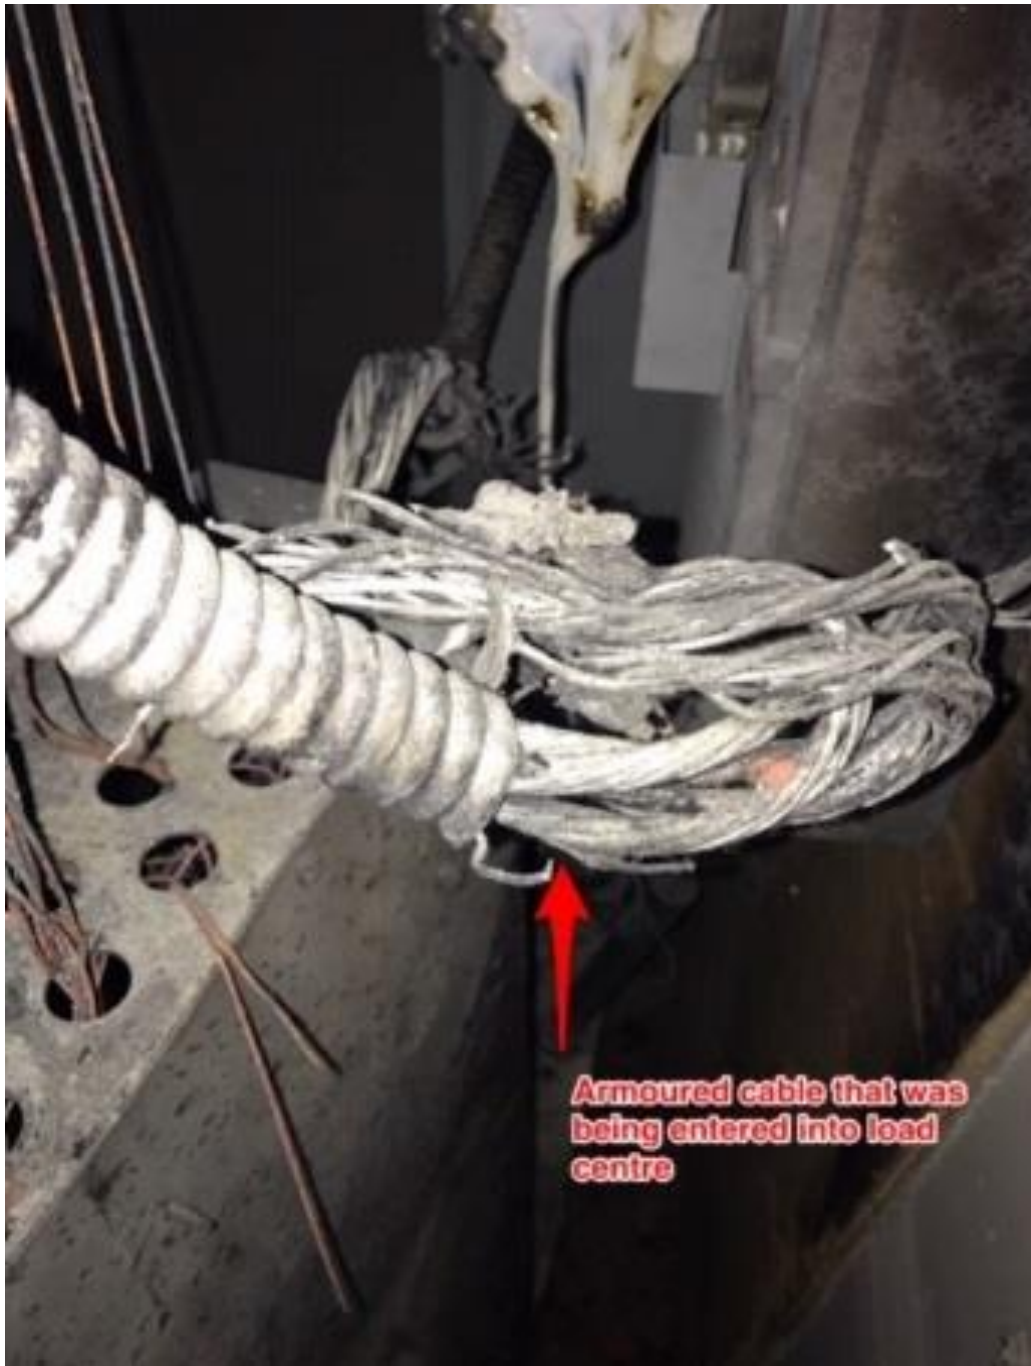
Photograph 2. Armoured cable that was being entered into load centre

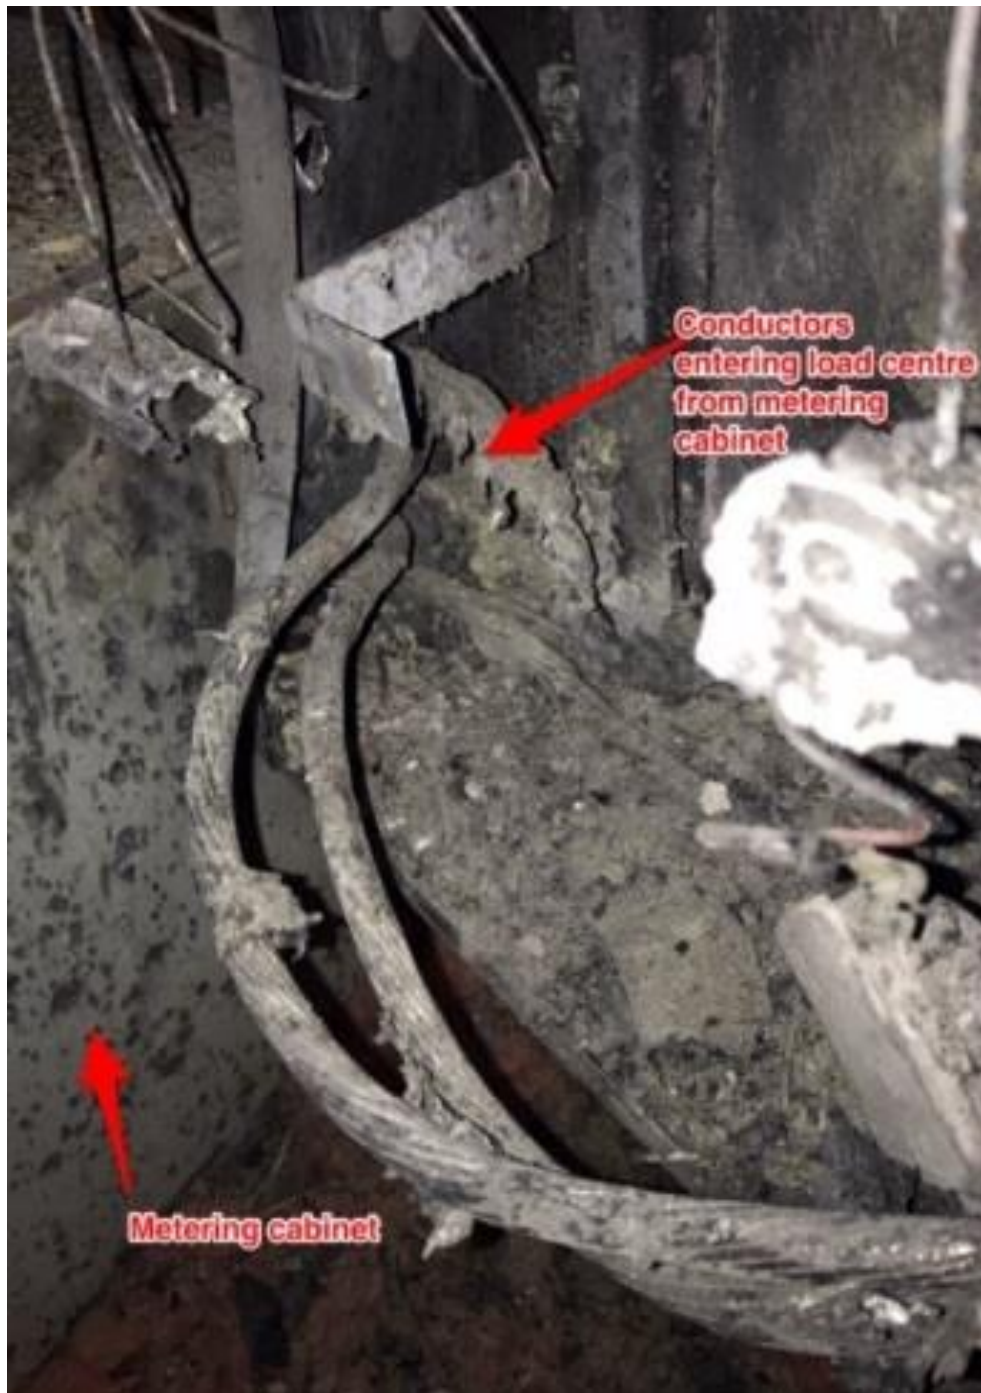
Photograph 3. Meter cabinet location and associated conductors entering load centre
