Incident Summary II-684356-2018 (# 7090) FINAL

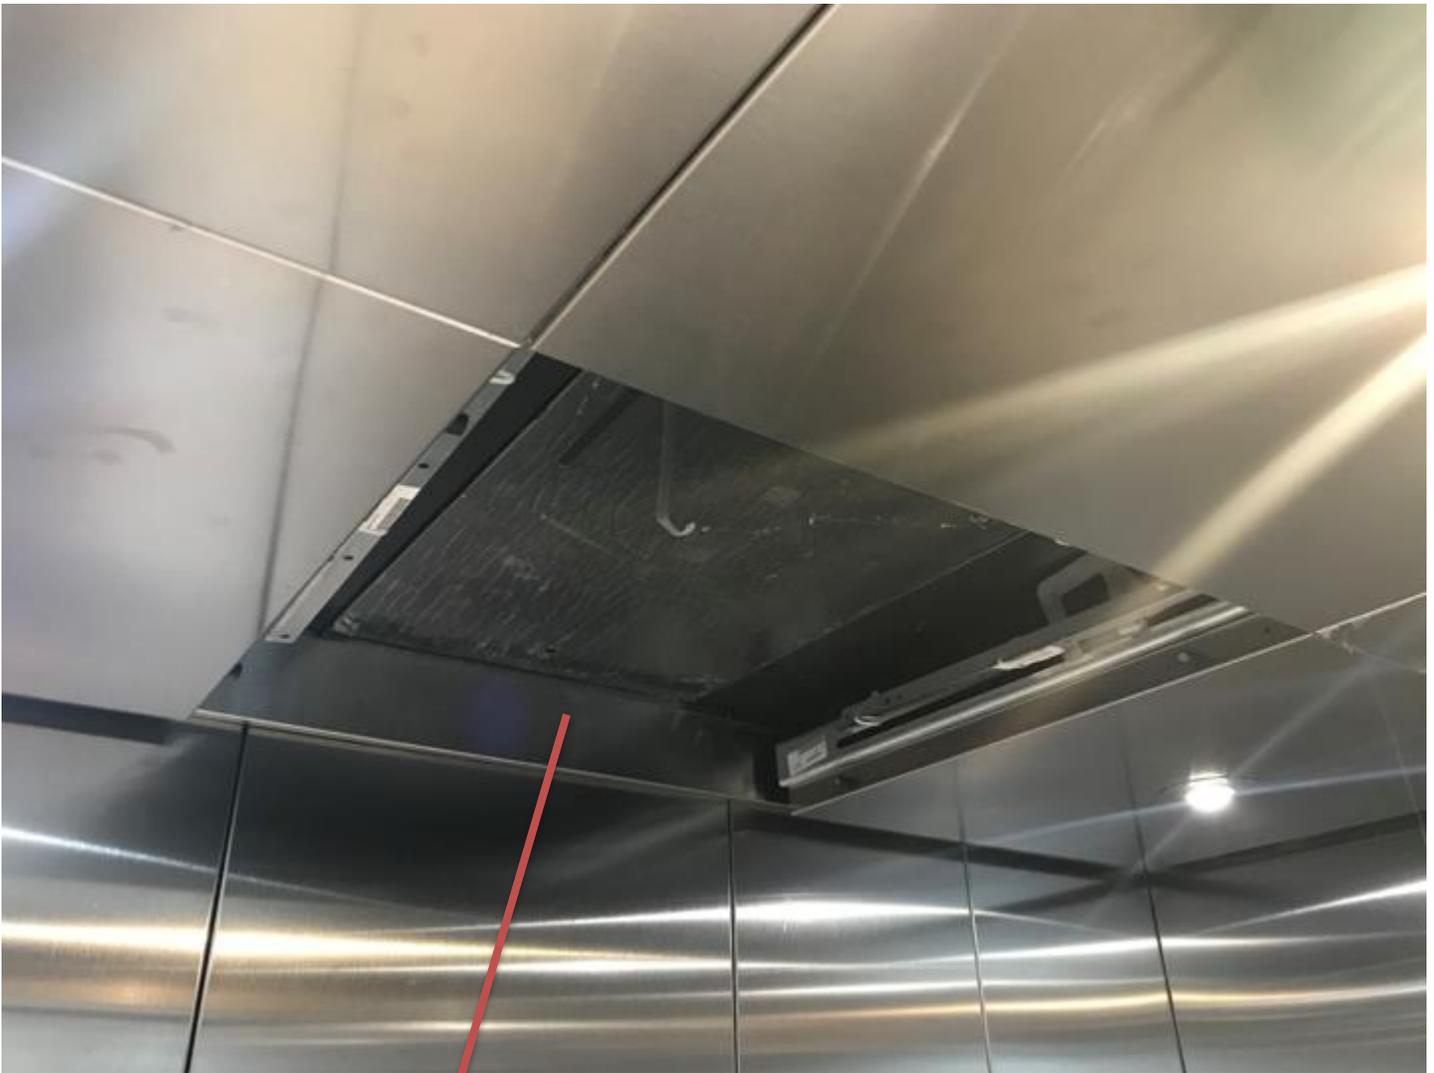
Missing metal emergency exit ceiling panel

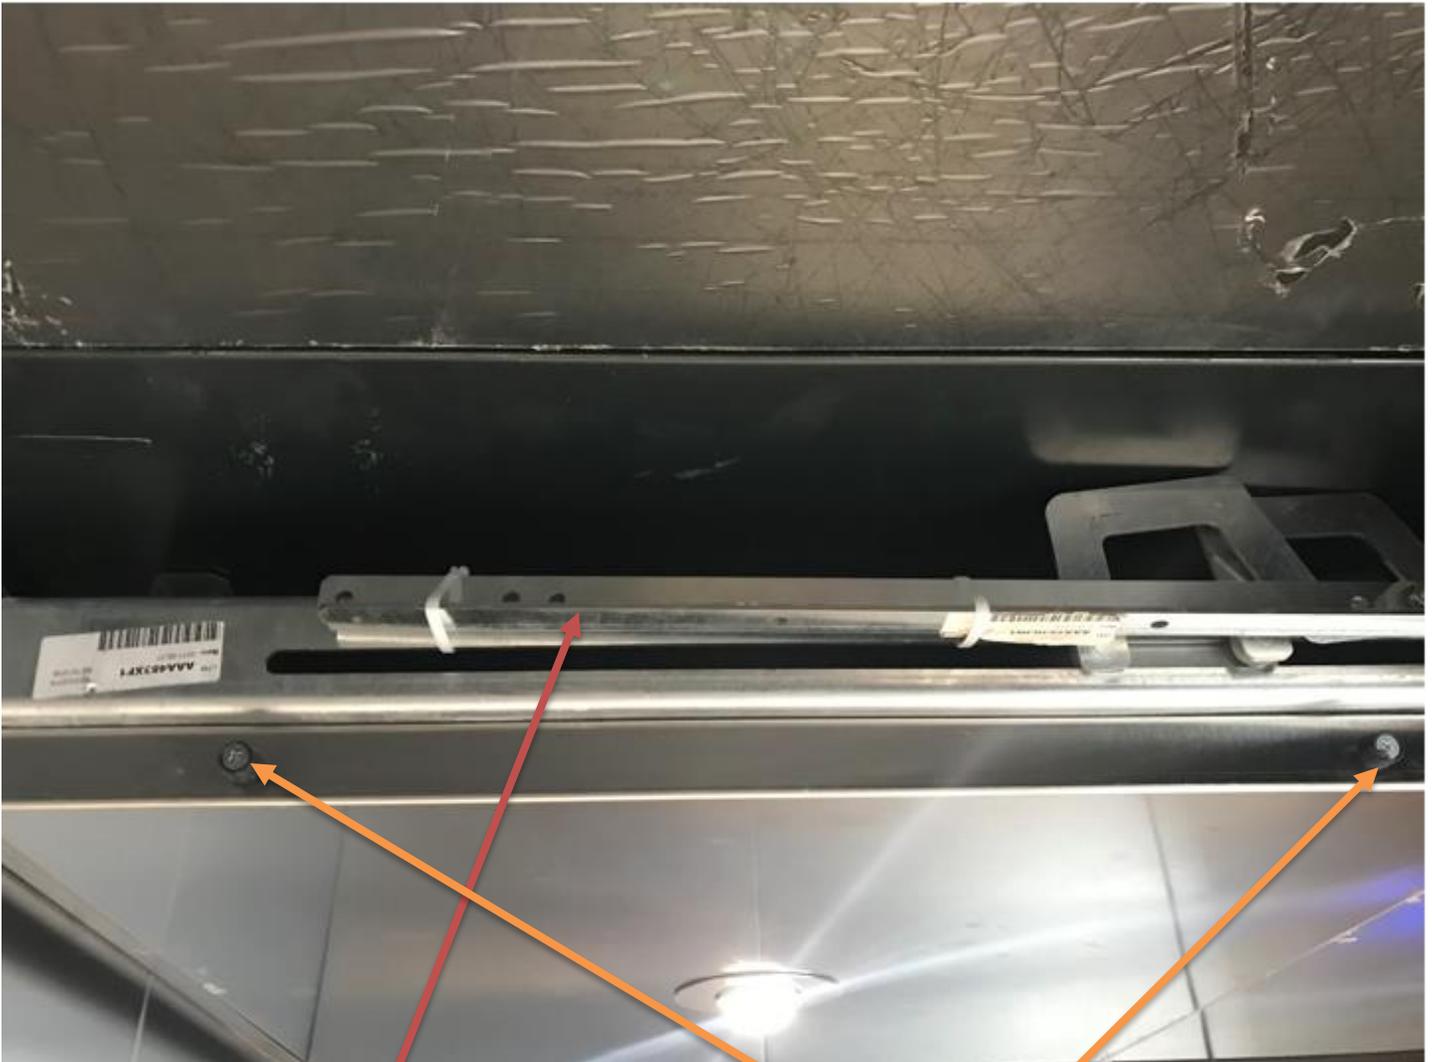
Failure scenario(s)		Due to the primary means of suspension becoming loose from regular vibrations in the elevator and the secondary means of suspension never being attached to the panel, it was able to vibrate itself loose and fall out of place.	
	Facts and evidence		<p>During investigation, it was found that :</p> <ul style="list-style-type: none"> • The secondary means of suspension was found in the elevator attached to the panel bars. The secondary suspension was observed to be not attached to emergency exit ceiling panel. • The emergency exit ceiling panel was placed back in the position it would have been before the incident, the drop ceiling was then lightly shaken to imitate the vibration of the elevator. Upon shaking of the drop ceiling the panel then fell out and crashed to the floor confirming the incident. 	
	Causes and contributing factors		<p>The cause for the emergency exit drop ceiling falling was most likely due to the secondary means of suspension not being installed during initial installation. It is very likely the natural vibration of the elevator over time was a contributing factor to the panel shifting and falling.</p> <ol style="list-style-type: none"> 1. Primary suspension loosened due to the vibration over time. 2. Secondary suspension was never installed to hold the panels in place.

Secondary Suspension not being used to hold panel in place.

Primary means of suspension is loose.
