Incident Summary #II-988065-2020 (#16794) (FINAL)

SUPPORTING INFORMATION	Incident Date	February 18, 2020	
	Location	Peace River Region	
	Regulated industry sector	Boilers, PV & refrigeration - Refrigeration system	
	Impact	Qty injuries	0
		Injury description	0
		Injury rating	None
	Damage	Damage description	Insignificant
		Damage rating	Insignificant
Incident rating	Insignificant		
Incident overview	<p>On February 18, 2020 the Alarm and light outside the Ammonia plant was activated at approximately 6:40pm. The plant operator checked the NH₃ (ammonia) readings and it read 43ppm (parts per million). At 6:45pm the readings increased to 51ppm and staff activated the Emergency Response Plan, contacted 911, the Chief Engineer, and evacuated the building to muster in the lobby of the building. By the time the fire department responded, the readings had dropped to 0ppm.</p> <p>Operators upon inspection of the number 6 compressor discharge valve bonnet “weep hole” using litmus test paper, (ammonia leak detection test method), observed that the test paper indicated a leak in the discharge valve. The operators tightened the discharge valve.</p> <p>There was no physical damage to the valve ot

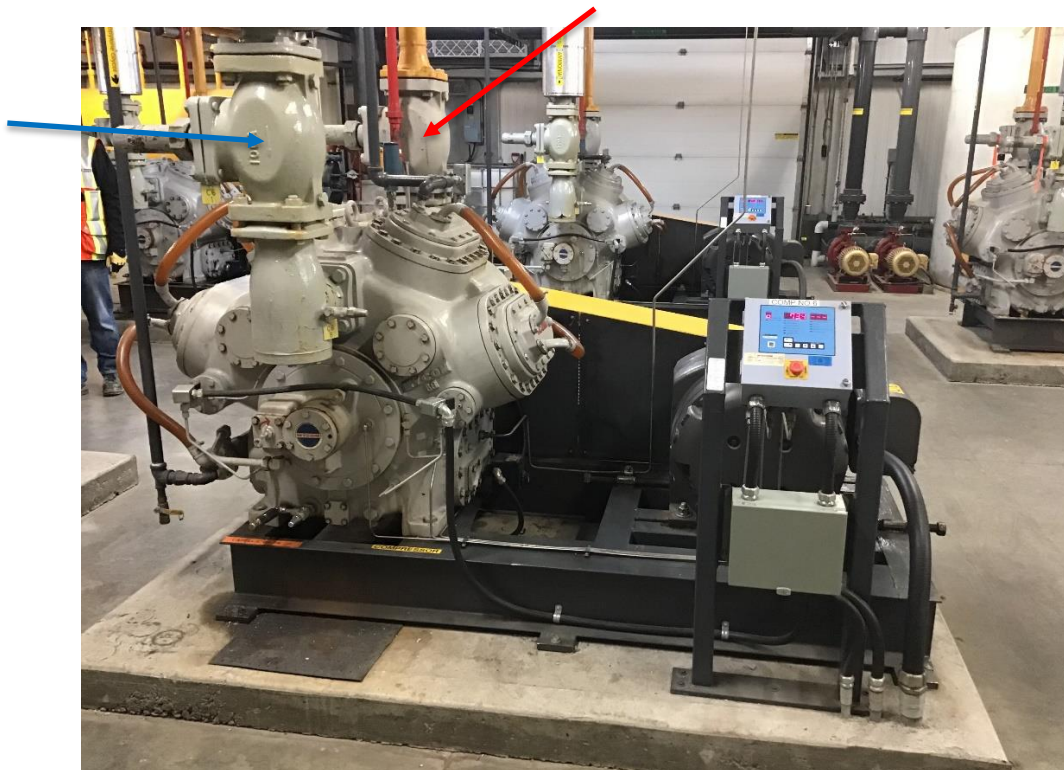
Above-Compressor Number 6 Overview: Blue arrow is inlet suction valve

The Red arrow is the discharge valve

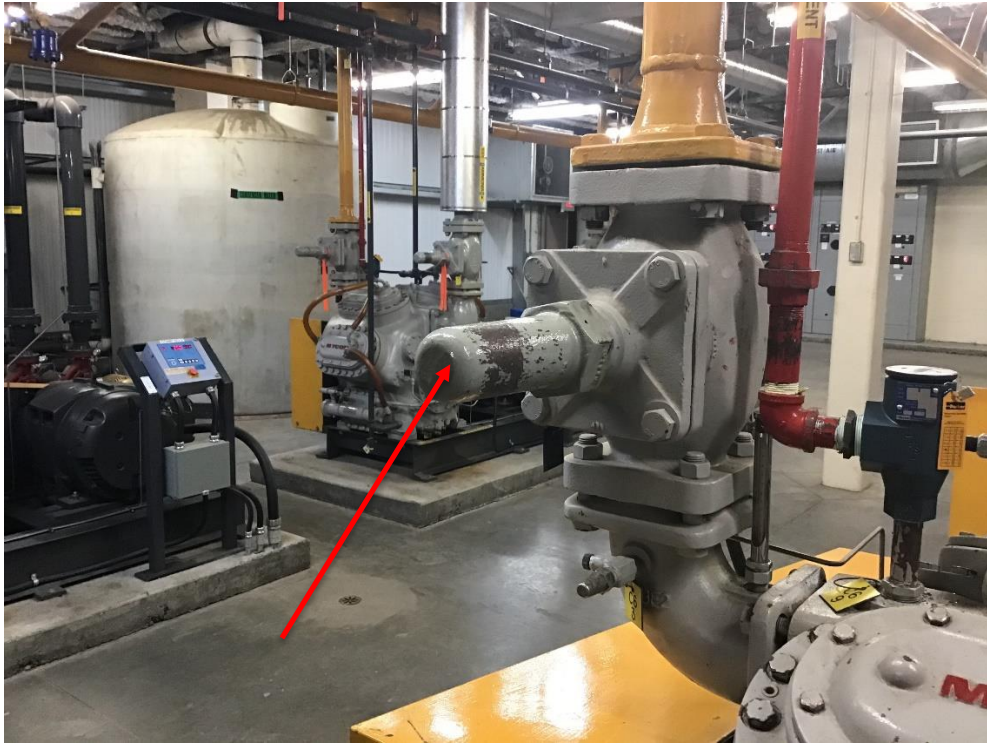
Failure scenario(s)	<ul style="list-style-type: none"> - Vibration from compressor number 6 may have affected the discharge valve stem packing causing the leak.

Compressor Number 6 Discharge Valve with valve stem bonnet (bonnet protects valve from potential external damage such as forklifts or other potential damage)

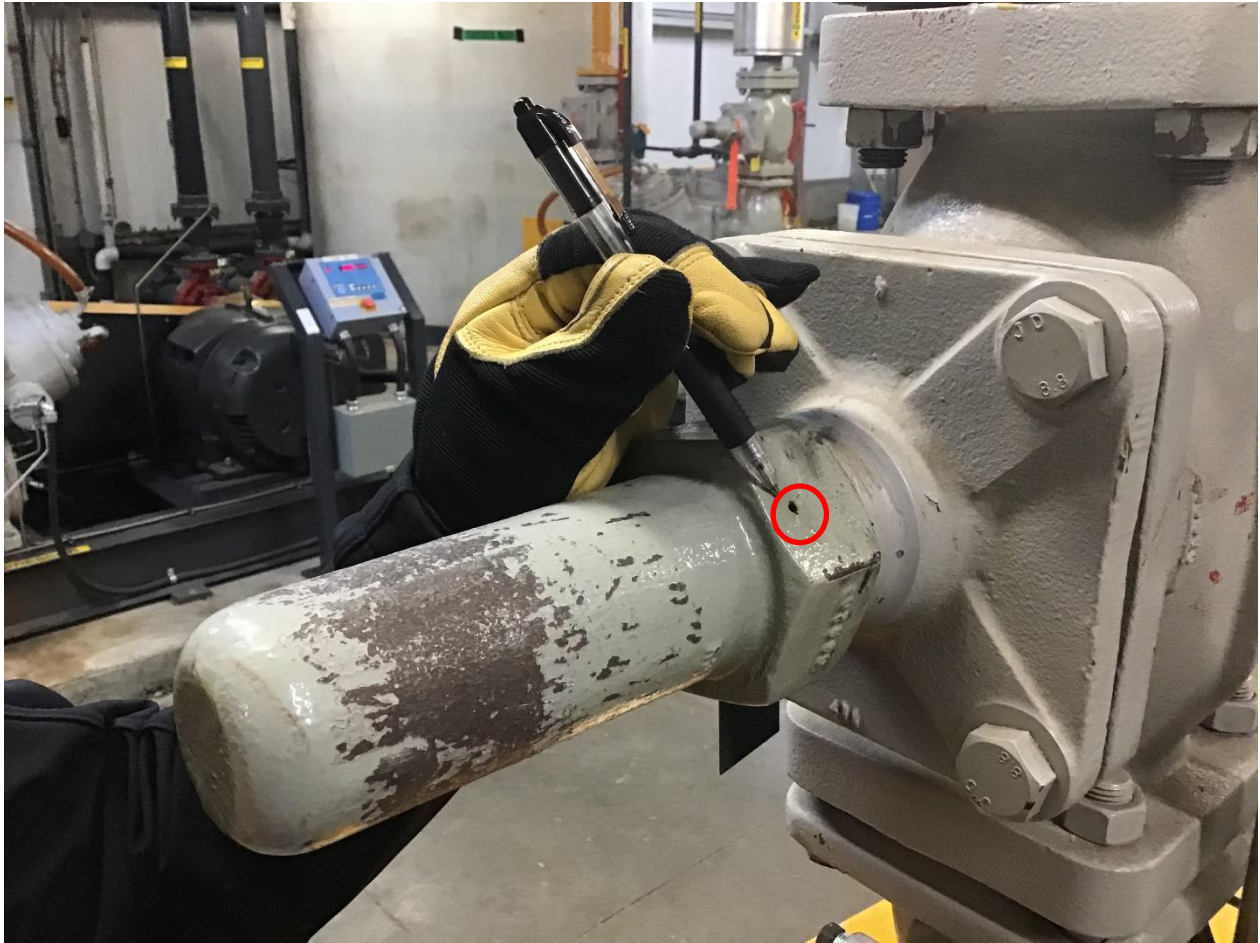
Facts and evidence	<ul style="list-style-type: none">- Operator reported that during the staff investigation of the ammonia leak, that leak detection litmus test paper indicated an ammonia leak at the No.6 compressor discharge valve bonnet weep hole with an ammonia monitor reading of approximately 3 parts per million.- Operator reported that the No. 6 compressor discharge valve stem was tightened by operator.
Causes and contributing factors	It is possible that vibration from the number six compressor may have caused the discharge valve to leak ammonia.

Pen points to discharge valve bonnet weep hole. Which allows ammonia to leak out and be detected in the event that the valve is leaking.
