Incident Summary #II-977639-2020 (#16571) (FINAL)

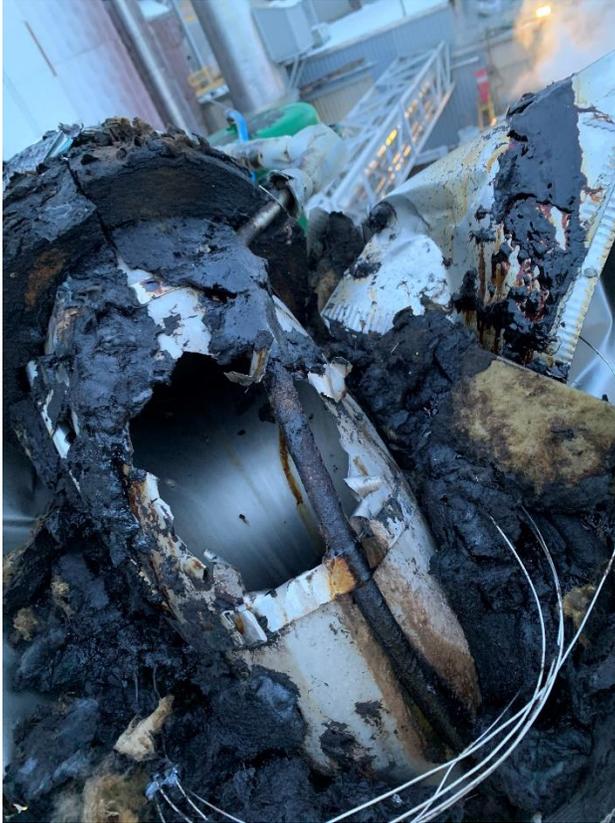
Failure scenario(s)	Black liquor traveling through a 6" - 90 degree piping elbow into a liquor storage tank eroded the grade SAE 304 stainless steel (SS) causing thinning of the piping wall. The thinned piping then ruptured resulting in a release of 125-145 degrees Celsius black liquor which flowed from the top of the storage vessel for approximately 1 hour until the process was stopped by pulped mill staff.	
	Facts and evidence	Inspection of the failed piping elbow found a large hole indicating a complete rupture had occurred. Inspection of the pipe wall verified thinning of the metal had occurred at the sweep of the elbow and was localized to that area of the piping. Inspection of the thinning determined that the primary damage mechanism was erosion/corrosion. An initial failure analysis determined why this elbow failed and not others. Upstream of the elbow a pressure and temperature drop through a control valve causes the black liquor to flash from a liquid to two phase (steam and liquid), this creates a higher velocity in the elbow increasing the rate of erosion/corrosion. Investigation determined that similar failures have happened at other facilities. An engineering solution has been to replace the SAE 304 SS with SAE 316 SS for improved erosion/corrosion resistance.

Causes and contributing factors	It is highly likely that erosion/corrosion caused thinning of the pressure piping elbow resulting in an eventual rupture of the pressure boundary. Flashing of the liquid to two phase (steam and liquid) just upstream of the elbow created a higher velocity in the elbow contributing to the rate of erosion/corrosion.

Ruptured Stainless Steel Elbow

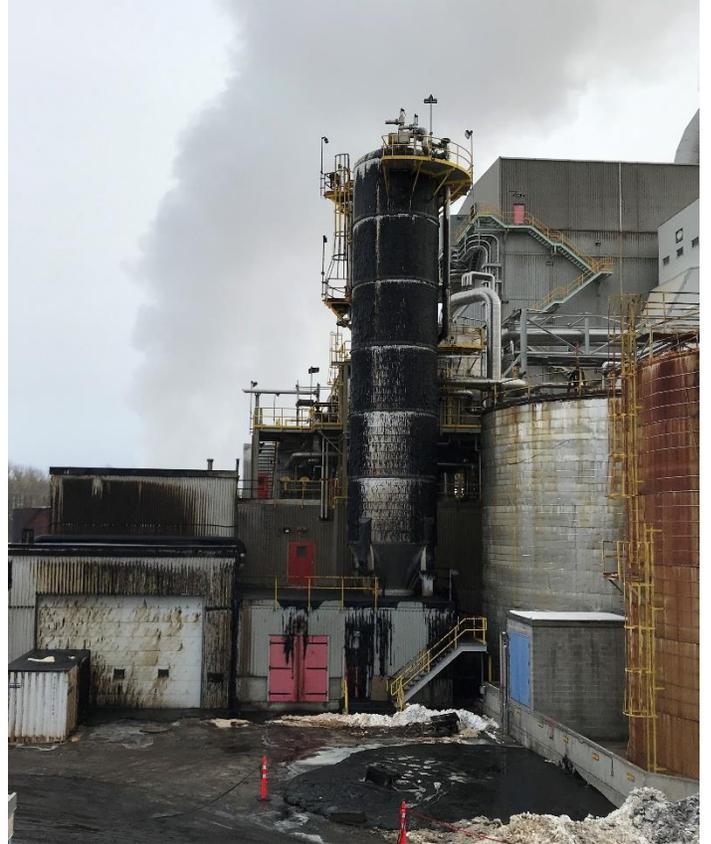
Black Liquor storage vessel and contamination after initial clean up
