Incident Summary #II-713160-2018 (#7838) (FINAL)

SUPPORTING INFORMATION	Incident Date	7/5/2018	
	Location	Coquitlam	
	Regulated industry sector	Electrical - Low voltage electrical system (30V to 750V)	
	Impact	Qty injuries	0
		Injury description	None
		Injury rating	None
	Damage	Damage description	Damage to the main distribution panelboard in a single family dwelling.
		Damage rating	Minor
	Incident rating	Minor	
Incident overview	A homeowner working on an energized panelboard caused an arc flash while attempting to relocated the system ground conductor within the panelboard.		
INVESTIGATION CONCLUSIONS	Site, system and components	A panelboard with a main circuit breaker rated for service entrance is common in most single family dwellings. The panelboards are installed and manufactured with covers and barriers to prevent contact with energized electrical conductors, busing and terminals and to contain any electrical faults that may occur. The panelboard enclosure cover is removable to provide access to the electrical components for installation or alteration but it is not to be removed unless the main circuit breaker is locked out in the off position as no repairs or alterations a

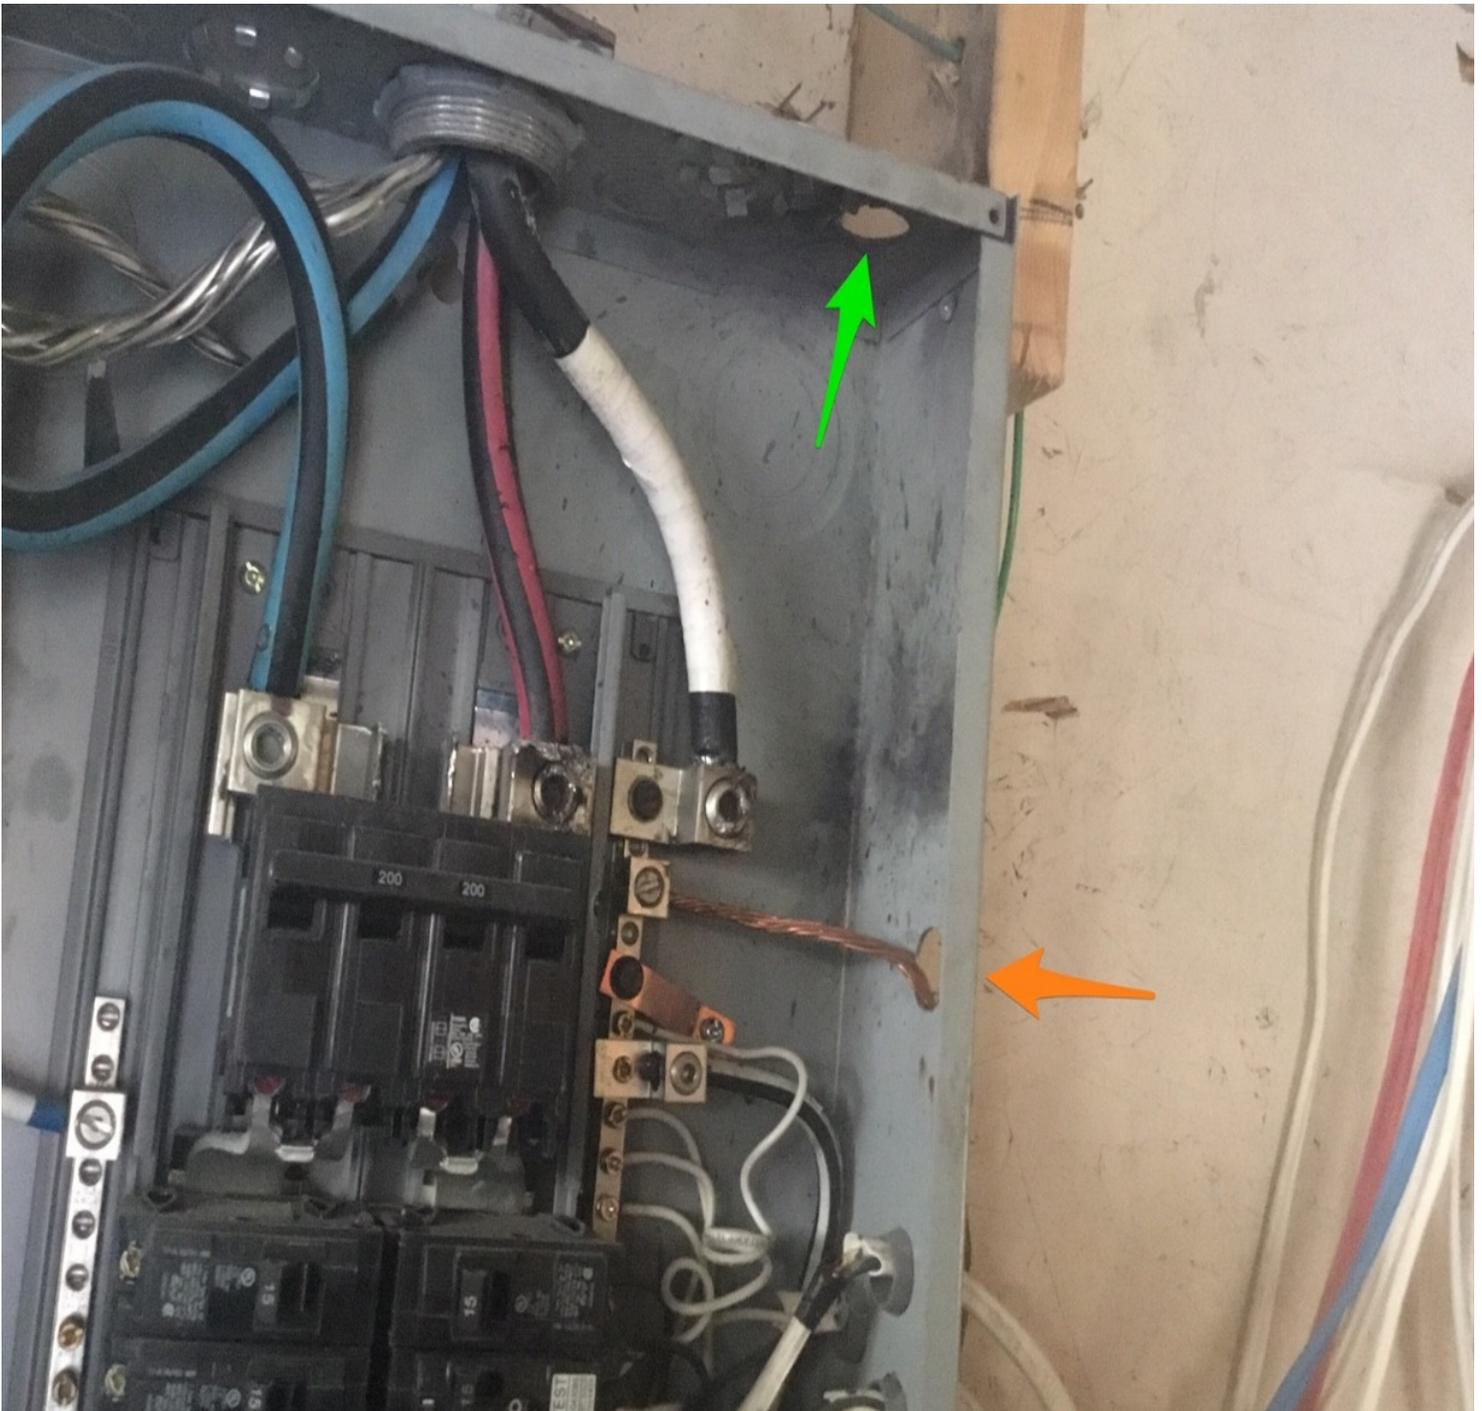
Photo #1

<p>Physical Evidence:</p> <p>There was visible damage to the panelboard (See photo's) and knockouts missing in the enclosure (See photo #1) that indicate that the damage was caused while trying to move the system ground conductor.</p>
Causes and contributing factors	It is very likely that the damage was caused to the panelboard by the homeowner performing electrical alterations on the energized equipment.

Green Arrow: The green arrow is pointing to the knockout missing in the top of the panelboard enclosure where the ground conductor was originally entering through.

Orange Arrow: The orange arrow is pointing to the new location of entry for the ground conductor. When the homeowner was moving the ground conductor into the new location it came in contact with the energized phase termination lug.

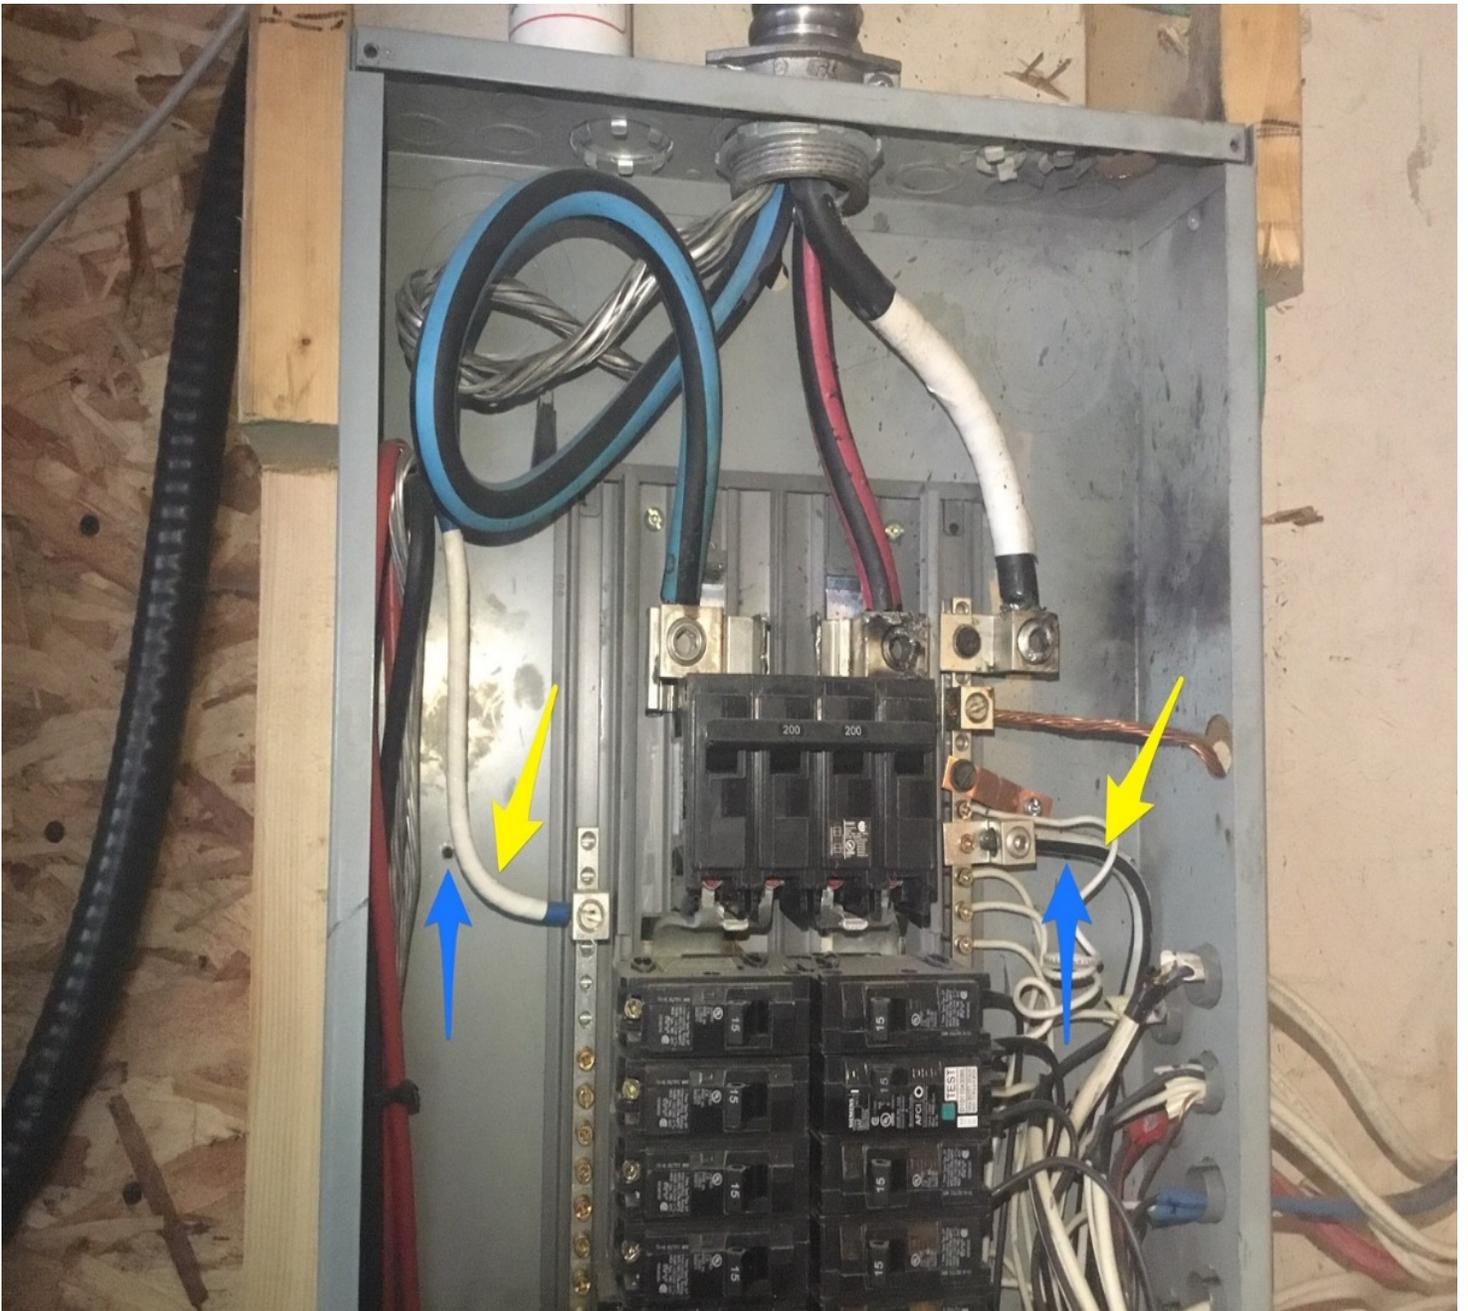
Photo #2

Blue Arrows: The blue arrows are pointing to the mounting holes for securing the service box barrier.

Yellow Arrows: The yellow arrows are pointing to conductors terminating to the neutral buss that would prevent the service box protective barrier from being installed and appears to have been removed before the branch circuit and feeder conductors were installed into the panelboard.

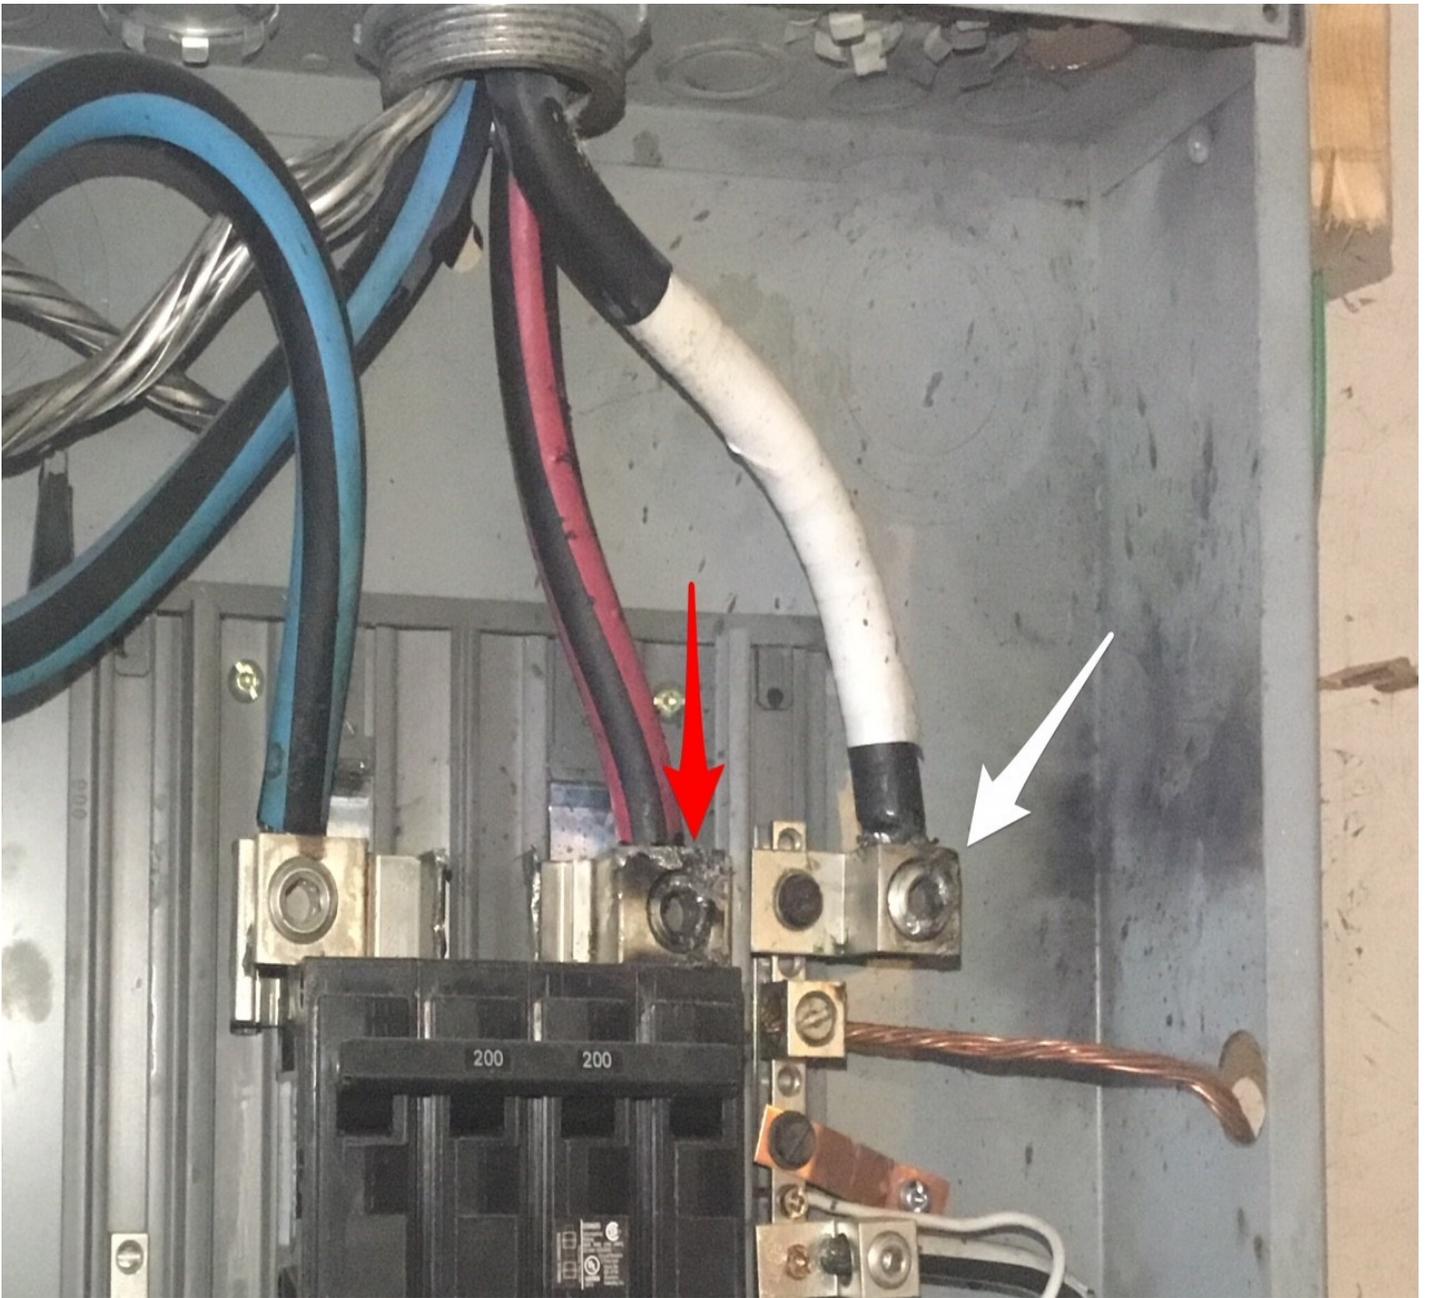
Photo #3

Red Arrow: The red arrow is pointing to the damage caused by the ground fault to one of the consumer service phase conductor termination lugs.

White Arrow: The white arrow is pointing to the damage cause by the ground fault to the lug for the consumer service conductor neutral termination.

On the right of the panelboard enclosure you can see black smoke / burn marks caused by the heat produced during the arc.
