Incident Summary Reference #II-639118-2018 (Final)

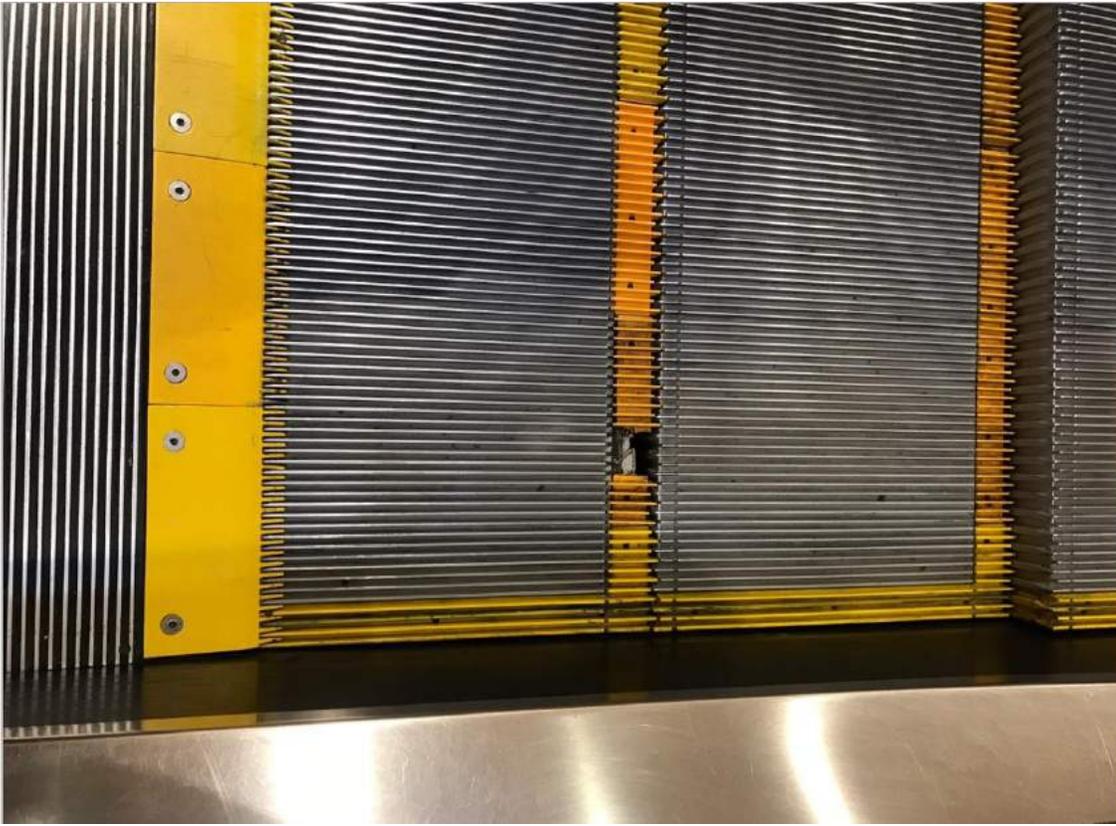
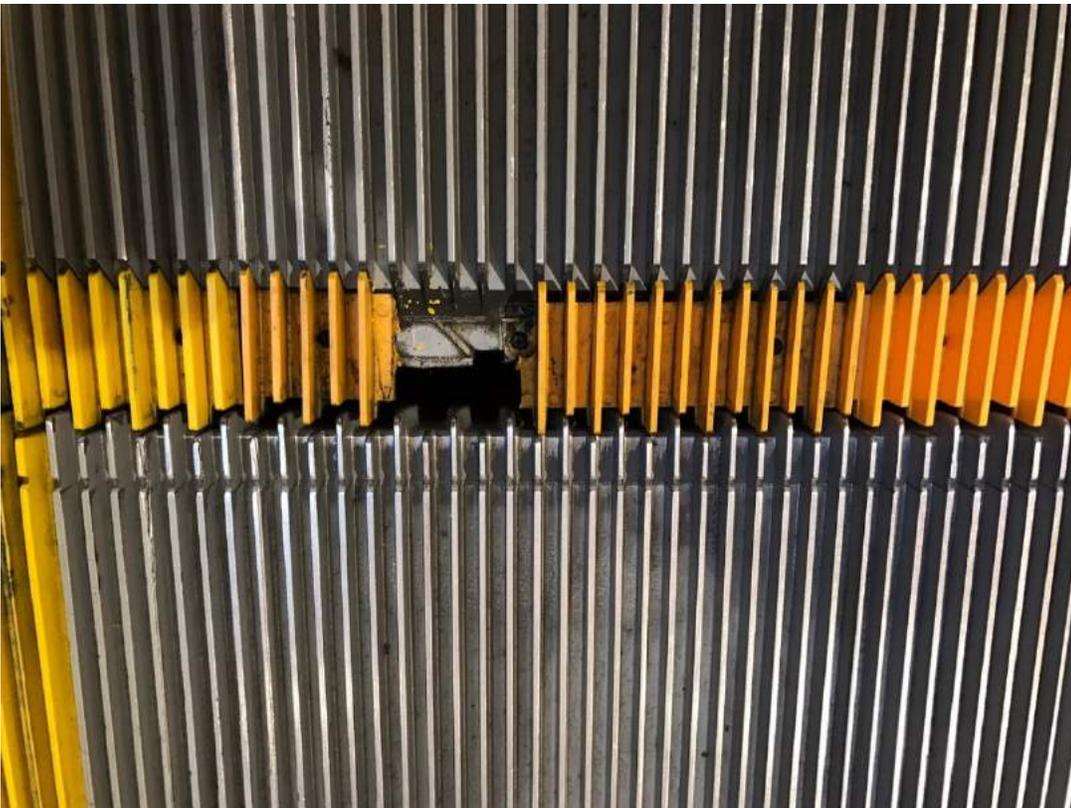
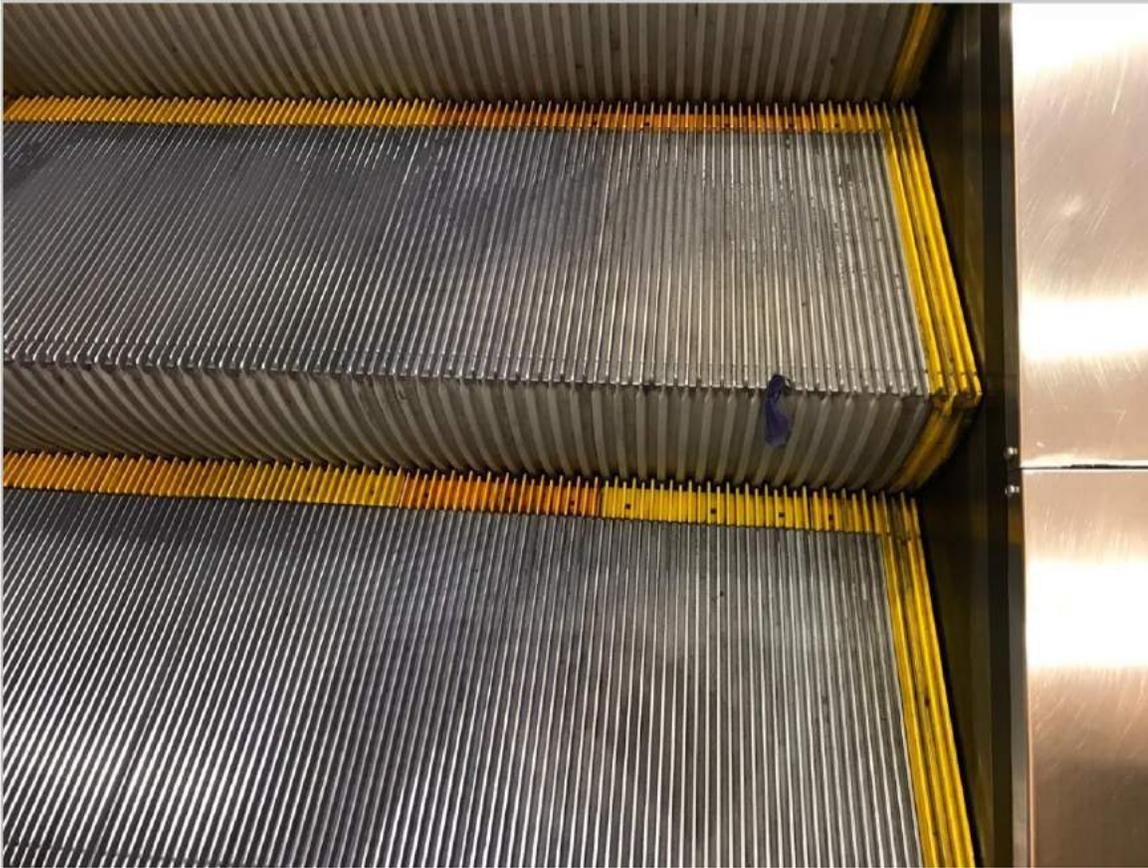
SUPPORTING INFORMATION	Incident Date	<i>December 23,2017</i>	
	Location	<i>Vancouver</i>	
	Regulated industry sector	<i>Elevating Device/ Escalator</i>	
	Impact	Qty injuries	<i>1</i>
		Injury description	<i>Cut/ Amputated tip of right index finger</i>
		Injury rating	<i>Minor</i>
	Damage	Damage description	<i>Section of the step demarcation was missing but was not caused by the incident</i>
		Damage rating	<i>None</i>
	Incident rating	<i>Minor</i>	
Incident overview	<i>It was reported to Technical Safety BC that a maintenance worker (cleaning staff) had been injured by an escalator. It was reported that a broken portion of an escalator step allowed the workers finger to get caught between the moving damaged section of step and the bottom of the escalator comb plate..</i>		
INVESTIGATION CONCLUSIONS	Site, system and components	<i>Escalator step demarcation lines are used to highlight the edges of the step for ease of loading/ unloading . The demarcation lines for this escalator are made of a plastic material affixed to the escalator step. At the beginning and end of an escalator are comb plates. Comb plates are positioned where the steps emerge and descend into the floor. Comb plates are designed to ensure that items do not become entrapped at the start and end of the escalator. The escalator step demarcation line is an outline of the step and is grooved in a way to be the opposite of the comb plate teeth. The step and comb plate are grooved in such a way to prevent items from getting pulled into the escalator internal workings.</i>

Failure scenario(s)	<i>A cleaner was wiping the step/ comb plate on a down moving escalator. When the damaged step approached, his right index finger partially was embedded in the missing section of the step injuring his finger.</i>	
	Facts and evidence	<i>-Video footage was obtained from the Mall security. The footage showed a maintenance worker at the bottom of the escalator. -Incident report was obtained from the Mall security who treated the injured cleaner until paramedics arrived. Incident report contains statement of the injured. Injured party stated that his “finger was caught in a missing escalator demarcation” -photos of the missing section of the escalator step. (see below)</i>	
	Causes and contributing factors	<i>It is likely that the step demarcation was damaged due to wear and tear or possibly it was fractured during installation/maintenance. It is highly likely that the injury was a result of the cleaner working on moving equipment, catching his finger between the damaged step and the comb plate.</i>
