Incident Summary #II-892940-2019 (#14785) (FINAL)

SUPPORTING INFORMATION	Incident Date	August 1, 2019	
	Location	Vancouver BC	
	Regulated industry sector	Elevating devices - Elevator	
	Impact	Qty injuries	1
		Injury description	Elevator occupant reported that the elevator became shaky and made a fast decent which resulted in their back injury.
		Injury rating	Moderate
	Damage	Damage description	Deteriorated packing gland and clogged check valve
		Damage rating	Minor
	Incident rating	Moderate	
Incident overview	A mechanical failure caused misalignment with the hydraulic system resulting in the elevator shaking and rapid but controlled decent.		
INVESTIGATION CONCLUSIONS	Site, system and components	<p>This elevator unit is a twin post hydraulic jack configuration. This hydraulic jack has an internal and external packing gland which maintains a seal between the hydraulic piston and the cylinder and prevents oil from leaking out.</p> <p>The check valve is located at the bottom of the main section of the piston and controls the flow rate of hydraulic fluid in both the up and down direction. When the valve on one side of the twin post remains open while the other cylinder check valve is

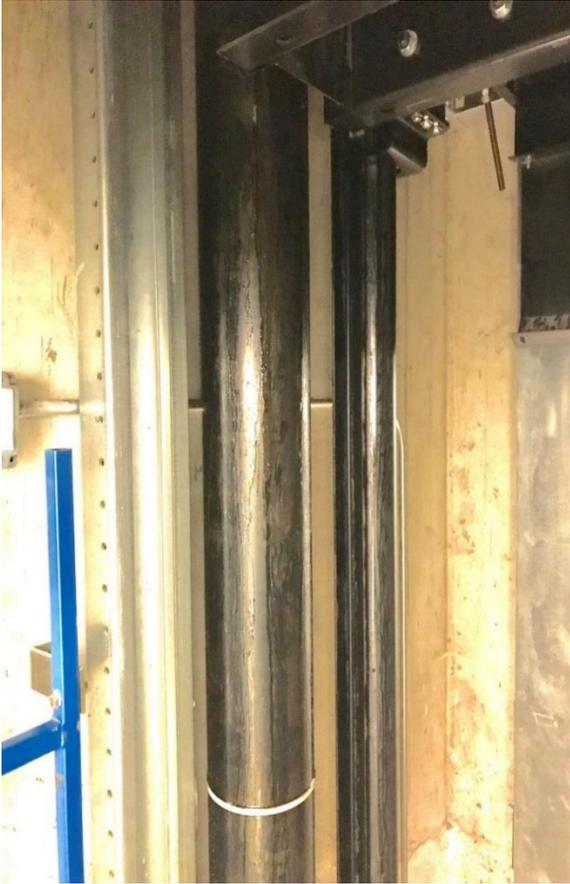
Failure scenario(s)	There was oil loss from one of the cylinders as a result of a deteriorated internal packing gland and uneven pressure due to a clogged check valve. The sensors, located within the system, detected that the pistons were not within the tolerances set by the manufacturer and proceeded to resync the jacks to ensure that both pistons were within equal positions. Resyncs usually occur at night but in this case it occurred during the day when there was an occupant in the elevator.	
	Facts and evidence	<p>During a visual inspection with the maintenance contractor, it was witnessed that there was a significant amount of oil on the outside of the cylinder casing.</p> <p>Interview with Maintenance Contractor confirmed:</p>

Photo 1: Picture of oil on exterior of cylinder

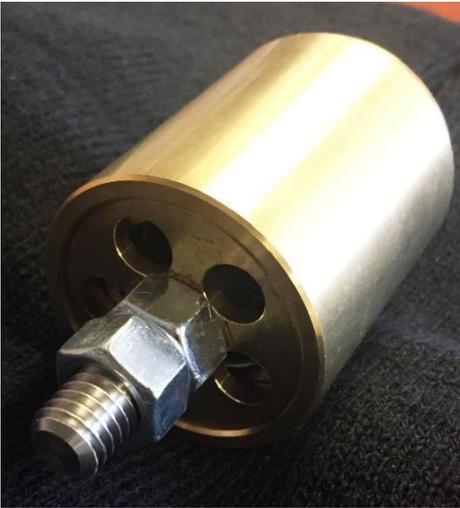
Photo 2: A new check valve – Rear

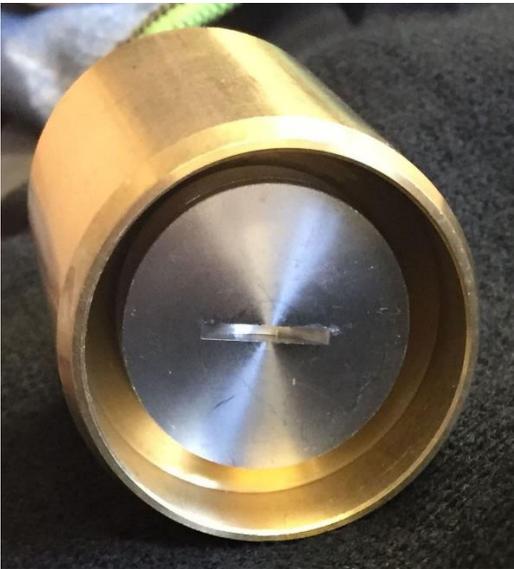
Photo 3: A new check valve – Front.
