## Incident Summary #II-743812-2018 (#8558) (FINAL)

SUPPORTING INFORMATION	Incident Date	September 13, 2018	
	Location	Vancouver	
	Regulated industry sector	Boilers, PV & refrigeration - Refrigeration system	
	Impact	Qty injuries	0
		Injury description	Not Applicable
		Injury rating	None
	Damage	Damage description	Pinhole in evaporative condenser coil.
		Damage rating	Moderate
Incident rating	Moderate		
Incident overview	Ammonia leaking through pinhole in evaporative condenser coil was smelled by operating engineer on duty.		
INVESTIGATION CONCLUSIONS	Site, system and components	The refrigeration plant is in a public assembly site. Plant is an indirect closed loop vented single stage vapour compression refrigeration system with anhydrous ammonia in primary side and brine solution on secondary side. In primary side, 4 single stage reciprocating compressors compress low pressure ammonia vapour to high pressure vapour which is condensed to high pressure liquid at the evaporative condenser. High pressure liquid refrigerant is fed at the bottom of shell side of the Chiller (for main rink) through float controlled solenoid valve and hand expansion valve (ammonia pressure drops while pas

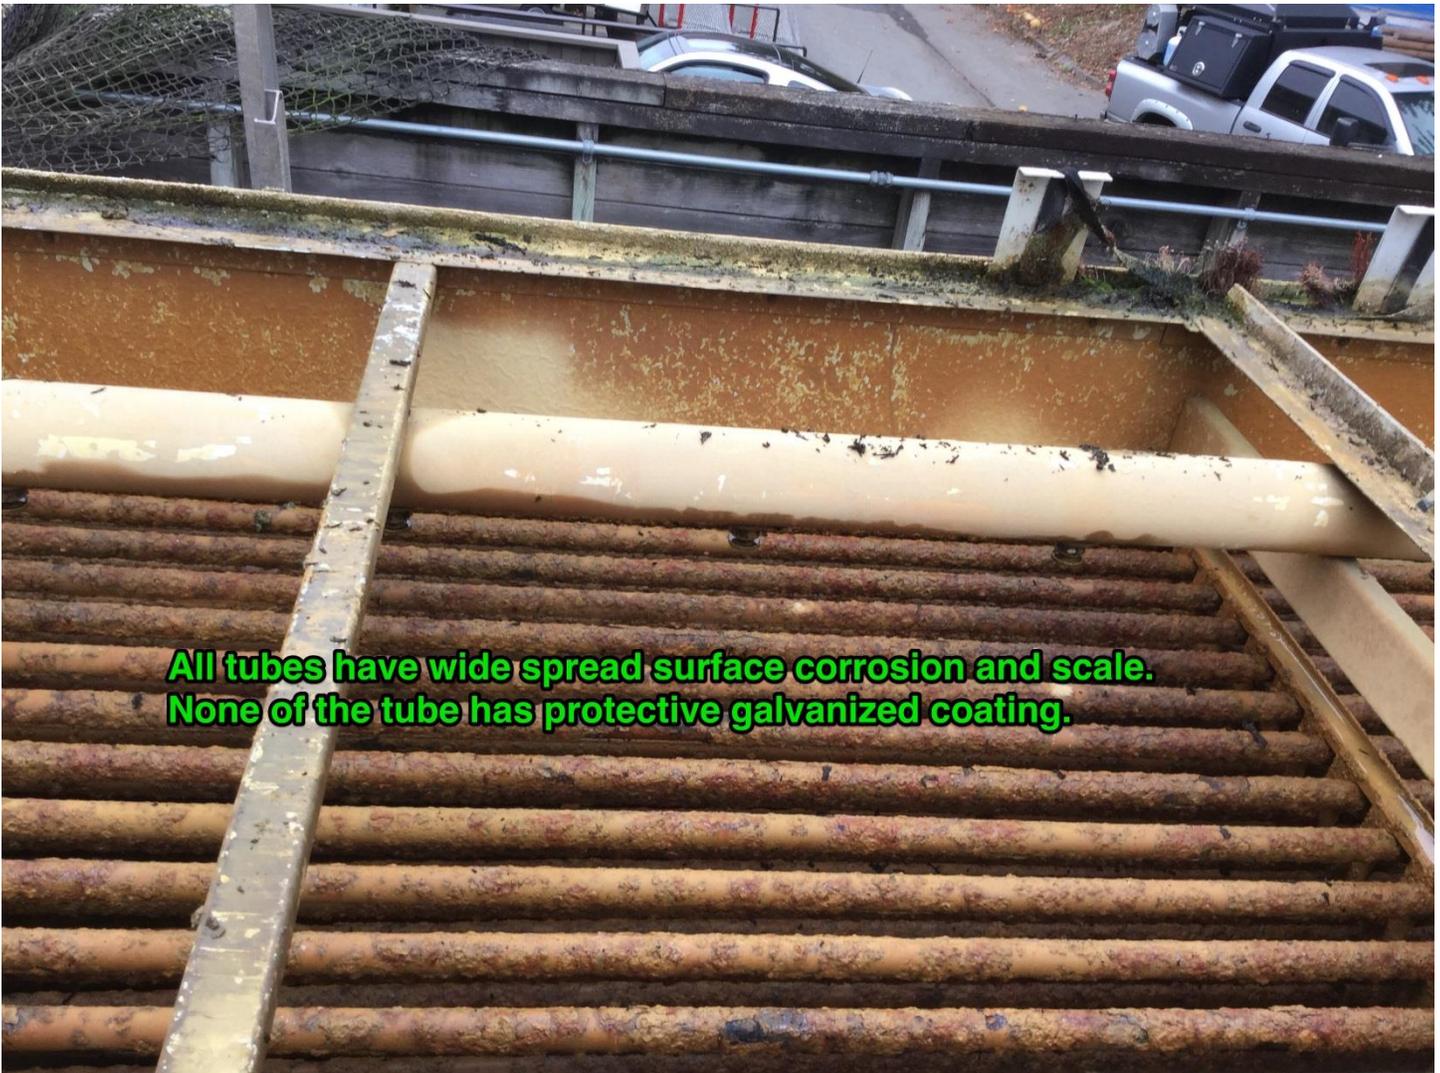
Picture of evaporative condenser coil taken from top

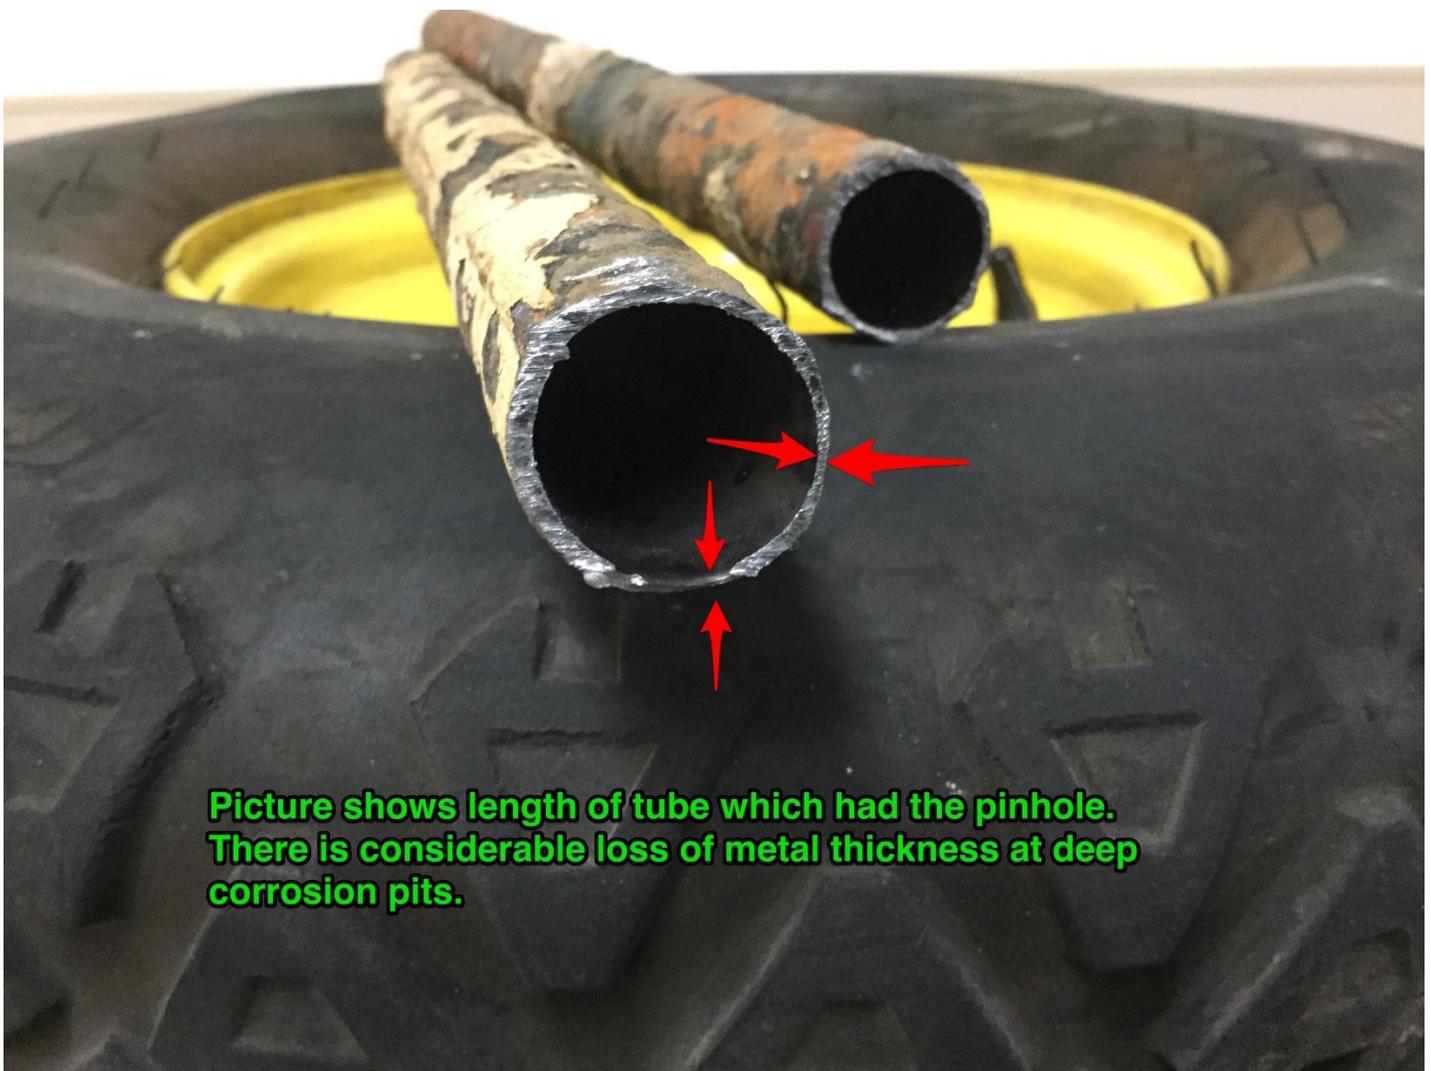
Failure scenario(s)	The evaporative condenser with hot-dip galvanized coil was built in 1996. Complete loss of protective galvanized coating made the bare carbon steel tube susceptible to corrosion. Heavy localized pitting corrosion penetrated full thickness of metal and created a pinhole in the coil.

**Picture shows length of tube which had the pinhole.  
There is considerable loss of metal thickness at deep  
corrosion pits.**

Picture of length of tube which had the pinhole
