Incident Summary (Reference #5616479)

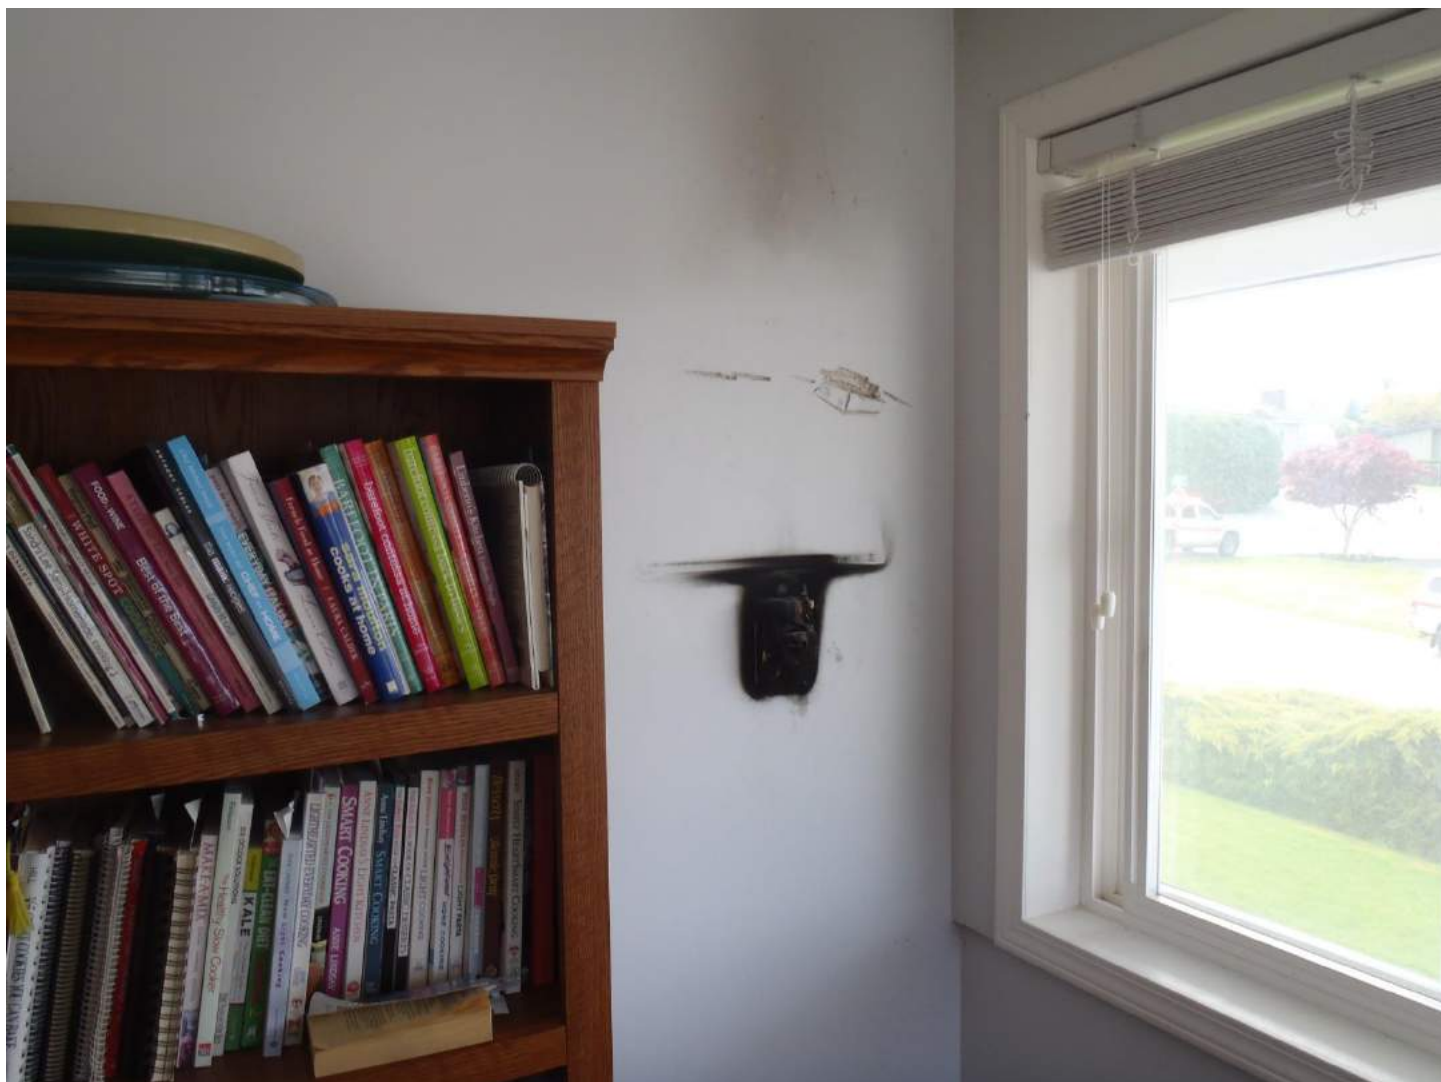
Failure scenario(s)		The outlet box wire fill capacity was exceeded, this caused the wires within the enclosure to press against the back of the thermostat. Over time, it is likely the back of the thermostat pressing on the wires inside the outlet box caused internal failure of the thermostat.	
	Facts and Evidence		-The back of the thermostat showed signs of a possible failure point as marks of electrical arcing were noticed. -The Home Owner had removed the original device from wall	
	Causes and Contributing Factors		-Thermostat outlet box capacity was exceeded. With the pressure of the large number of conductors against the back of the thermostat, this may have compressed the internal components of the thermostat causing the overheating of the device.

photo attached: device was removed from original scene
