## Incident Summary (Reference #5610772)

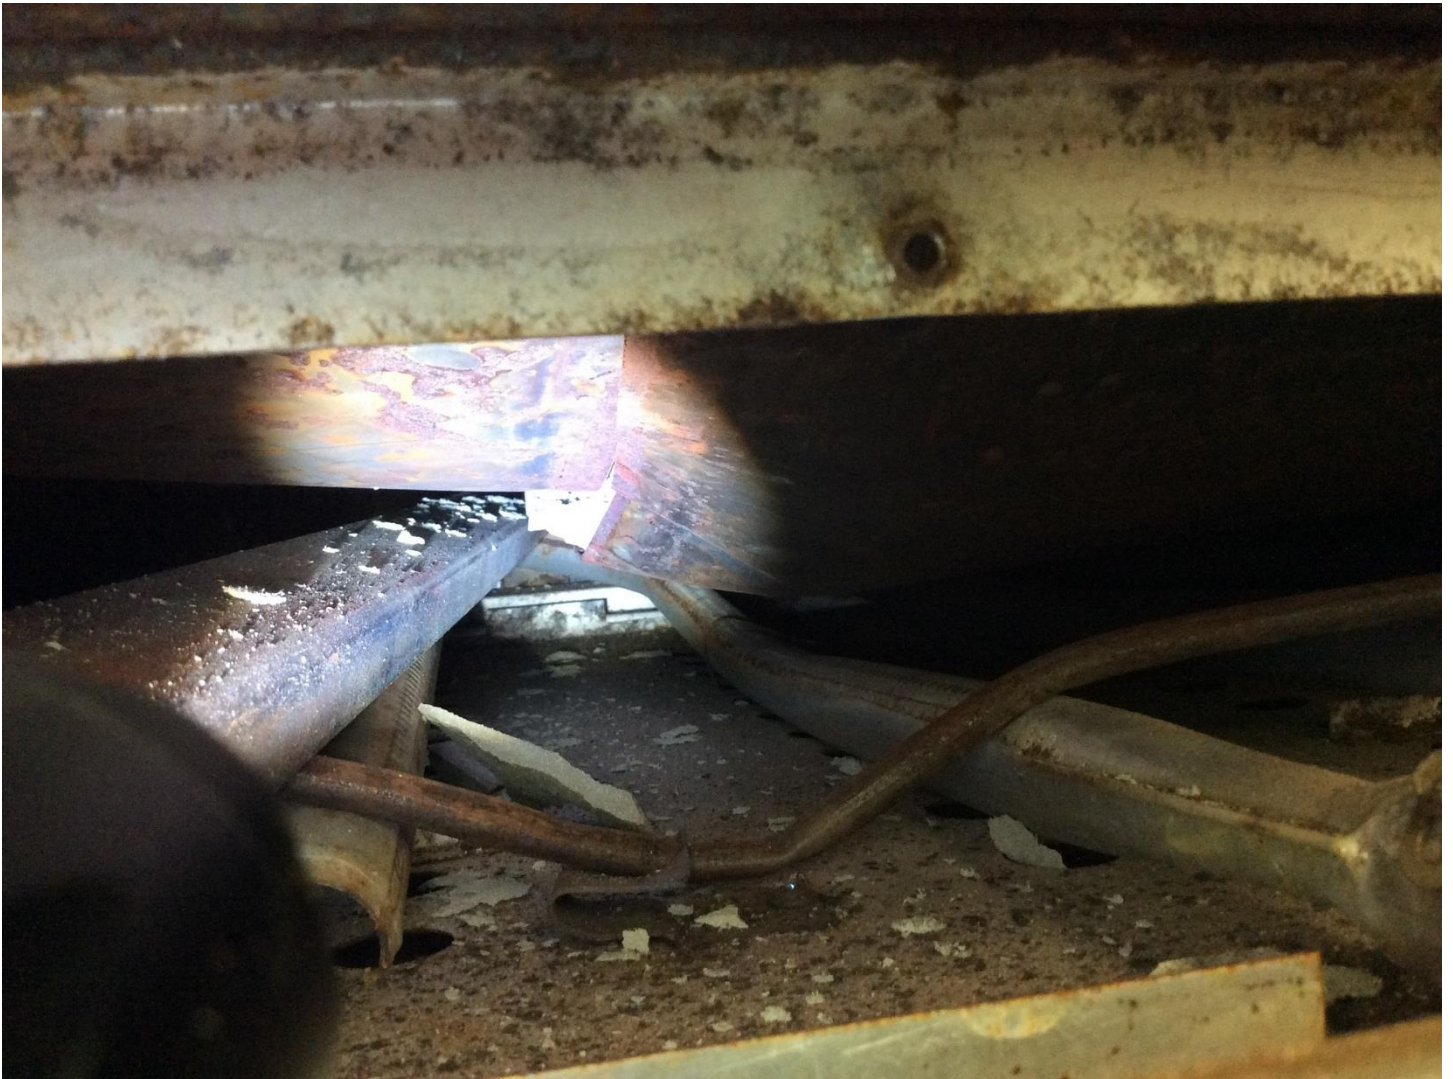
Facts and evidence		Distortion of the oven portion protruding into the burner drawer and bowing up the top of the cabinet. Burner drawer and flue passages do not communicate directly with oven compartment. Total destruction of all oven lining material.	
	Causes and contributing factors		Bake in procedure of new refractory may not have been performed as per manufactures instructions requiring a maximum temperature of 300 f for a minimum of 5 hours.

Burner drawer located below oven.
