Incident Summary #II-1144715-2021 (#20737) (FINAL)

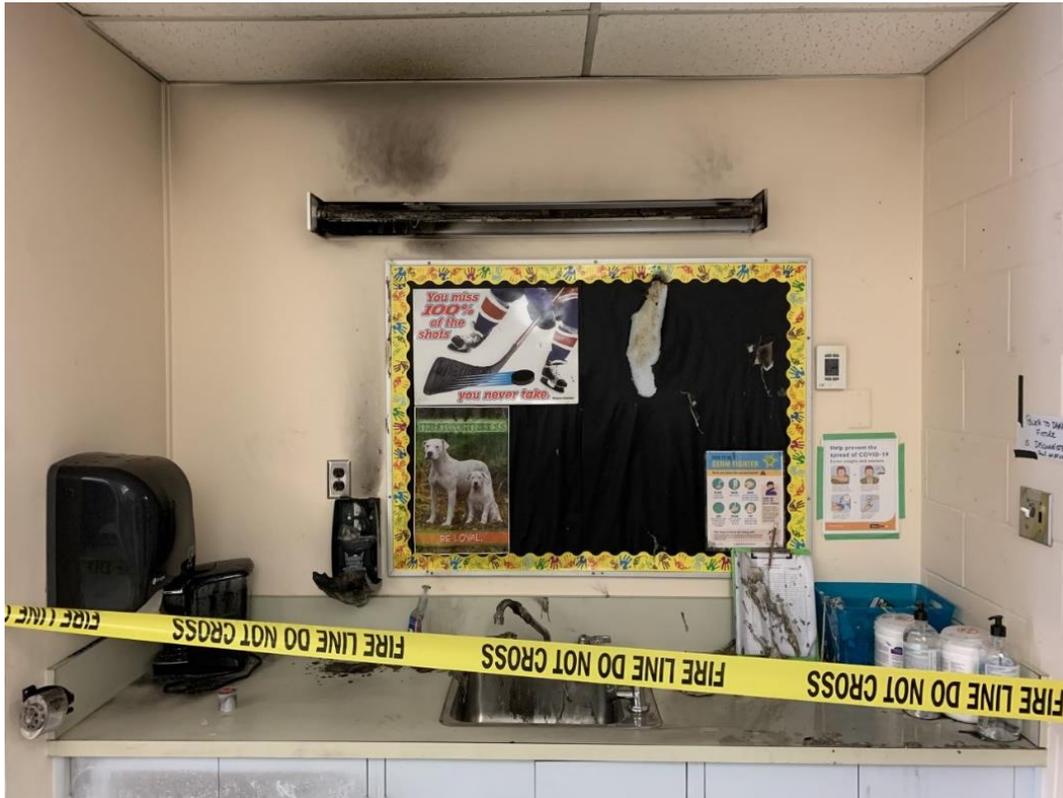
Photo #1 – Overall Incident Scene

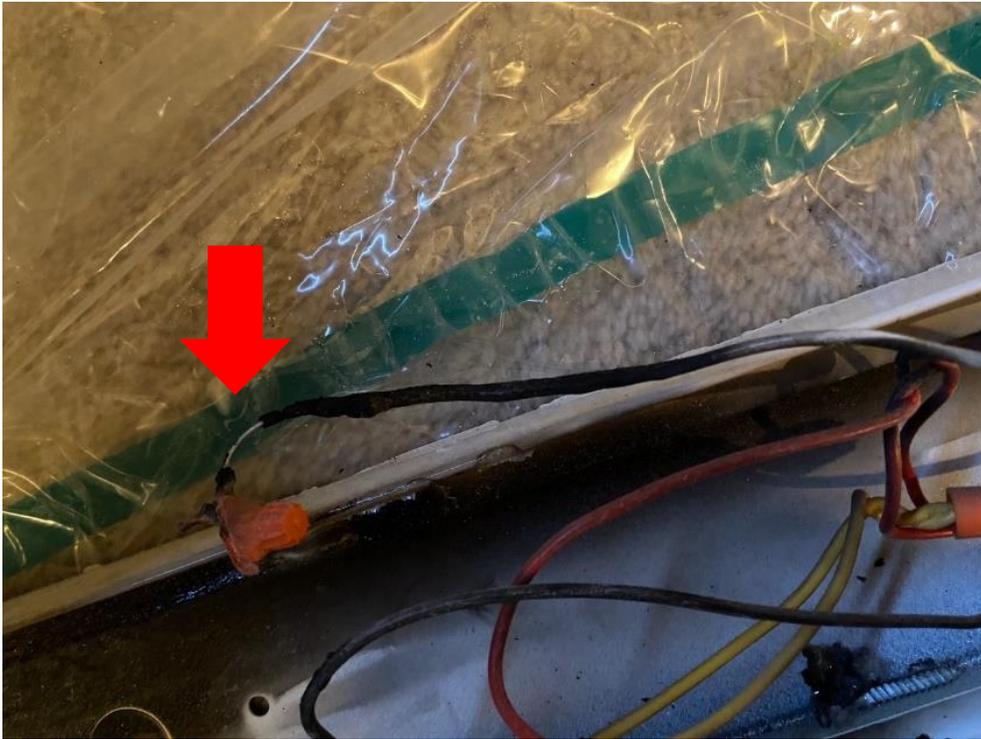
Photo #3 – Identified conductor showing burned insulation.

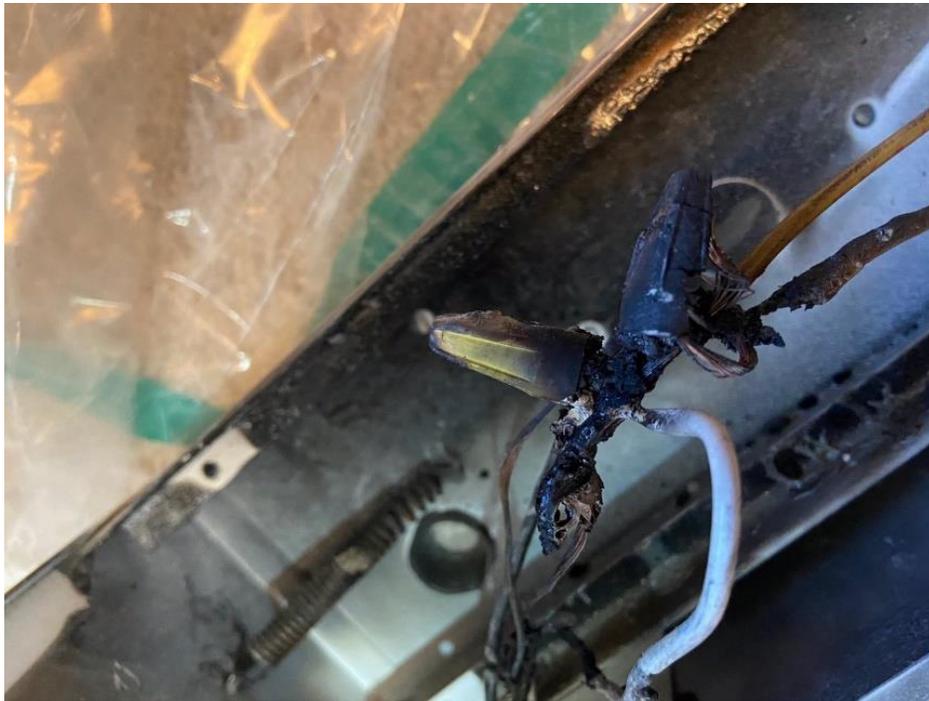
Photo #4 – Other connections melted due to heat.

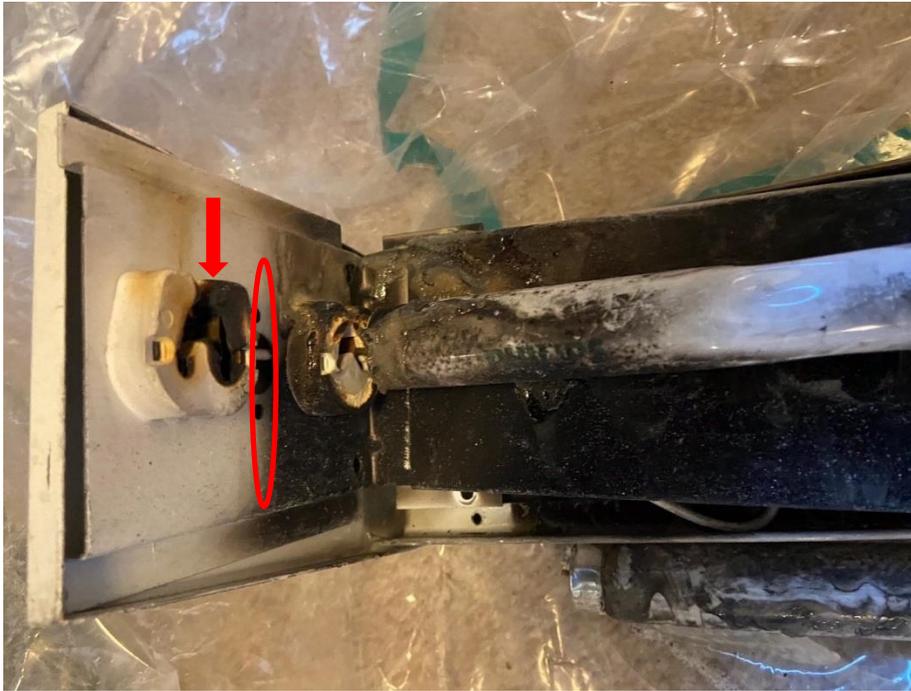
Photo #5 – Outer tombstone burning separate from fire.

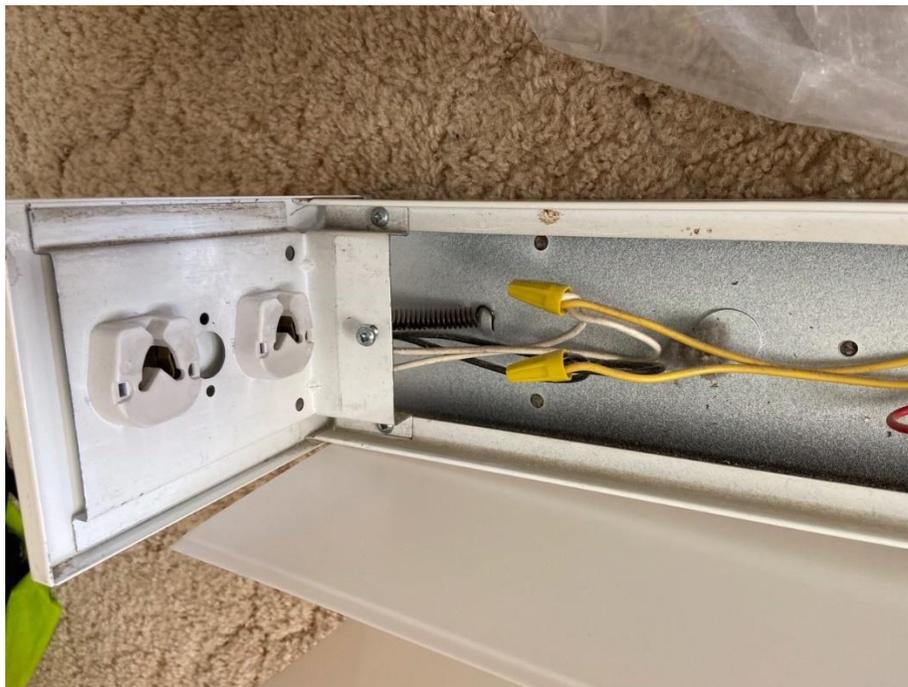
Photo #6 – Example fixture wiring matches damaged fixture wiring.
