## Incident Summary (II-648560-2018 #)

SUPPORTING INFORMATION	Incident Date	<i>February 07, 2018</i>	
	Location	<i>Abbotsford BC</i>	
	Regulated industry sector	<i>Natural Gas system</i>	
	Impact Injury	Qty injuries	<i>0</i>
		Injury description	<i>N/A</i>
		Injury rating	<i>None</i>
	Damage	Damage description	<i>Fire damage to a warehouse heater , equipment and materials stored within the warehouse.</i>
		Damage rating	<i>Major</i>
Incident rating	<i>Major</i>		
Incident overview	<p><i>The warehouse room where the fire occurred was used to store large quantities of food packaging materials such as plastics, cardboards and Styrofoam. These materials were stacked and bundled up on wooden pallets for easy storage.</i></p> <p><i>High above these materials is where a typical warehouse heater (unit heater) was installed and operating. A failure took place within the heater that led to a serious warehouse fire.</i></p>		
INVESTIGATION CONCLUSIONS	Site, system and components	<p><i>Warehouse heaters (also called “unit heaters”) are commonly installed and used to heat larger open spaces such as warehouses, shops and garages. They are typically suspended from the ceiling so as to be up and

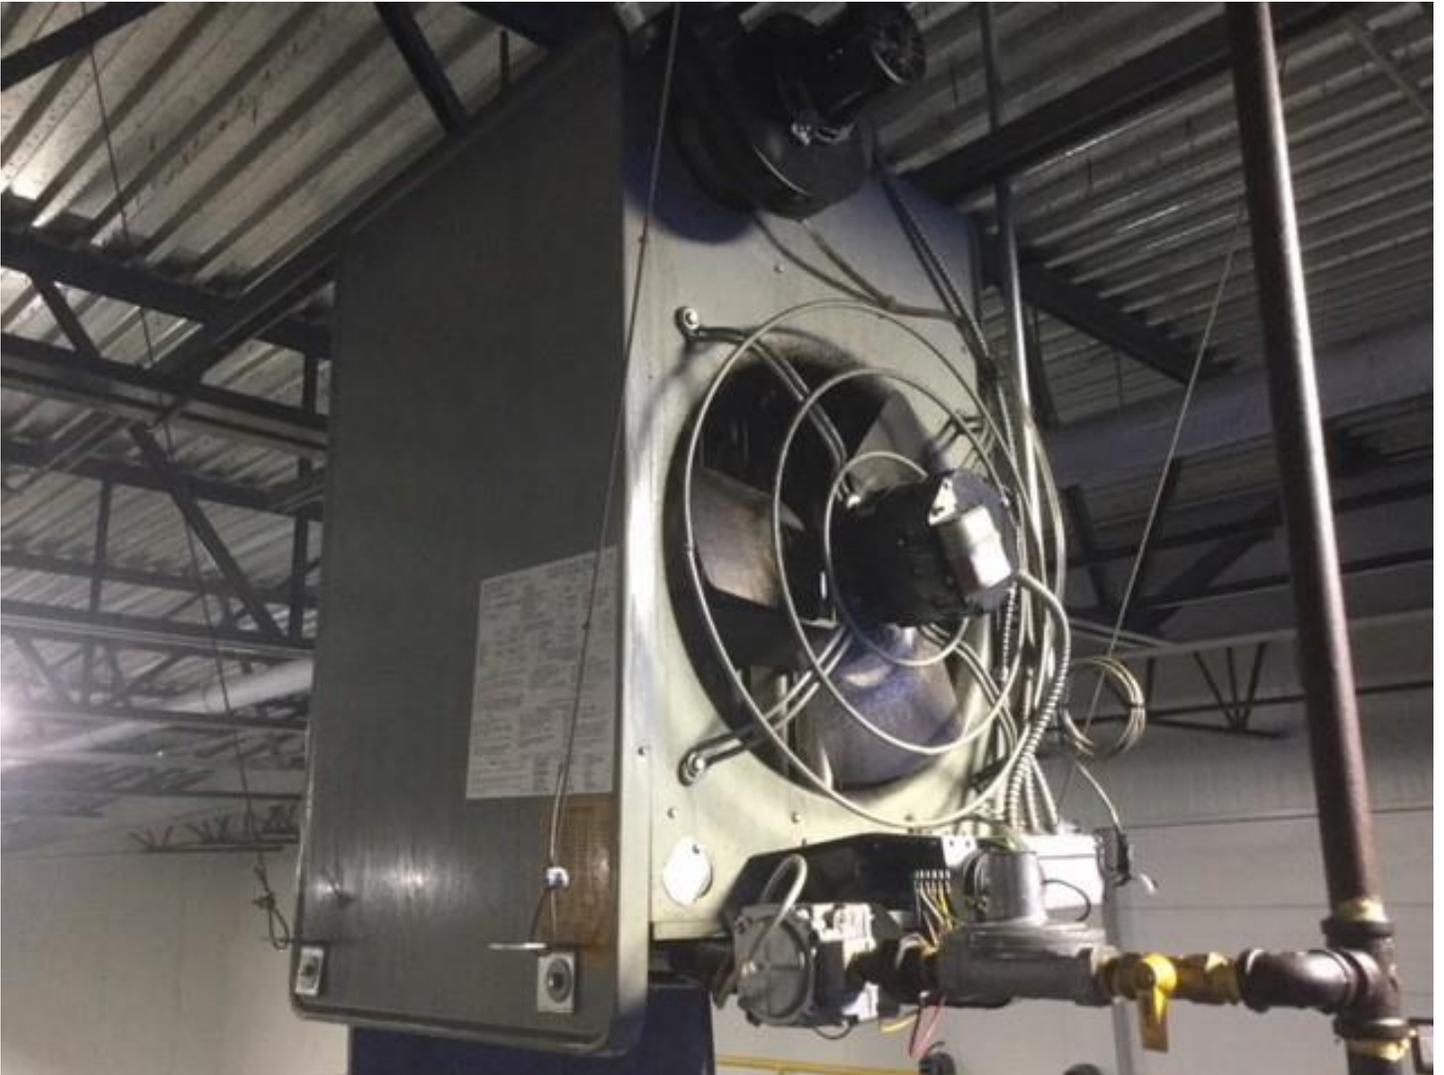
Pictured above is a typical warehouse heater (Unit heater) in normal working condition.

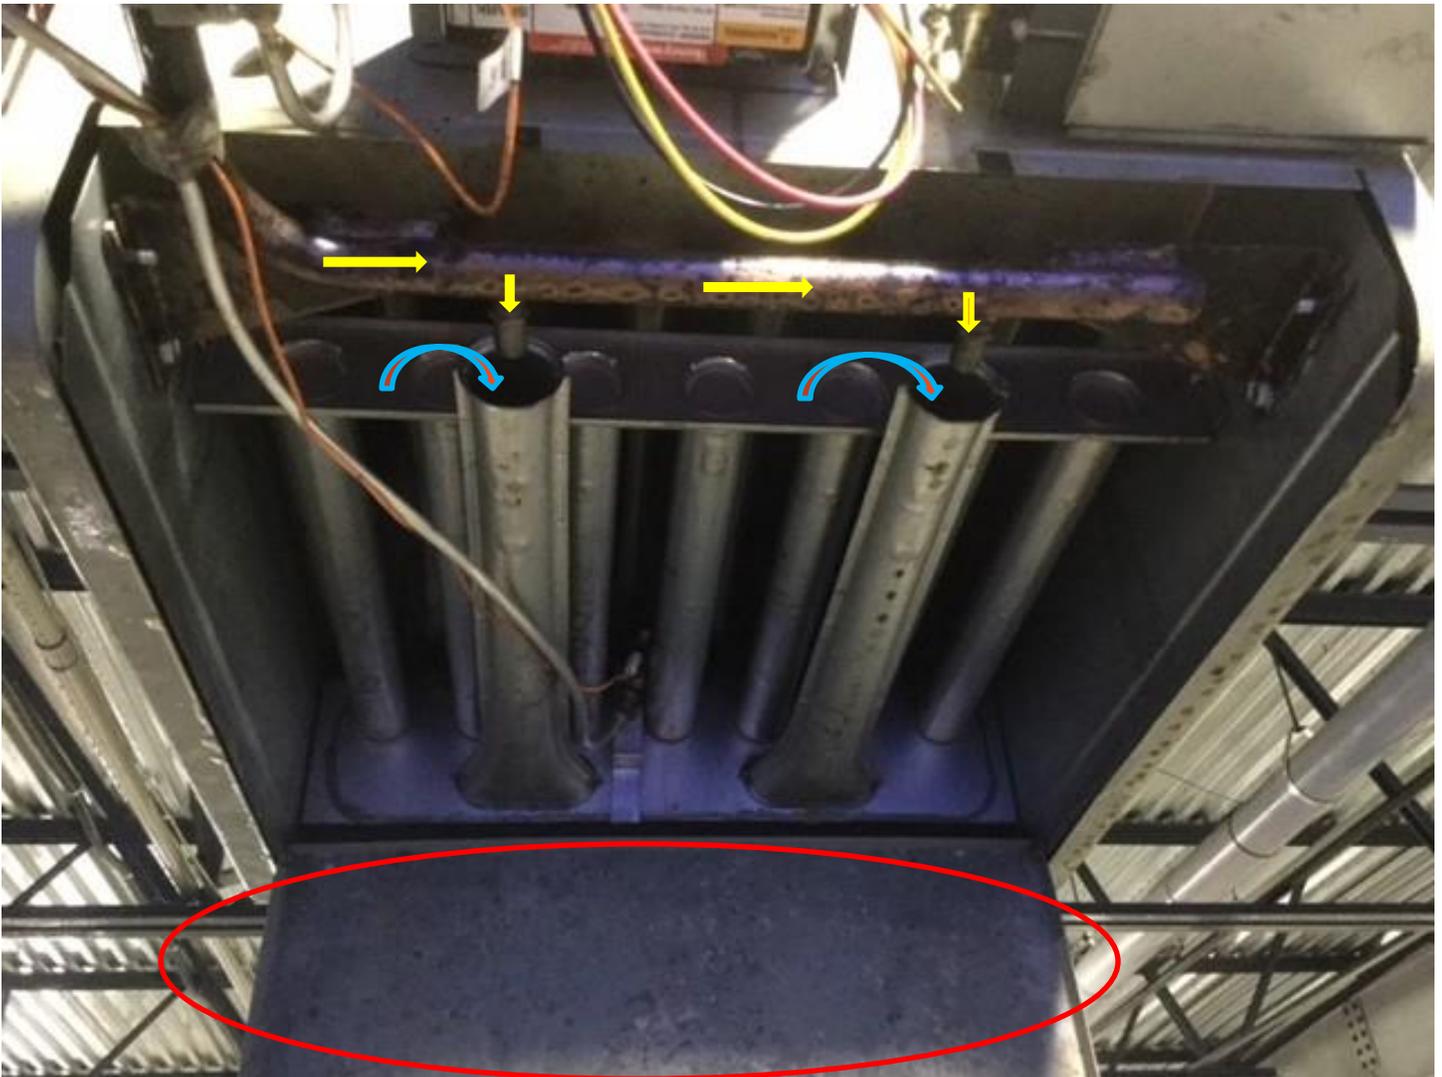
Looking up at the burners and flue passageways on a heater in good working condition.

-The red oval circles the flip down burner access tray, no signs of dirt, debris or soot.

-Yellow arrows pointing right show the flow of gas through the manifold , with the yellow arrows pointing down to where natural gas is fed into the burners through the orifices.

-Blue arrows are where air is drawn in and mixed with the natural gas

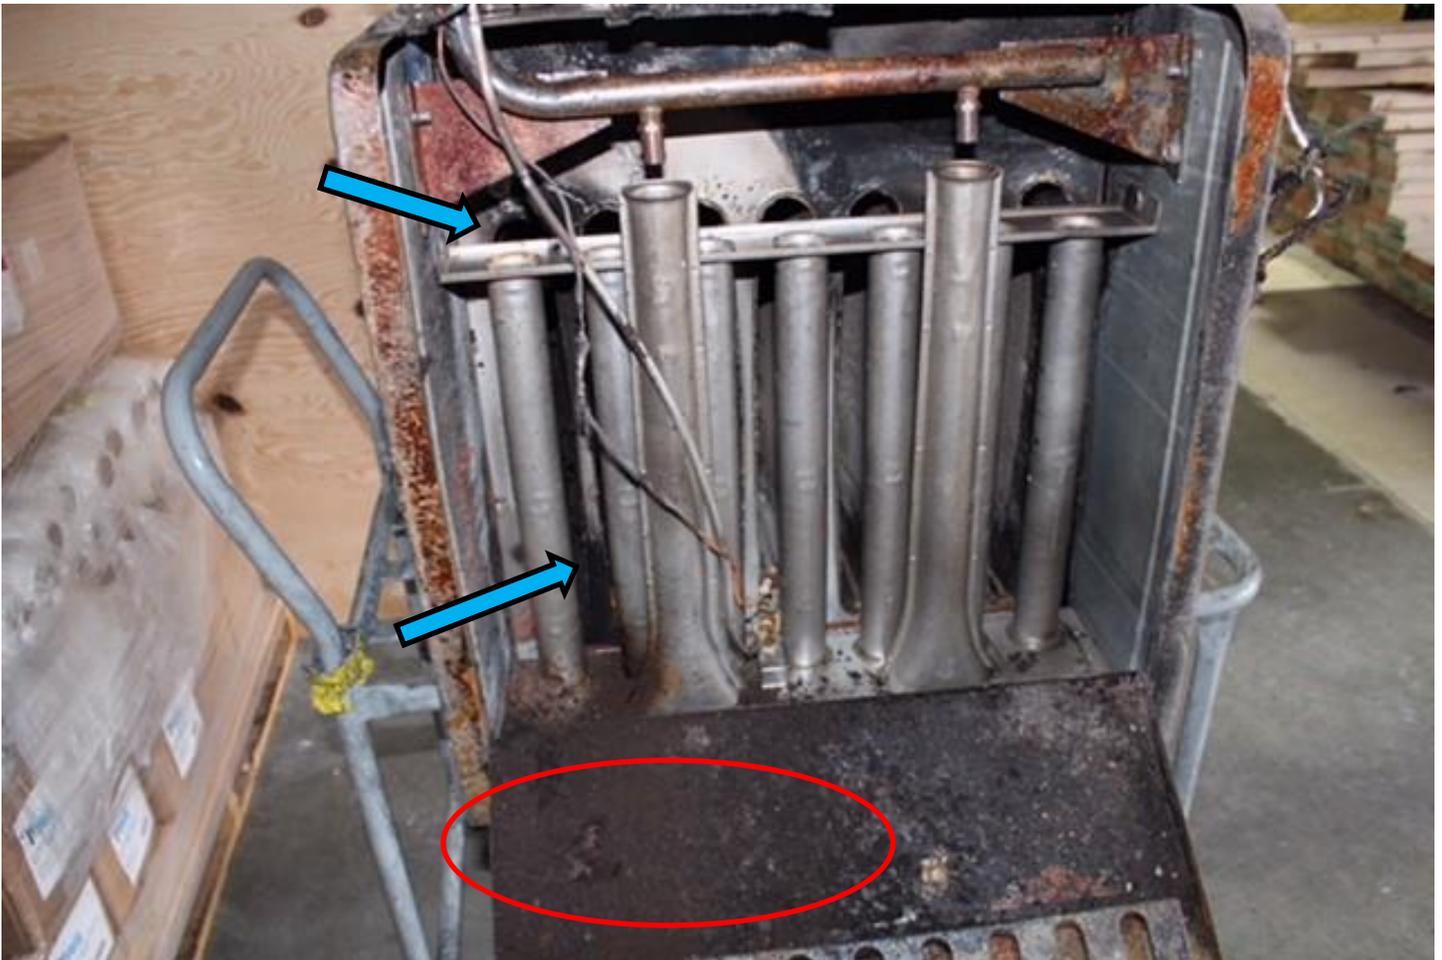
A view of the burners of the damaged heater. This heater was removed from site and is currently laying on it's side on a dolly for easy inspection.

-Red oval circles the left side of the flip down burner access where allot of soot, rust and debris can be seen.

-blue arrows point to the left most burner and heat exchanger passage way.

<p>Causes and contributing factors</p>	<p><i>It is very likely that a dirty burner caused the heavy accumulation of soot in the heat exchanger. This ultimately led to the rollout condition that melted other plastic and electrical components on the appliance. It is also very likely that a flaming piece of these components dropped onto the combustibles below and started the fire.</i></p>

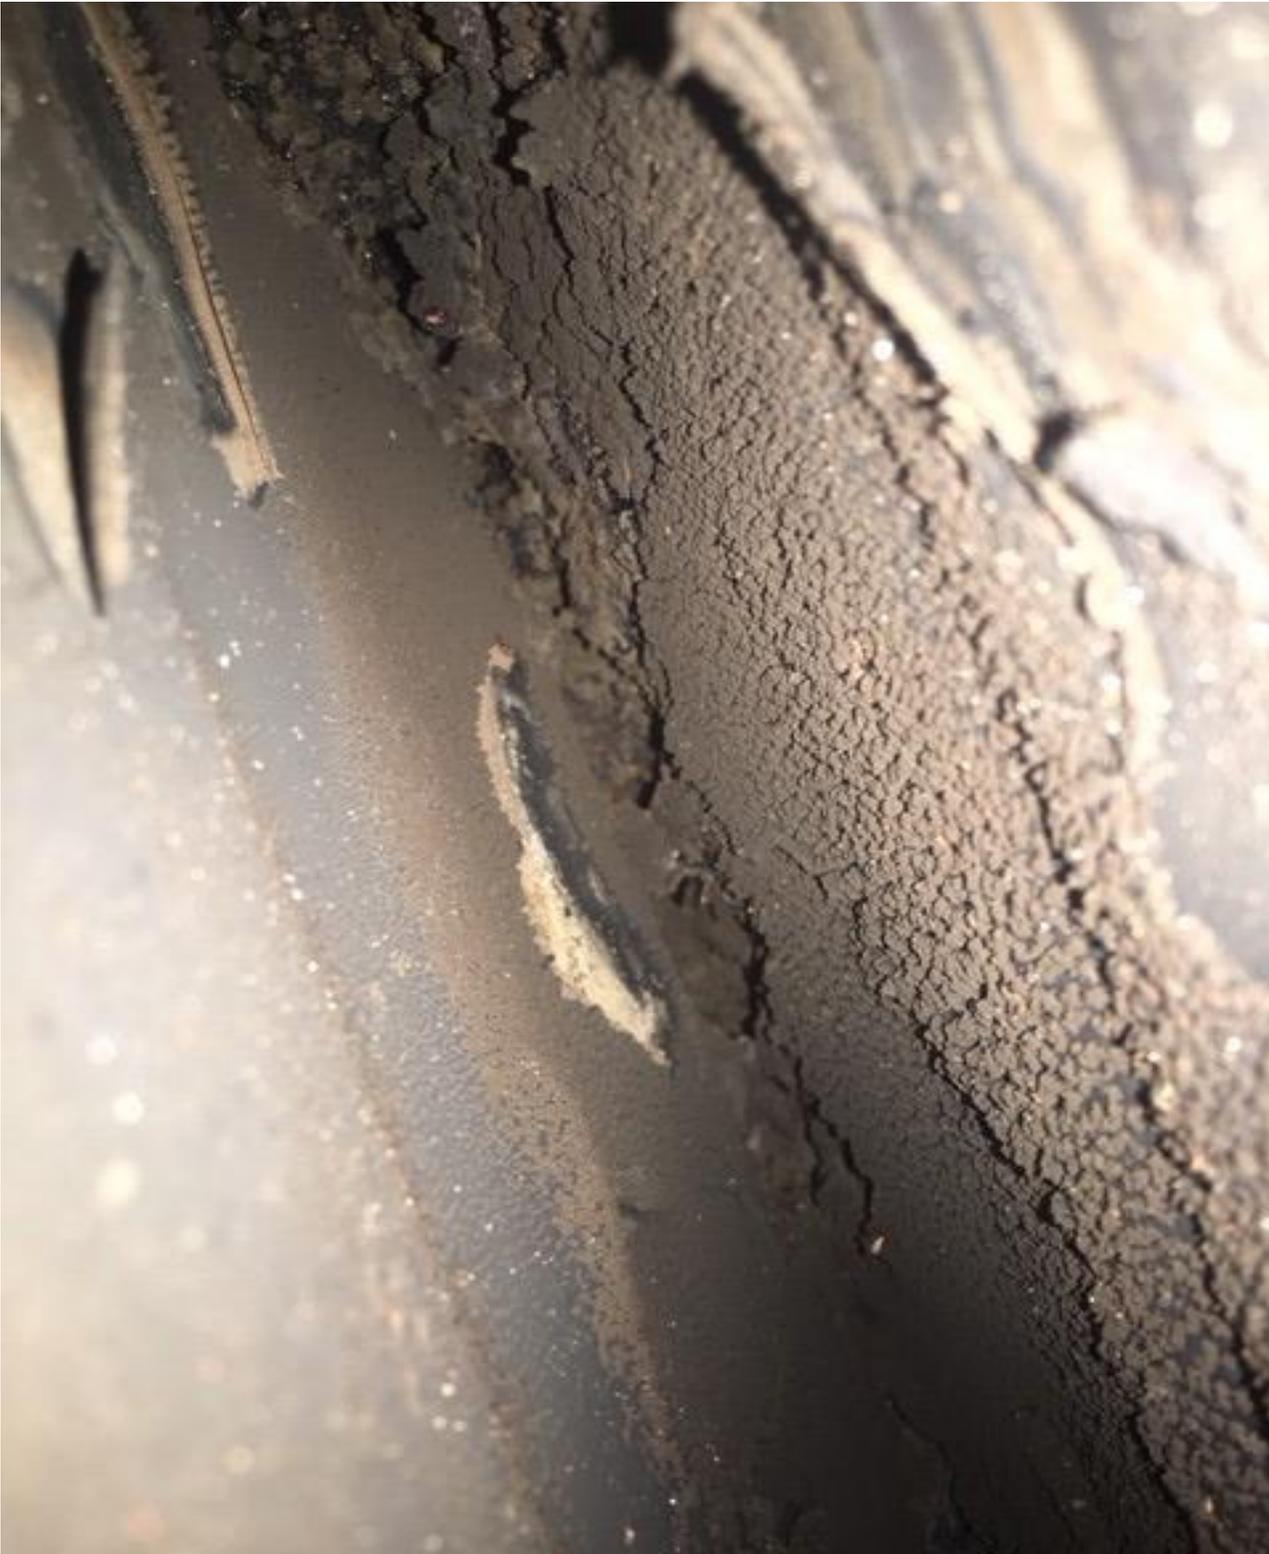
Picture above: This is a close up of the left most flue gas passage way. This is caked on soot that accumulated on the walls of the heat exchanger and completely plugged this passage. For normal operation this needs to be totally unrestricted.

<p>Facts and evidence</p>	<ul style="list-style-type: none"> <li><i>-The left most heat exchanger passageway was completely plugged with soot .Pictures were taken to show this and can be seen below.</i></li> <li><i>-Flame pattern on the outside of the unit heater suggest that a flame rollout occurred burning the paint off of the outside of the heater. (See pictures)</i></li> <li><i>-Melted wiring and other electrical components also suggest that a flame rollout occurred overheating the wiring and components.</i></li> <li><i>-Eye witness accounts stated that the flames from the burning cardboard did not reach high enough to come into contact with the heater, suggesting that the source of ignition came from the heater itself.</i></li> <li><i>-Questions were asked regarding maintenance intervals for these appliances. No record of service could be produced.</i></li> <li><i>- The equipment manufacturer states that the appliance and components need to be serviced and checked annually in the owner’s manual.</i></li> <li><i>-The unit heaters were approximately 7 years old based on the unit serial numbers and the age of the building.</i></li> <li><i>-The high location of these heaters make it doubtful that anyone working in the warehouse would have noticed any abnormalities with the appliance as they carried out their day to day operations.</i></li> </ul>

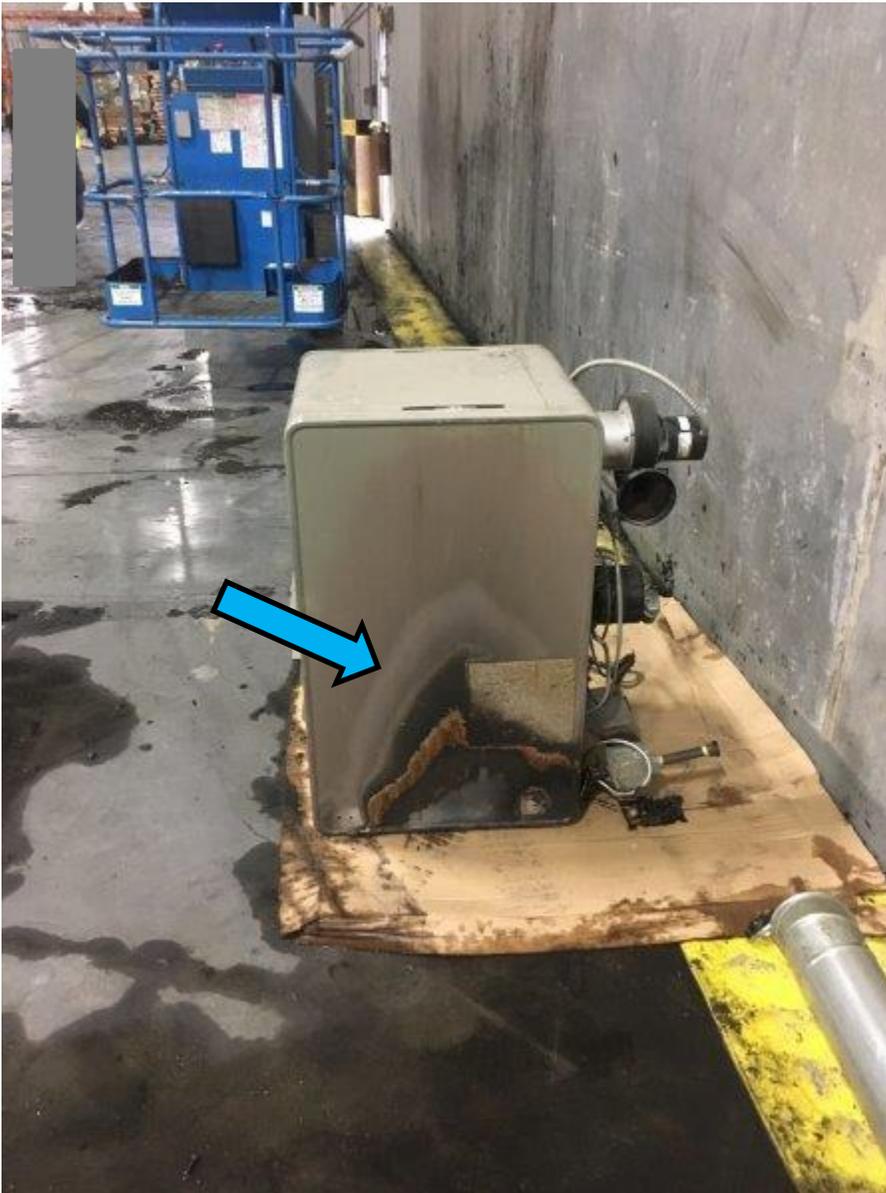
The flame pattern seen here suggest that a flame rollout occurred, causing the flames to lick the bottom and side of the heater.

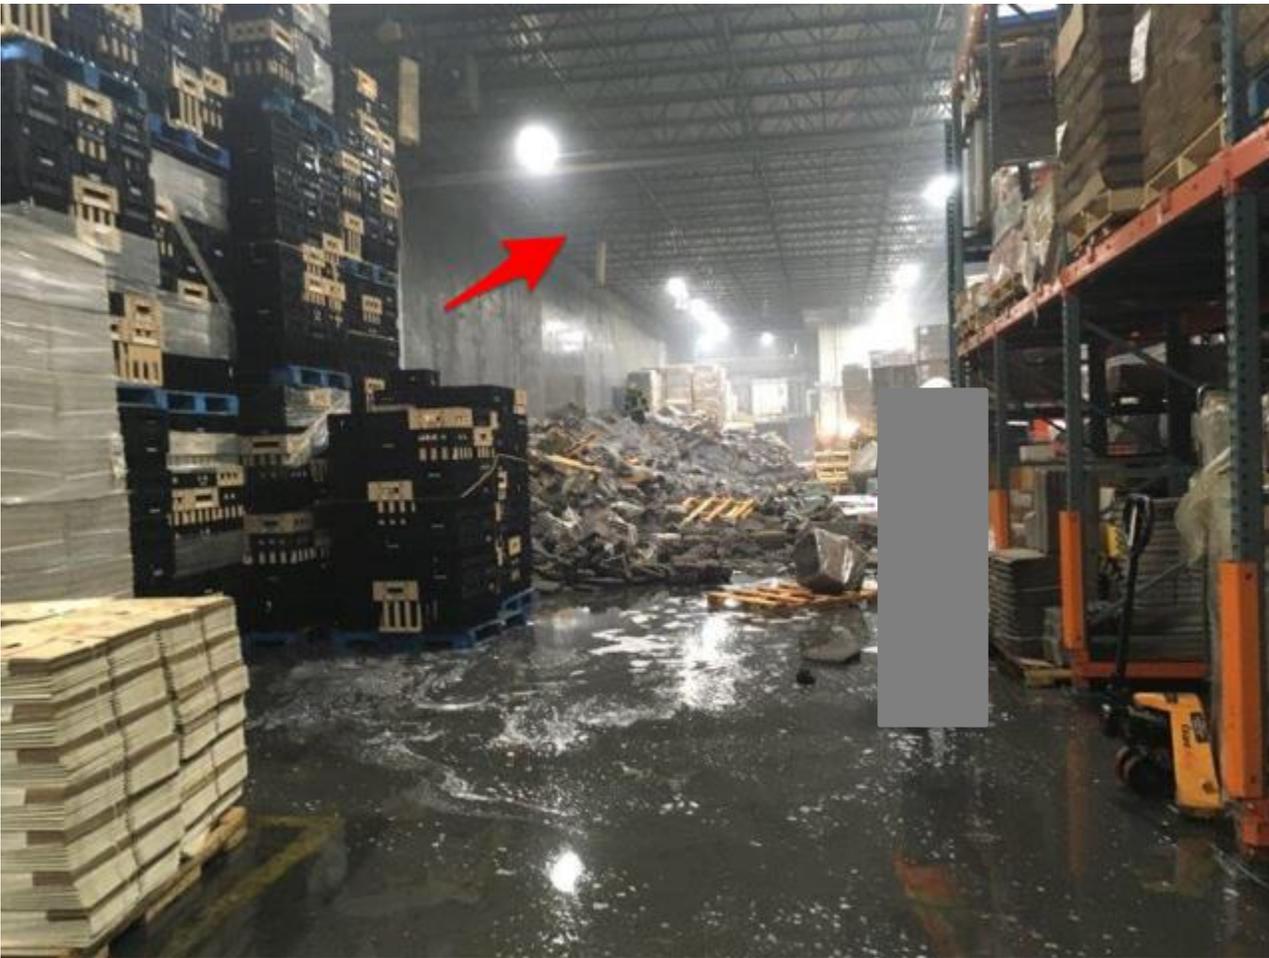
Fire damaged combustibles laying in a pile. The red arrow points to the approximate location where the heater was hanging from the ceiling.

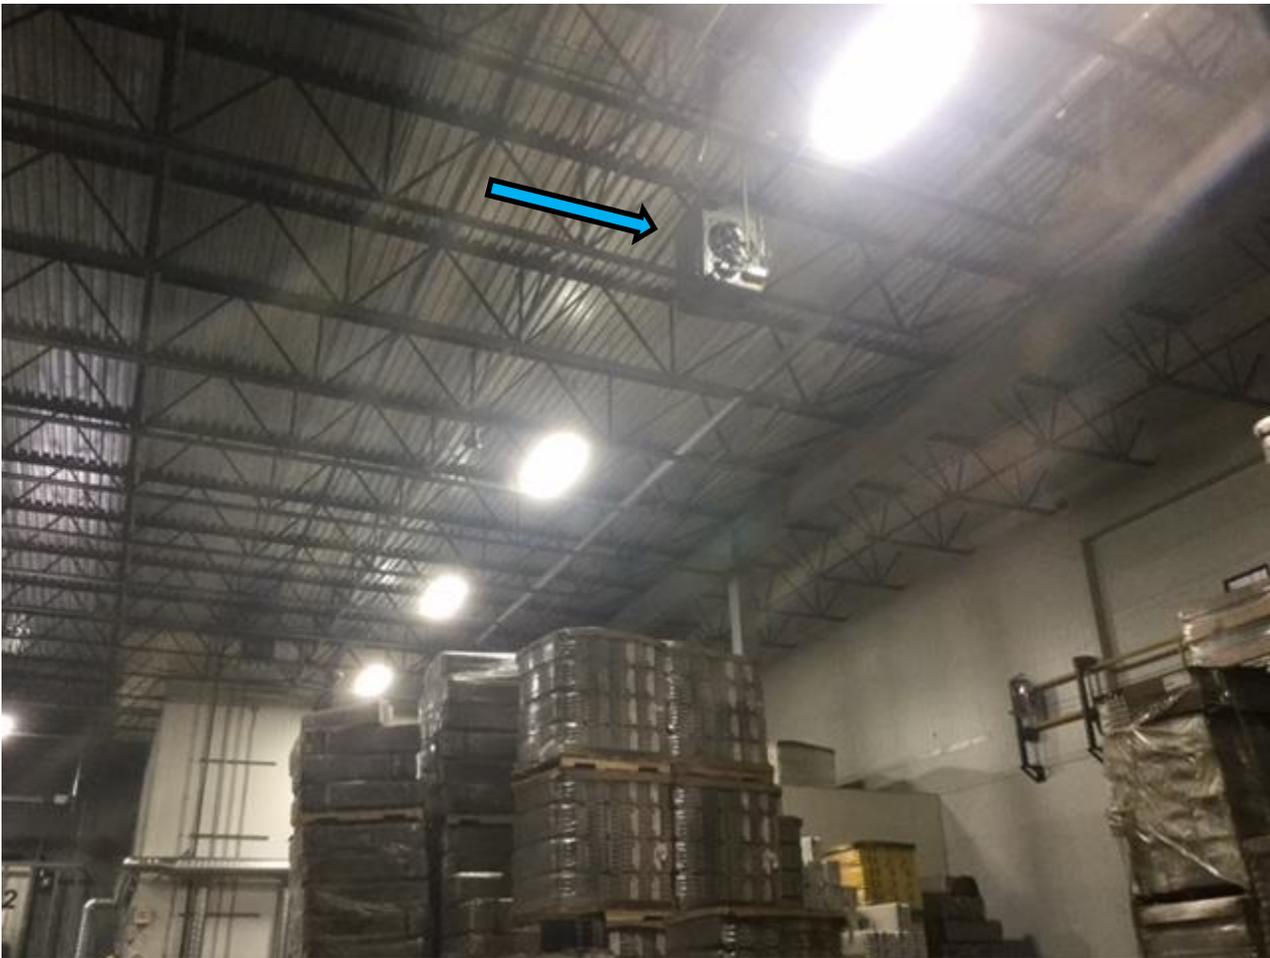
Another heater in the same warehouse can be seen hanging high above the skids of material.
