Incident Summary #II-950213-2019 (#16064) (FINAL)

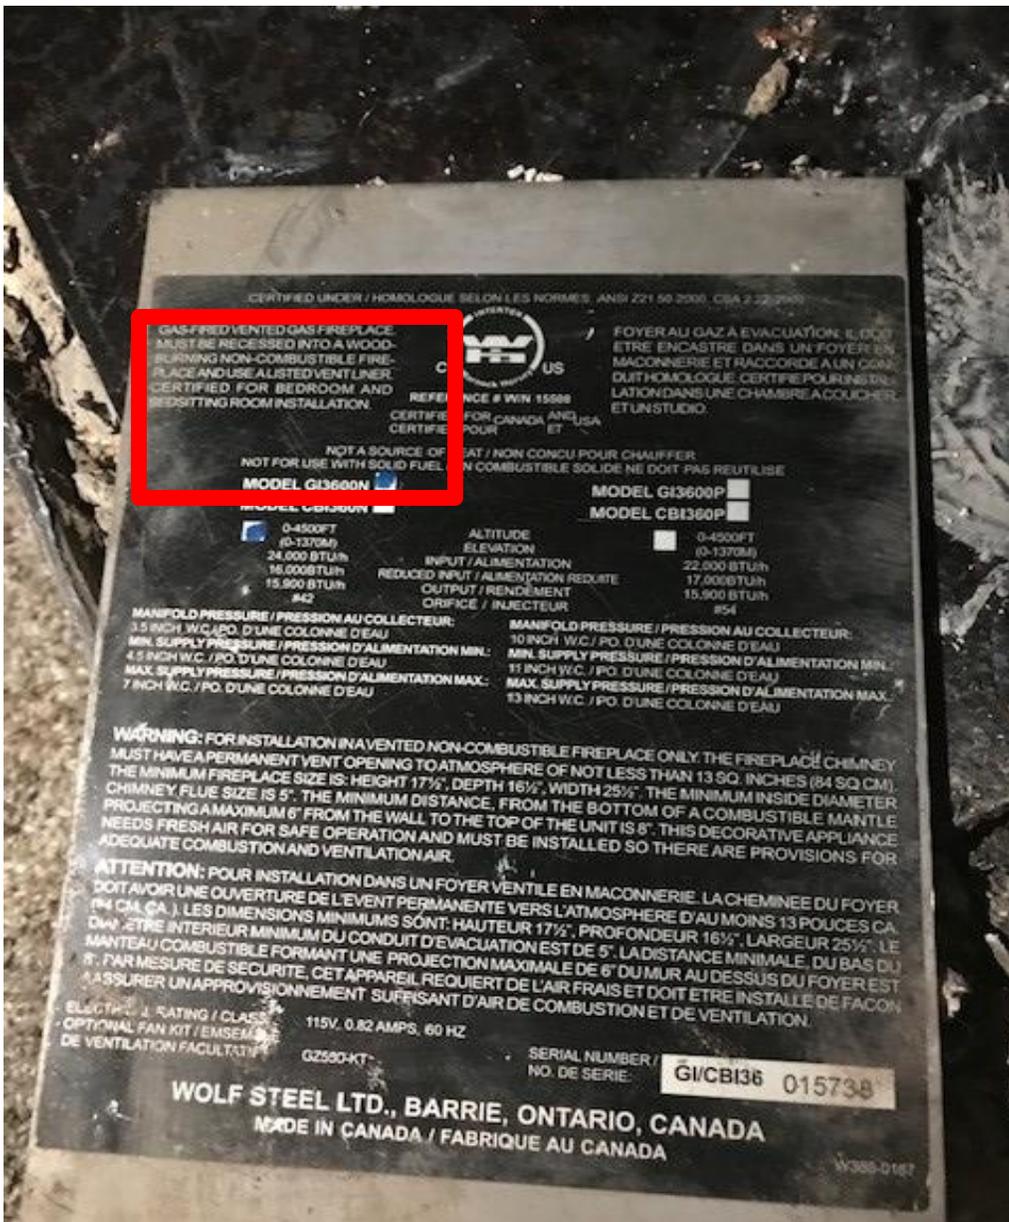
1. Rating plate – top left indicates fireplace approved as a wood burning insert only

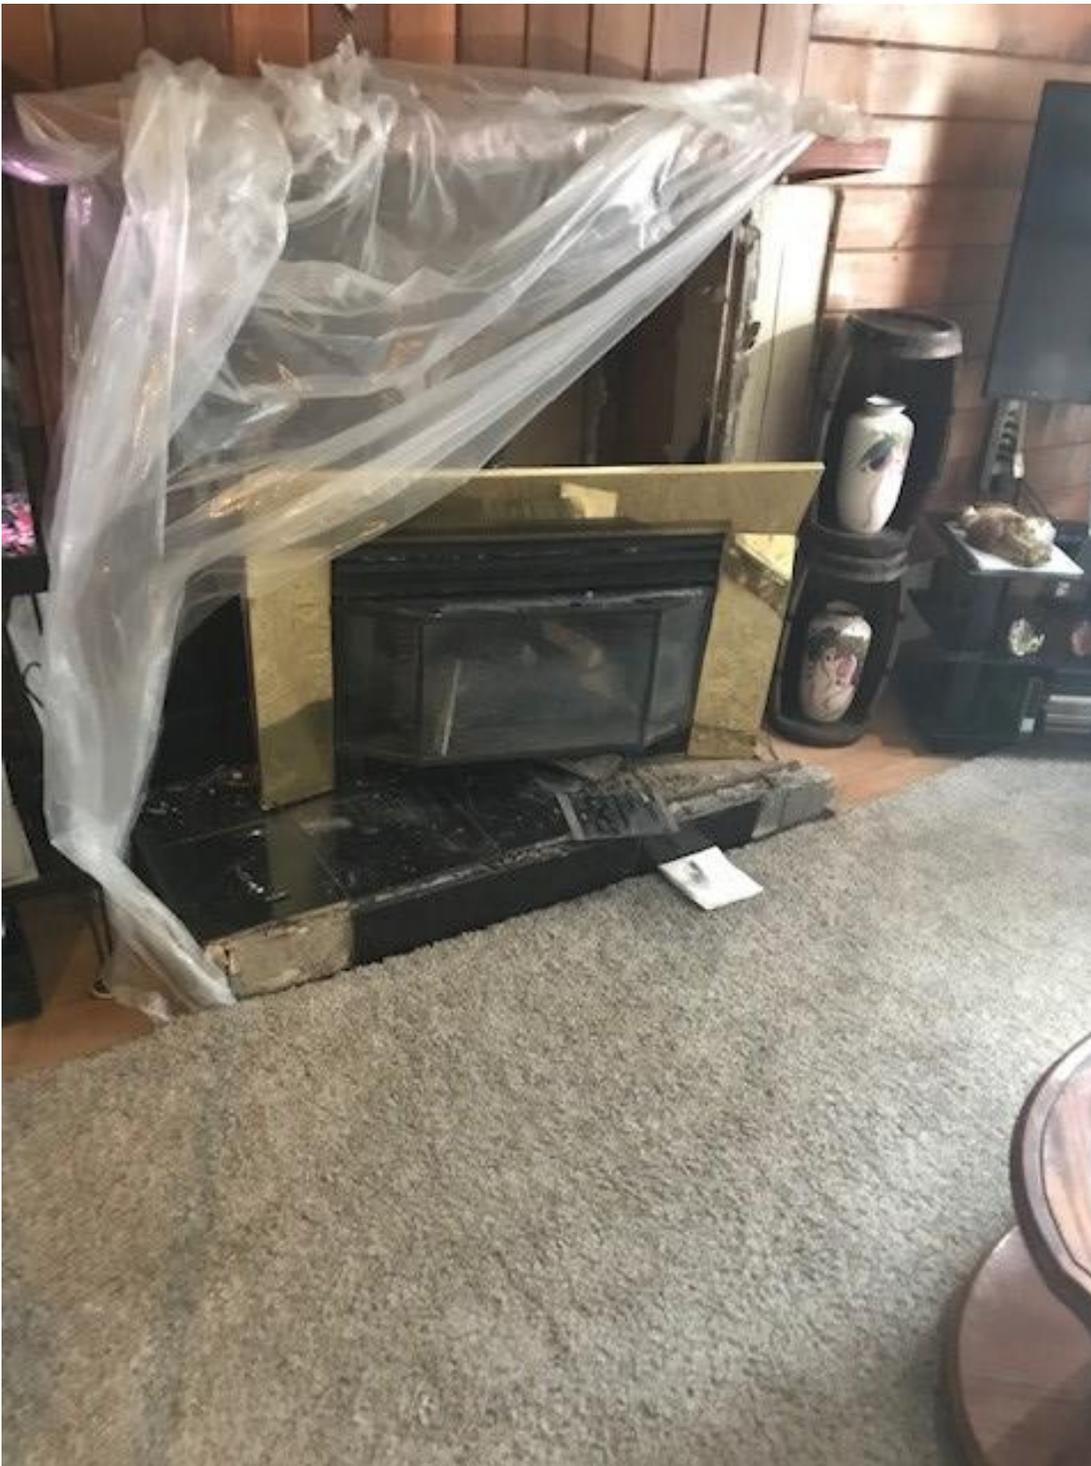
2. Front view of fireplace
