## Incident Summary #II-814368-2019 (#11013) (FINAL)

SUPPORTING INFORMATION	Incident Date	February 19, 2019	
	Location	Abbotsford	
	Regulated industry sector	Gas - Natural gas system	
	Impact	Qty injuries	8
		Injury description	5 adults and 3 Children were taken to hospital after being exposed to carbon monoxide .
		Injury rating	Minor
	Damage	Damage description	Venting connector for residential furnace and water heater became dislodged from a vertical chimney.
		Damage rating	Moderate
	Incident rating	Moderate	
	Incident overview	<p>Occupants within a home began to feel ill and uncomfortable. Several of the occupants reported developing a headache.</p> <p>Emergency services were called and initial report was that occupants thought there might be some type of gas leaking inside the home.</p> <p>First responders used a gas analyser to determine carbon monoxide was present at a level of 100 parts per million.</p> <p>All 8 occupants were evacuated and sent to hospital to be treated for carbon monoxide exposure.</p> <p><i>1 part per million (ppm) =1 part of carbon monoxide gas per 1 million parts air by volume.</i></p>

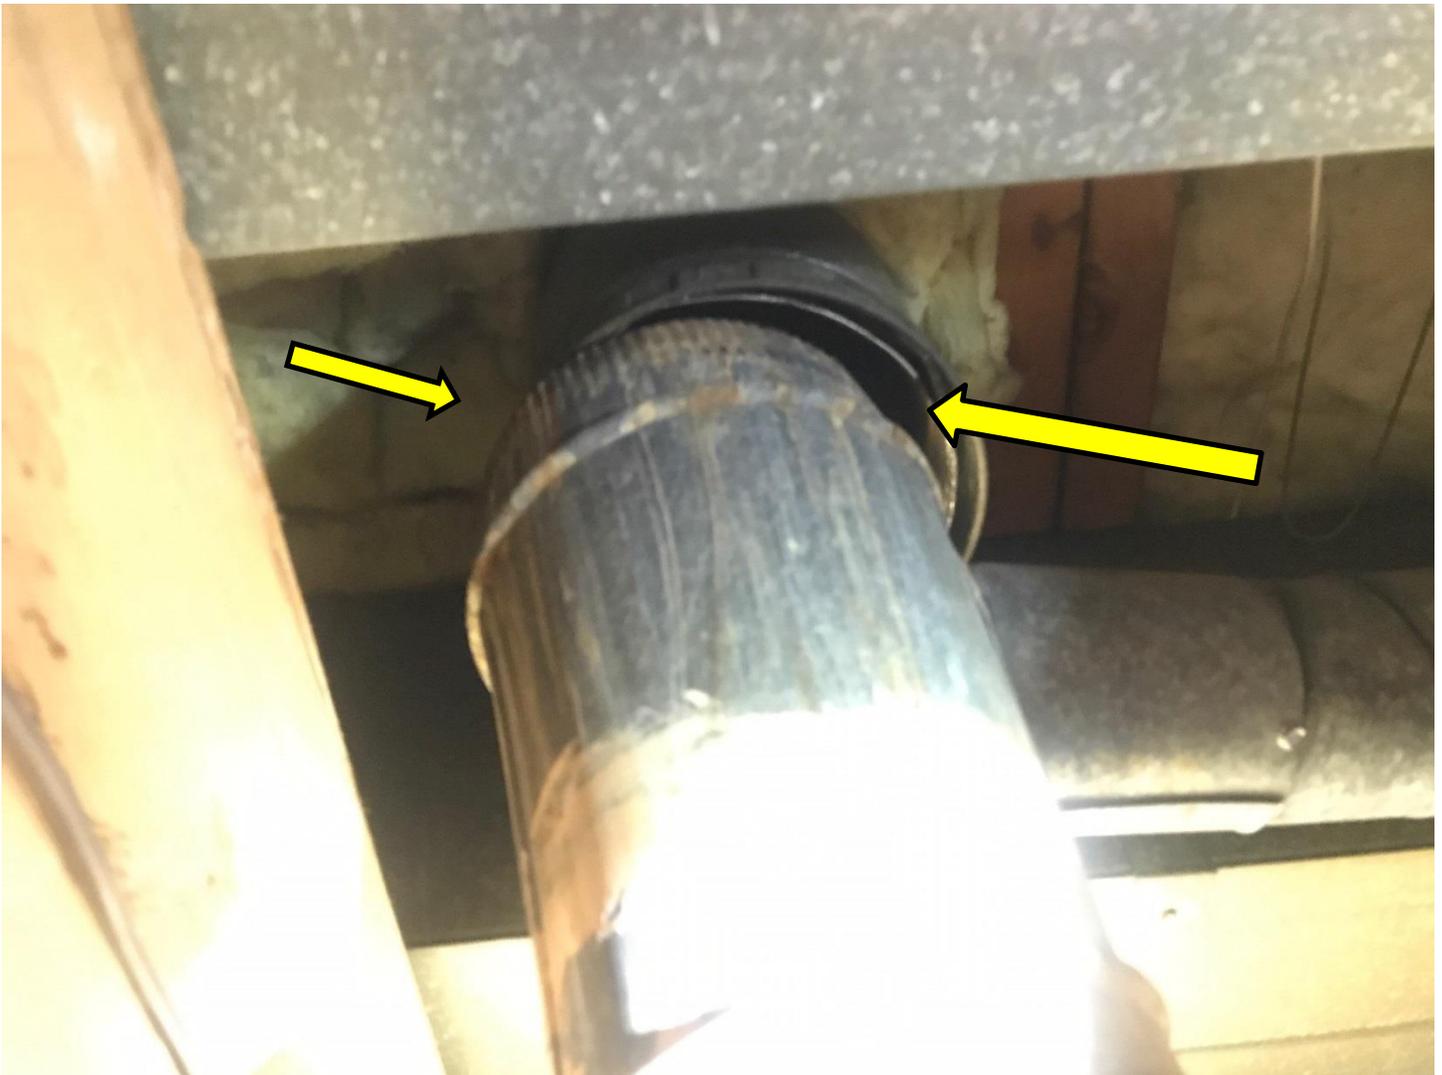
**Picture 1-** Yellow arrows point to where flue gasses were spilling from dislodged vent. Horizontal section of vent is where water heater is connected into furnace vent.

Failure scenario(s)	Over the years this venting system was subject to expansion and contraction when heating up and cooling down as well as vibrations from the connected furnace and blower motor. Eventually this caused the vent to dislodge from where it was friction fit into the vertical chimney.
Facts and evidence	<ul style="list-style-type: none"> <li>-Vent connector was found dislodged from chimney connection (See <b>picture 1</b>)</li> <li>-Furnace filter was extremely dirty and plugged.</li> <li>-100 ppm CO reading was confirmed.</li> <li>-Weather was cold, resulting in longer run times of the furnace and more flue gases spilling into the basement.</li> </ul>
Causes and contributing factors	<p>The furnace/ water heater vent connector fitting was not secured to the vertical chimney by way of screws or other fasteners. This operated without incident for many years however eventually became dislodged. It is likely that a dirty/unbalanced furnace blower wheel or worn bearings caused increased vibration the past few years resulting in further dislodging of the vent.</p> <p>Another factor that may have contributed to the carbon monoxide being dispersed throughout the home is the badly plugged furnace air filter. If such a filter is plugged, normal airflow through the return duct will be restricted and air can be drawn into the blower downstream of the plugged filter. In this case, the flue products that had spilled into the space around the furnace, may have been drawn into the blower and mixed with the supply air feeding the warm air ducts throughout the home. (See <b>Diagram-1</b> below)</p>

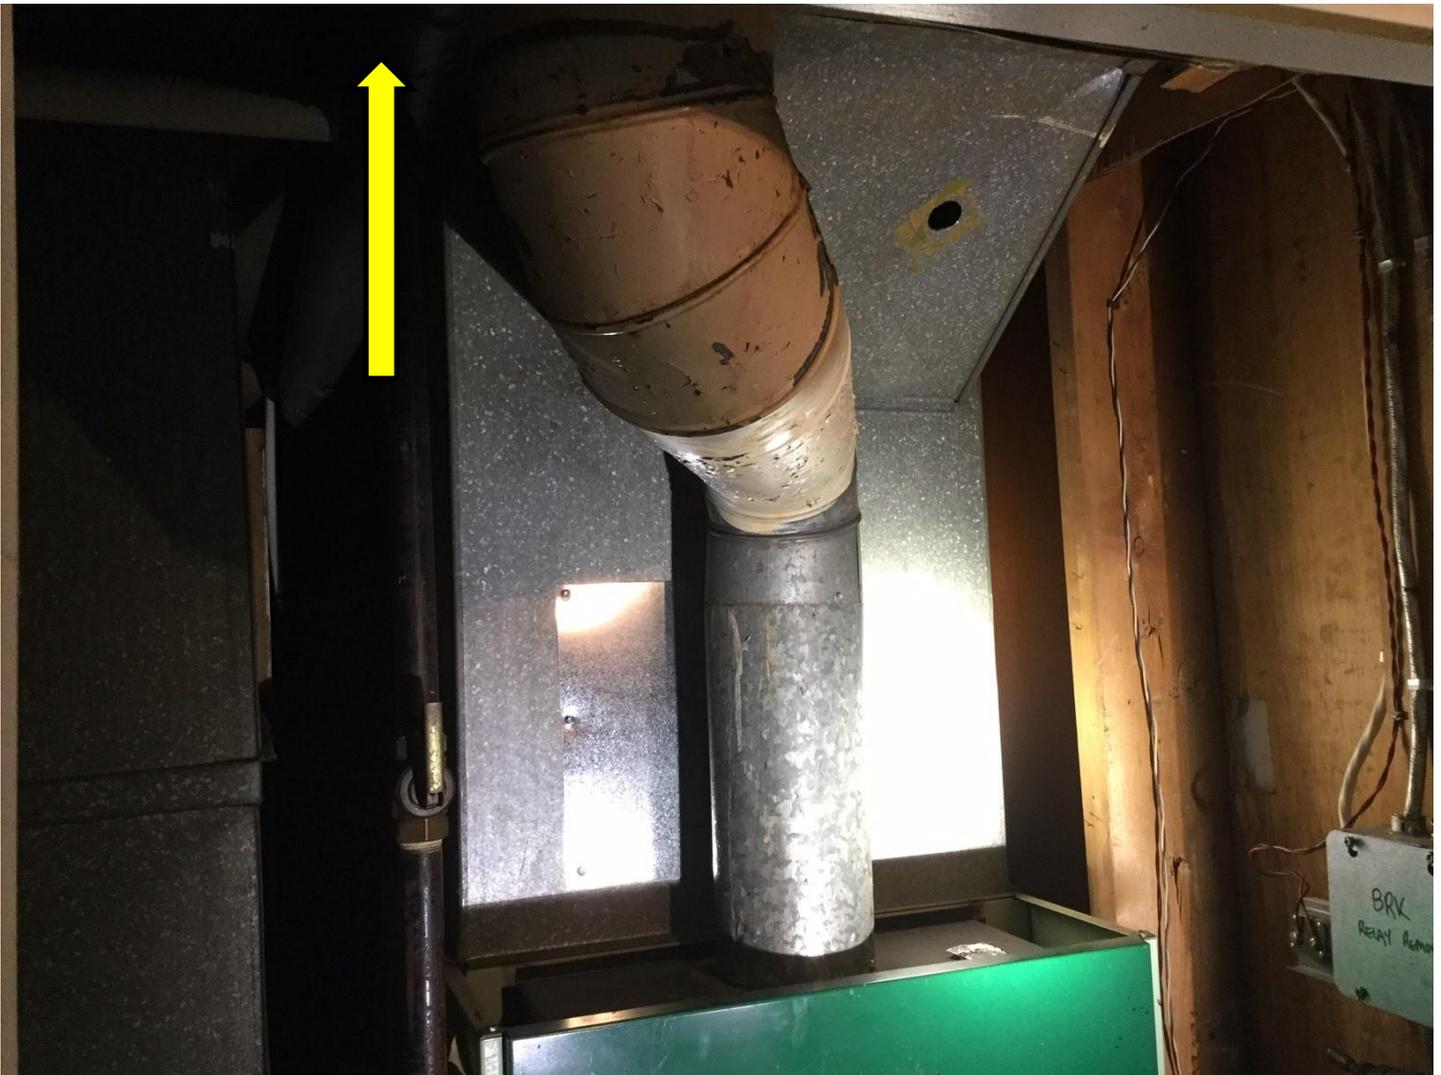
**Picture-2**

Furnace vent elbow pictured above , connects directly to vent connector in **Picture-1** ( Yellow arrow points to where elbow was connected to the dislodged vent seen in **picture-1** )

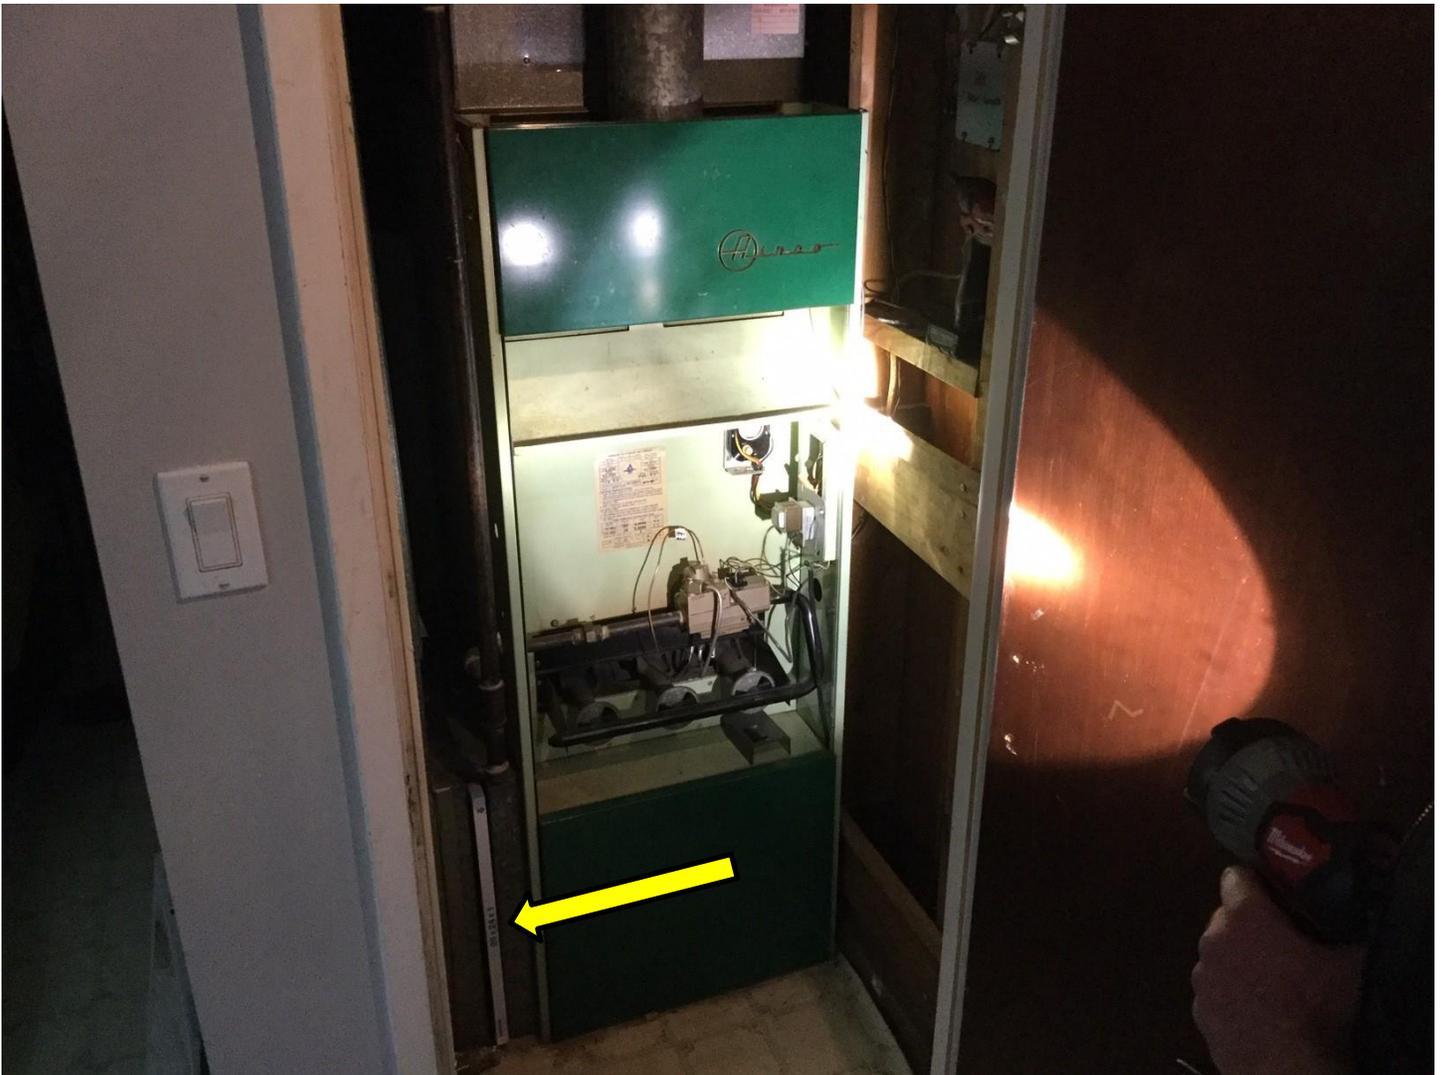
**Picture-3**

Above: Vintage furnace Circa 1970's. See filter missing cover plate in bottom left hand corner.

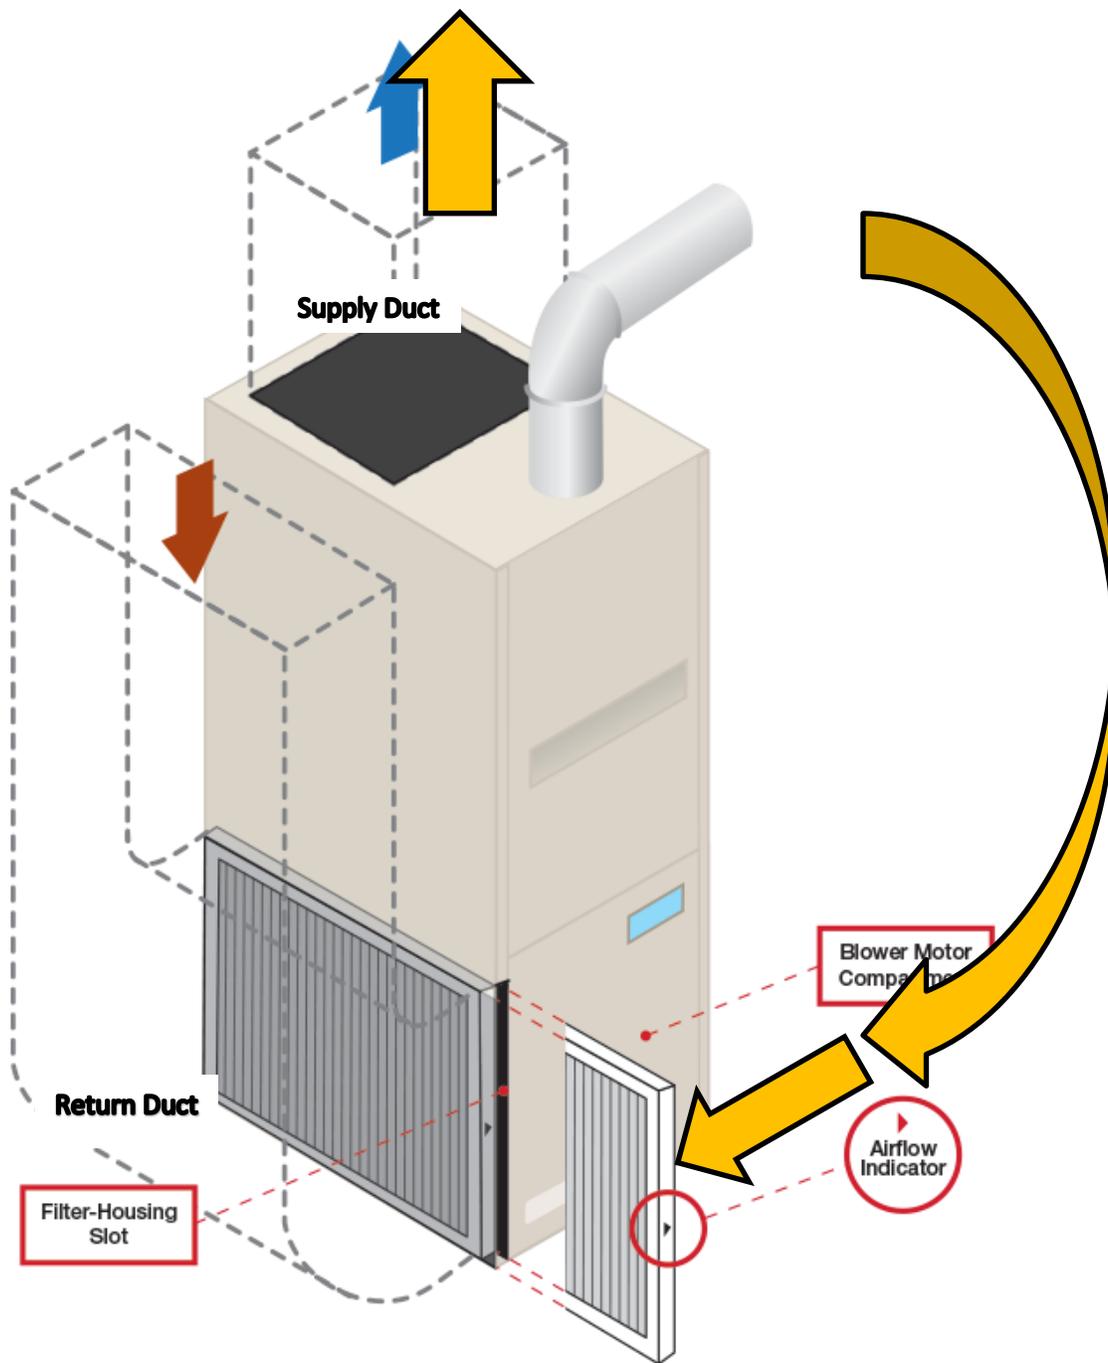
**Diagram-1-** If the furnace filter becomes plugged, the increased restriction can cause the blower motor to draw air/ spilled products of combustion into the furnace downstream of the filter and distribute them through the home.

*-Yellow arrows above show how these flue gases from the dislodged vent could have been drawn into the blower and pushed throughout the home via the supply duct.*
