Incident Summary II-948424-2019 (Reference # 16043) FINAL

SUPPORTING INFORMATION	Incident Date	November 30, 2019	
	Location	Regional District Fraser Fort George BC	
	Regulated industry sector	Gas	
	Impact	Qty injuries	4
		Injury description	Carbon monoxide poisoning
		Injury rating	Major
	Damage	Damage description	None
		Damage rating	None
	Incident rating	Major	
	Incident overview	Four people were taken to hospital with carbon monoxide poisoning, likely due to a gas furnace issue in their home. Volunteer Fire Department and gas utility company were dispatched to site.	
INVESTIGATION CONCLUSIONS	Site, system and components	<p>A newly renovated residential single family dwelling (one storey with basement), contained a mixture of natural gas and wood burning appliances. Exhaust equipment was also installed in the home to exhaust air that contains moisture and contains odors.</p> <p>A natural draft central gas furnace with standing pilot and an attached decommissioned drum style humidifier located in the basement, provides primary heat to dwelling by distributing heated air through a ductwork system throughout the home. The furnace is operated by a programmable thermostat.</p> <p>A w

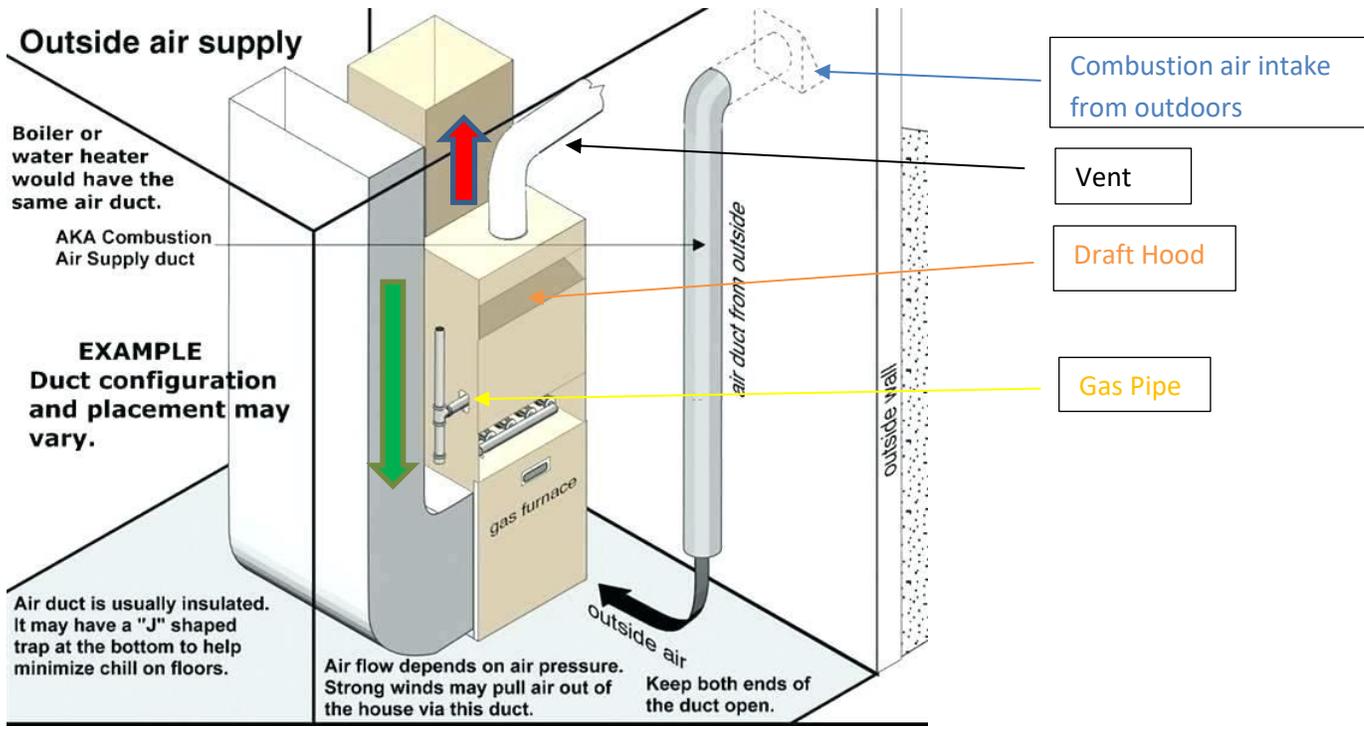
Example 1: Typical Natural Draft Furnace with draft hood and outdoor air supplied.

RED arrow indicates supply air to home from furnace

GREEN arrow indicates return air from home

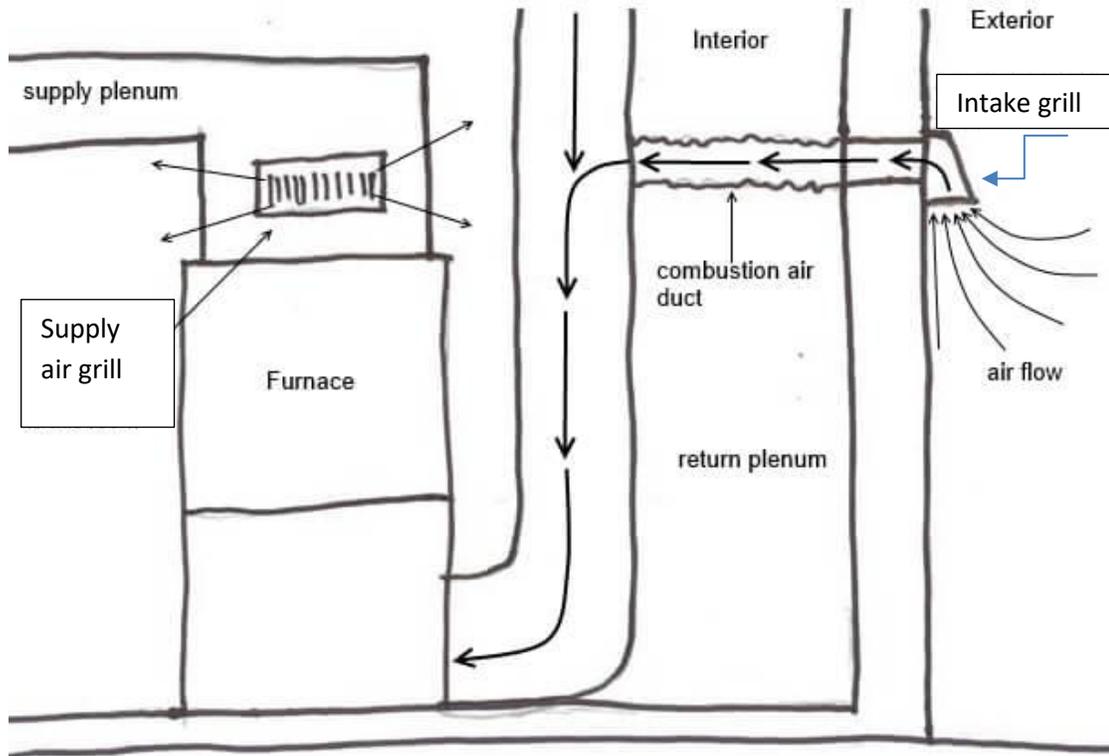
Example 2: Typical Building Air supply for older homes

Combustion air duct connected to return plenum

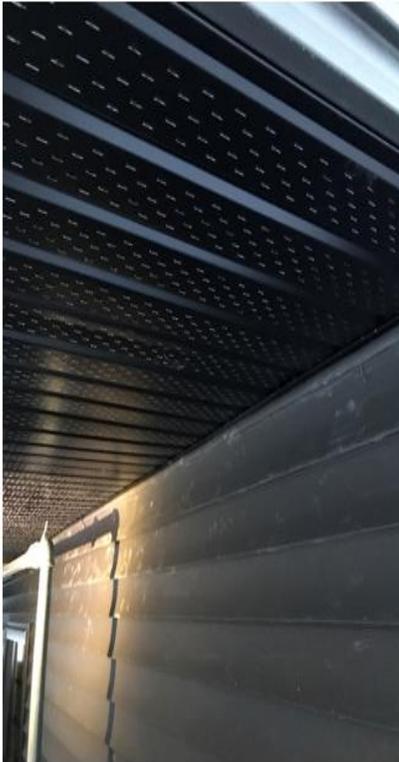
Picture 3:

Soffit covering building air intake

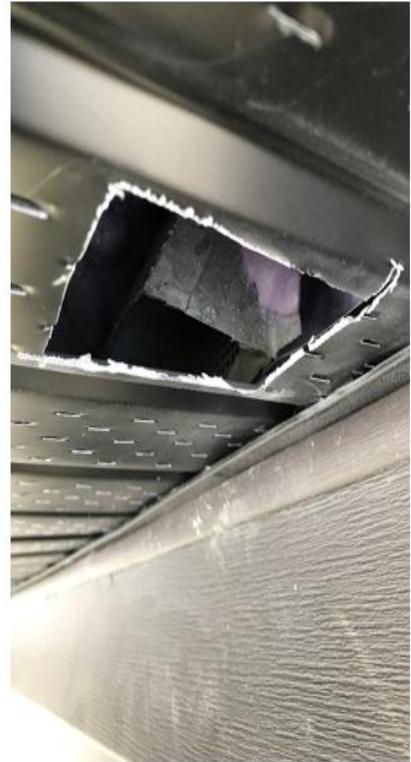
Hole cut in soffit shows building air intake.

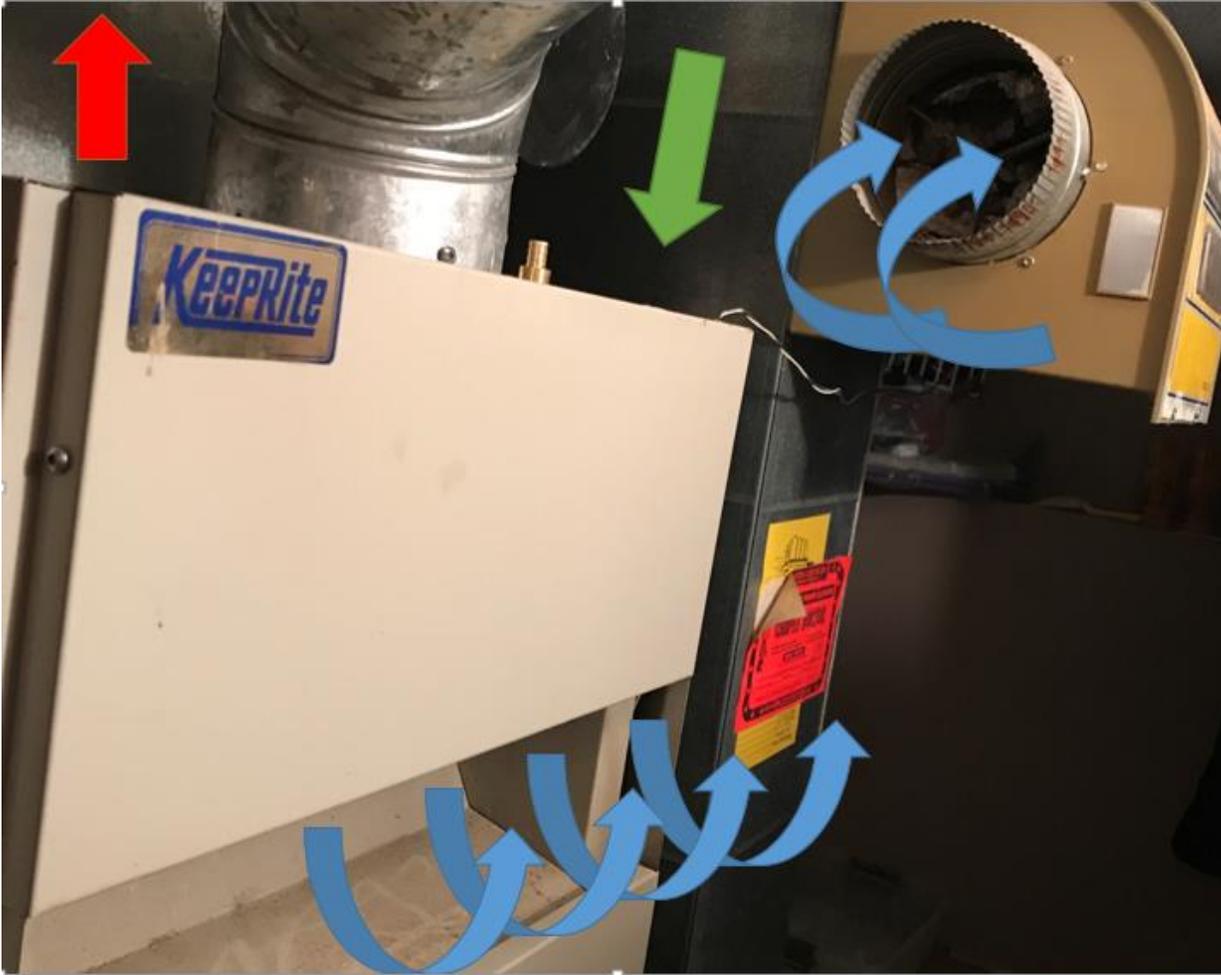
Picture 4:

<p>Combustion air — the air required for satisfactory combustion of gas, including excess air.</p> <p>The natural draft gas furnace, range and wood burning fireplace insert require combustion air to operate correctly.</p> <p>Two bathroom fans exhaust air to outdoors one located upstairs one located in the basement. An over the range hood fan exhausts air to the outdoors and an electric dryer located in the basement exhausts air to the outdoors.</p> <p>A four inch fresh air pipe from outside was connected to the furnace return air ducting (building air), which is meant to replace air being removed from the house by exhaust fans, wood fireplace and the clothes drier. (Example 2 & Picture 3)</p>
<p>Failure scenario(s)</p>	<p>Likely due to the depressurization of the newly renovated home the natural draft furnace and wood burning insert fireplace were unable to vent correctly. The addition of an over the range exhaust hood, created a lack of combustion air and make-up air which was likely the cause of the appliances back drafting.</p> <p>If the over the gas range exhaust fan was turned on it would have exhausted inside air out of the home potentially creating a depressurization state. The home would have used open sources of outdoor air to replace the air being exhausted. The only outdoor air sources were a 4" building air duct connected to the return air of the natural draft gas furnace, the furnace venting through the draft hood and the wood fireplace insert chimney. If the over the range exhaust fan was turned on prior to the spillage susceptible appliances being fired a back drafting condition could have been present. It is probable that the automatic thermostat change from 16 to 23 degrees Celsius causing the furnace to operate for extended period, and the exhaust hood causing a negative pressure in the home the products of combustion from the furnace spilled into the mechanical room instead of safely up the chimney.</p> <p>As the furnace blower started it began drawing products of combustion into the return air ducting through the disconnected humidifier and furnace air filter openings. Which efficiently distributed a high concentration of carbon monoxide throughout dwelling via the supply air ducting. (Picture 4)</p>

Blue Arrows show products of combustion, Green arrow direction of return air, Red arrow direction of warm air supplied to house.
