## Fact Sheet: Hydraulic Elevators with Single Bottom Cylinders

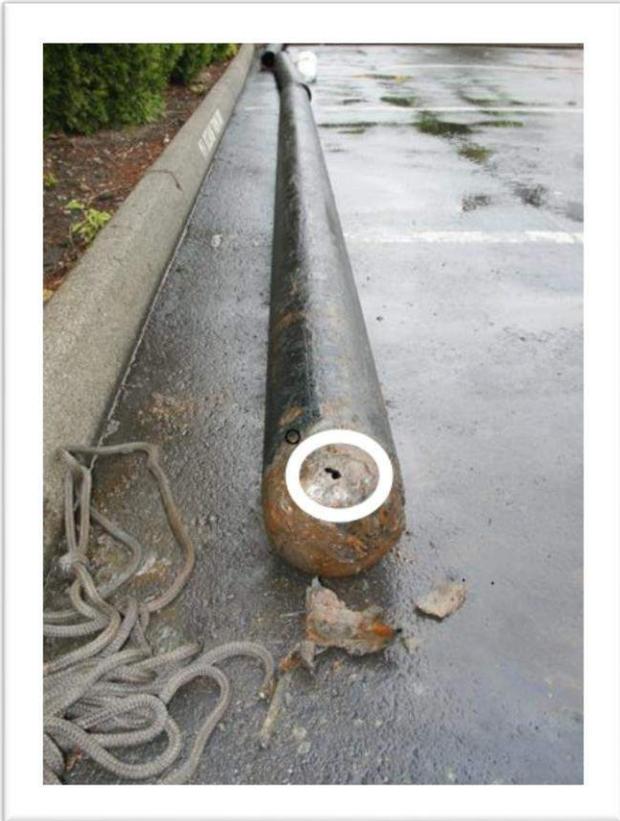
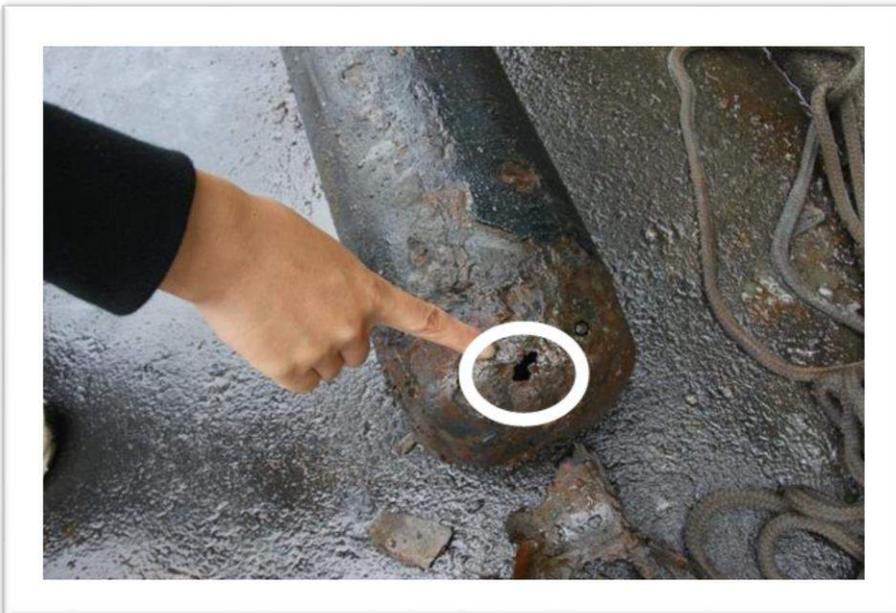
**These photos depict a single bottom cylinder which was removed from an elevating unit.**

**The white circled area on the photos shows a breach in the cylinder as a result of corrosion.**

1. Provide proof that their cylinder is already a double bottom cylinder;
2. Install a mechanism to grab and hold the elevator cylinder in case of failure;
3. Install elevator car safeties to hold the car in place in case of failure;
4. Replace the single bottom cylinder with a double bottom cylinder; or
5. Remove the elevator from service.
