Incident Summary (Reference# 5613743)

SUPPORTING INFORMATION	Incident Date		March 24, 2017	
	Location		Surrey, BC	
	Regulated industry sector		Gas	
	Impact	Injury	Qty Injuries	0
			Injury description	N/A
			Injury rating	N/A
	Damage		Damage description	Fire damage to floor and boiler, smoke damage to house
			Damage rating	Minor
	Incident rating		Minor	
	Incident overview		The household residents awoke to their smoke detectors going off, and got out of the house. The fire department found that a fire had started on the wood flooring beneath the house's boiler.	
INVESTIGATION CONCLUSIONS	Site, system and components		<p><i>In residential applications gas is either supplied to the house at 14 inches water column (Herein referred to as "WC) or 2 psi. In a 2 psi system a regulator must be installed in the piping before any appliances to regulate pressure down to an acceptable working pressure for the appliances. Most appliances have a maximum supply pressure of 14"WC. If gas is supplied to your average appliance at 2psi it will cause the appliance to overfire (Operate with an input above what the appliance is rated for.) and run much hotter than designed.</i></p> <p><i>When a boiler sy

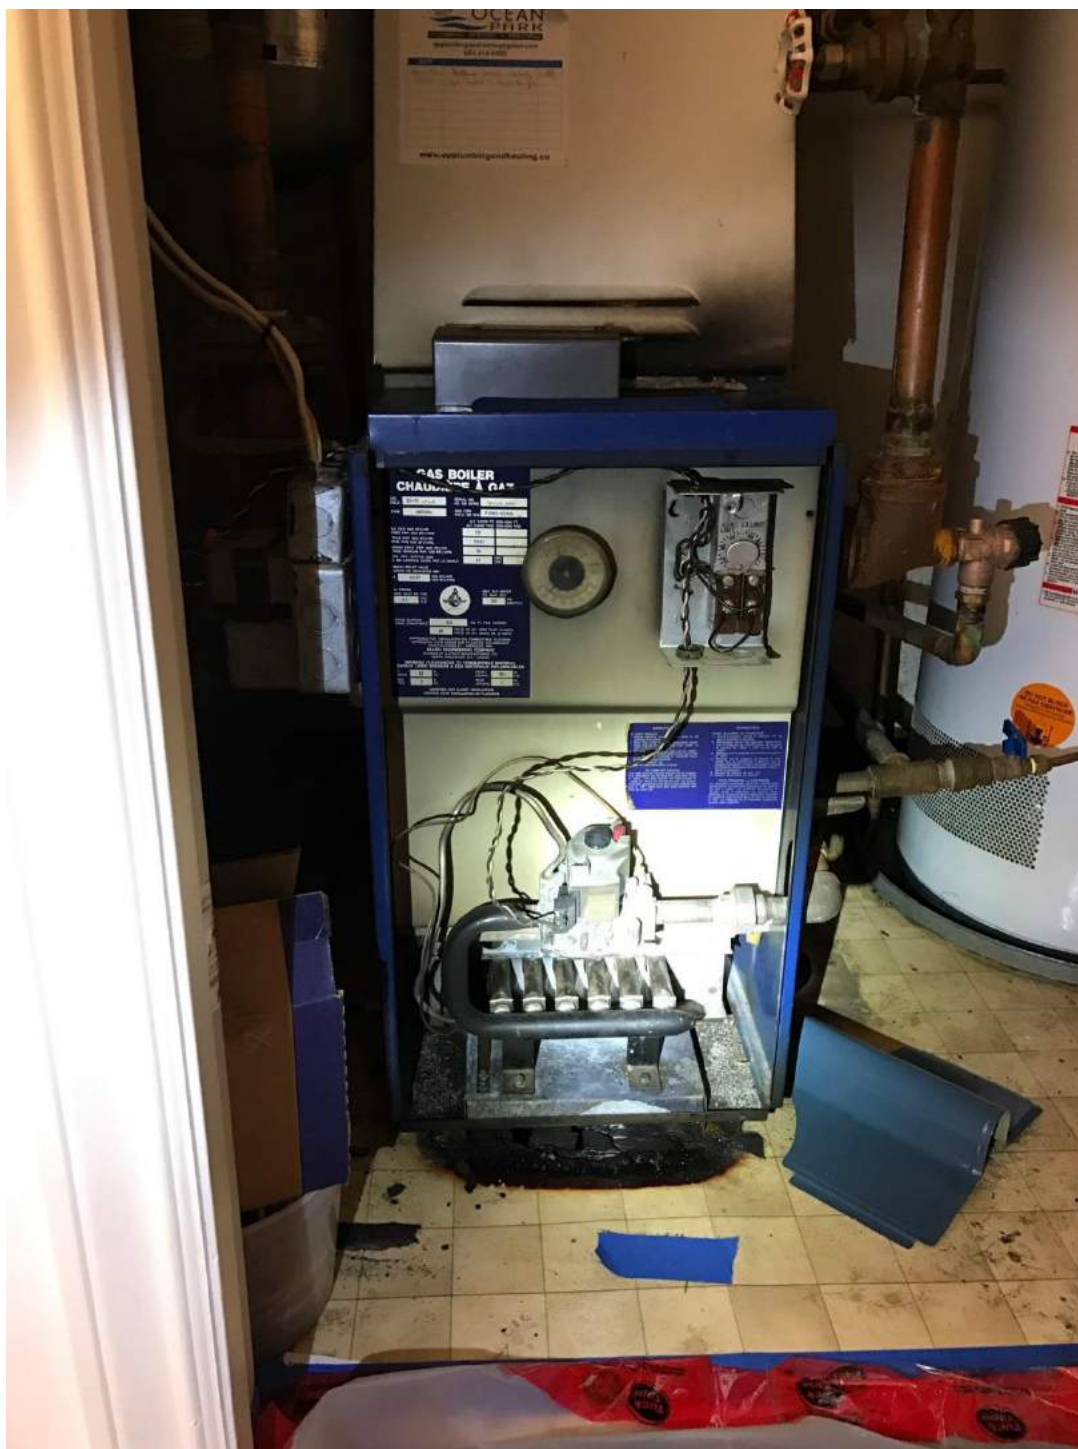
Figure 1: Front of boiler after fire.

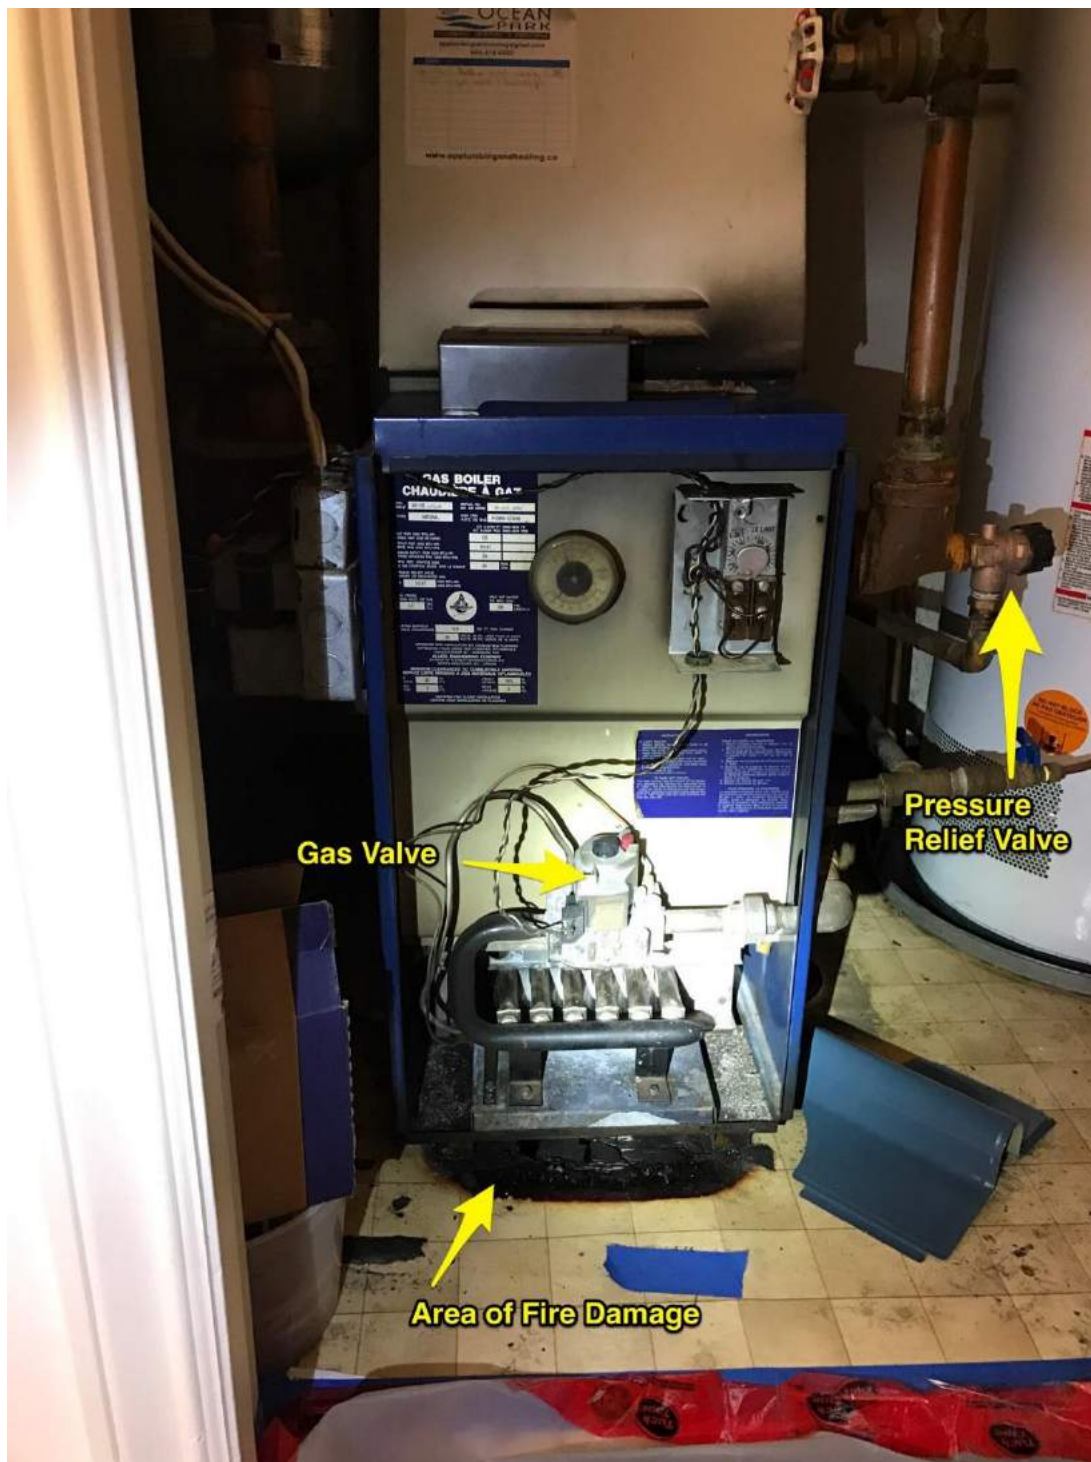
Figure 3: Front of boiler annotated to show components and fire damage.

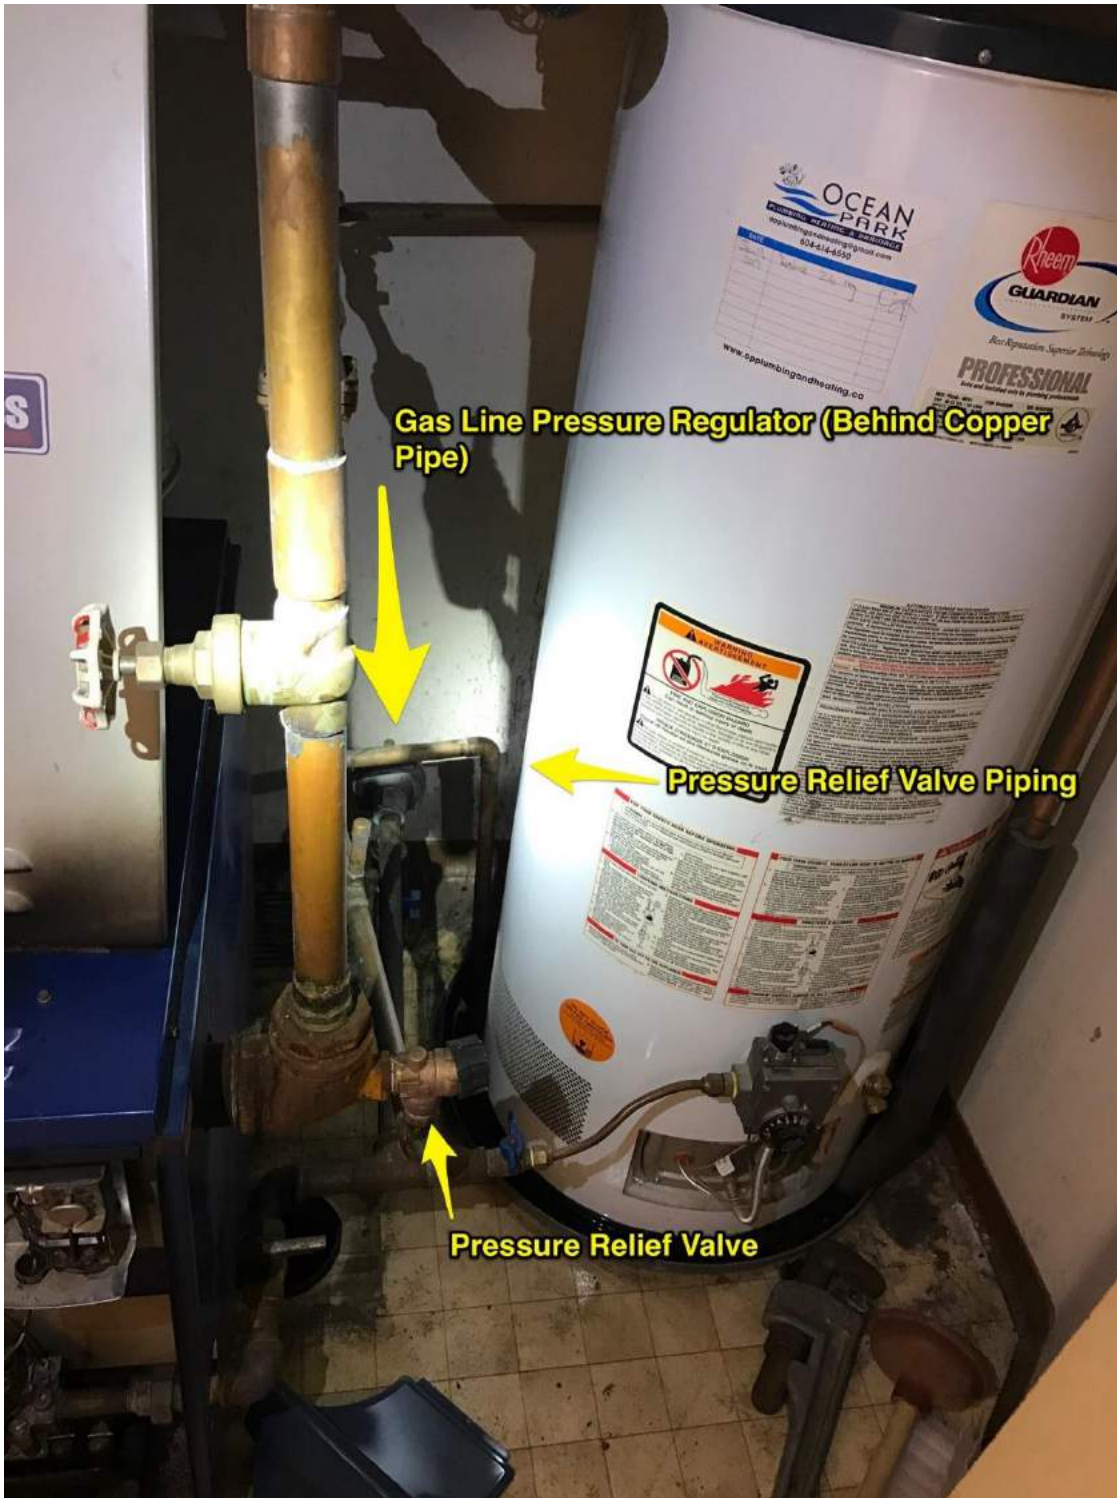
Figure 4: Pressure relief piping, and gas line pressure regulator.

<p>To further understand what happened here one must also be aware that on the water side of the system there is a safety device called a "Pressure Relief Valve" which is installed to limit the amount of pressure in the water system so that system components cannot be damaged by high water pressures. When the relief valve is subjected to high system pressures it opens and releases water from the system to drop the pressure within safe operating limits. However if the relief valve lets out too much water the system pressure may drop, and the boiler system's "make-up water" supply will allow water from the house's plumbing system into the boiler system to try and make up for any water that is lost. This water is often much cooler than the temperature the operator is looking for so the boiler will fire to heat this water.</p>
<p>Failure scenario(s)</p>	<p>In January, the line pressure regulator serving the mechanical room failed, causing 2 psi gas to be supplied to the boiler. This damaged the gas valve and caused the boiler to stop working, however it is not known how long the boiler was overfiring on 2 psi gas before the gas valve failed and caused the boiler to stop working. A service technician attended and replaced the line pressure regulator, damaged gas valve, and a few other components which do not apply to the failure scenario. However in this process the technician did not check or set up the manifold pressure to the appliance causing it to overfire by roughly 30% (based on an orifice flow calculation of $(1658.5 \times K \times A) \times (\sqrt{\Delta p / \text{sg}})$). Later, at an unknown time, the pressure relief valve began to leak causing cool water to be drawn into the system to make up for the water that was leaking out of the relief valve. This constant supply of cool water caused the boiler to fire more frequently and for longer periods of time, as well as contributed to sooting of the heat exchanger. In a normally operating boiler system this would lead to high gas usage and reduced efficiency. But given the additional factors that the boiler was overfired for an unknown amount of time when the line pressure regulator failed, that it was possibly overfired by an incorrectly adjusted gas valve (see facts and evidence), and that a partially plugged heat exchanger was radiating heat to the floor below; pyrolysis of the floor below occurred until it ignited.</p>

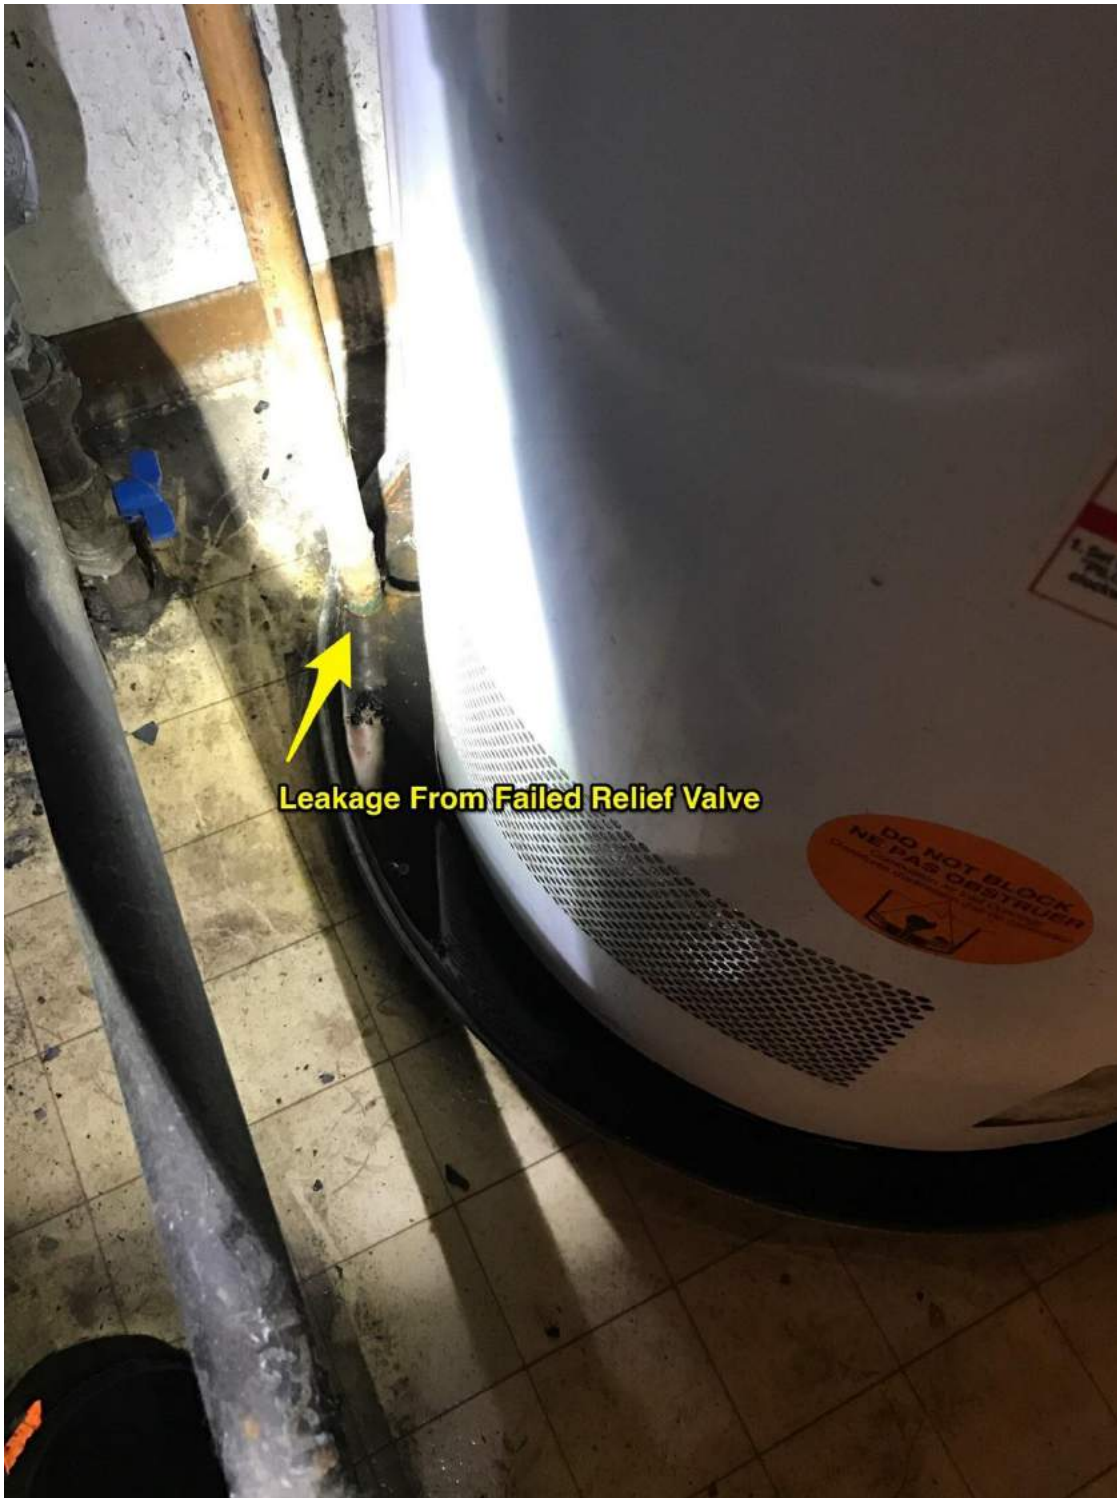
Figure 5: Discharge of relief piping showing leakage.

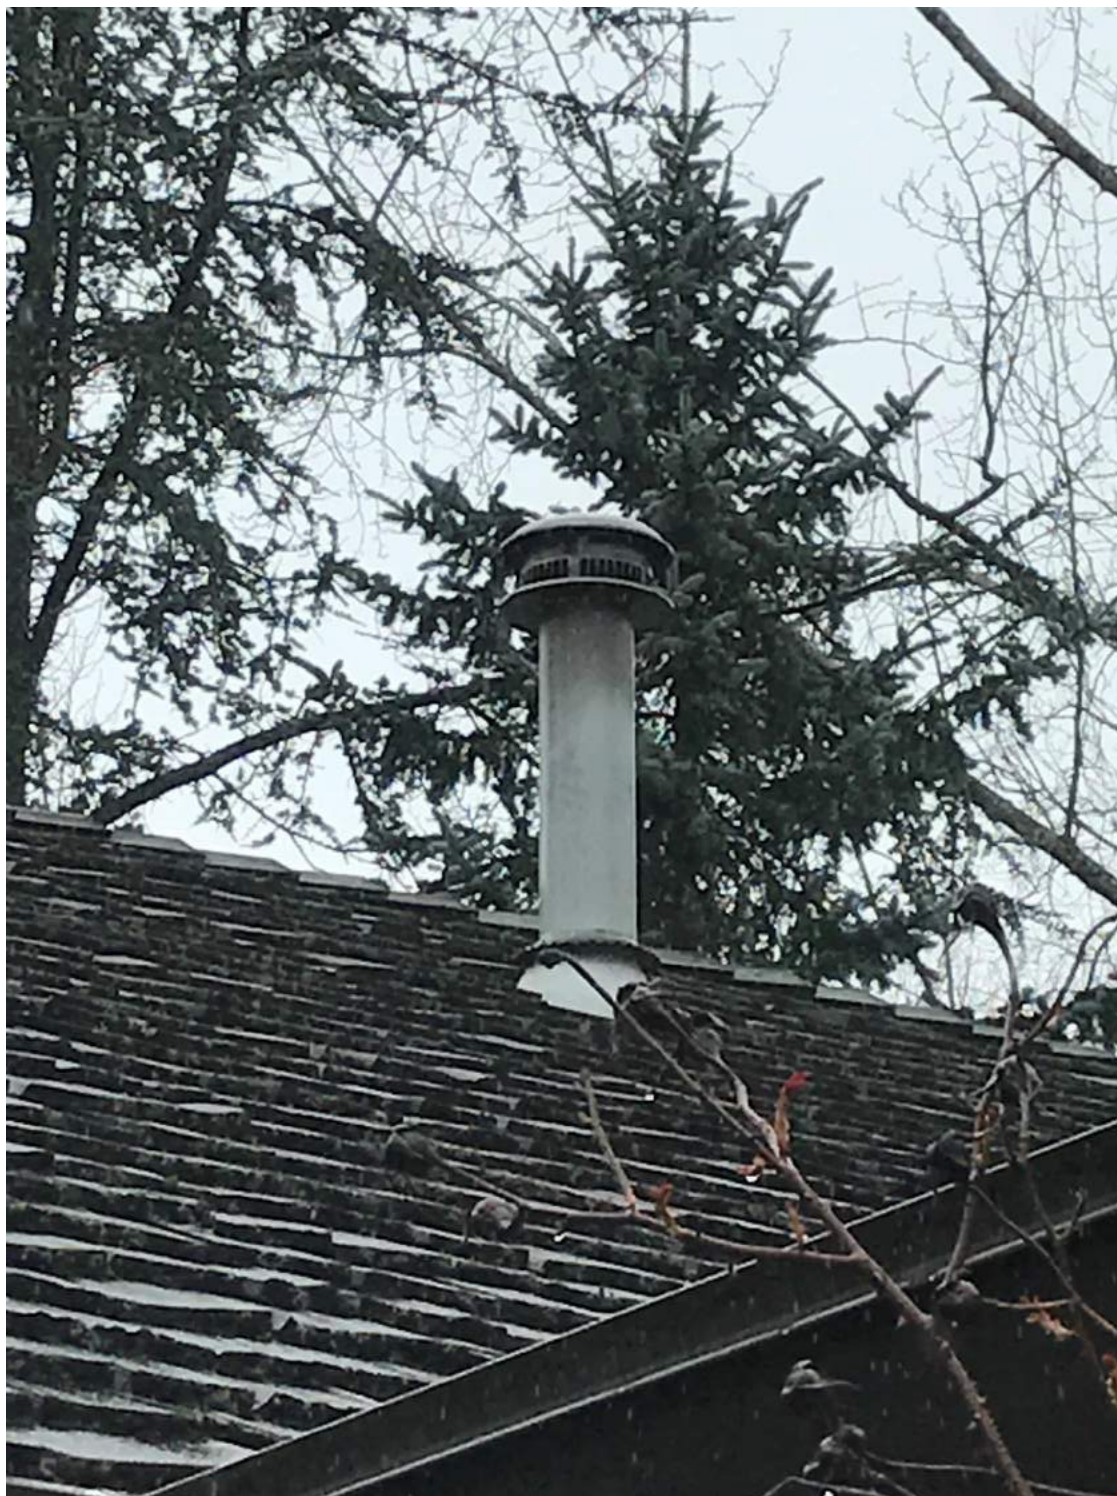
<p>- The roof cap of the venting system showed signs of sooting beyond what would be expected from a normally operating gas appliance. This would suggest that it may have been conducting smoke from the fire for a while before the fire was noticed.</p>
	<p>Causes and Contributing Factors</p>	<p>The most likely cause of the fire was pyrolysis of the floor due to excess heat from the boiler.</p> <p>A partially blocked heat exchanger most likely contributed to this fire by radiating excess heat to the floor, coupled with increased run time due to the failed pressure relief valve, speeding up pyrolysis.</p> <p>If the boiler were firing with a 2PSIG supply pressure for an extended period of time before damage to the gas valve occurred and was noticed, this may have contributed to pyrolysis of the floor prior to any repairs being performed.</p> <p>The possibility exists that the service tech may have incorrectly adjusted the manifold pressure of the gas valve. If this were the case and the boiler was firing with excessive manifold pressure it certainly would have contributed to pyrolysis and ignition of the floor. However a conflict between the service tech's statement and onsite findings makes it impossible to rule this in or out.</p>

Figure 7: Roof termination for boiler, showing sooting beyond what would be expected from this type of appliance if it were burning properly.

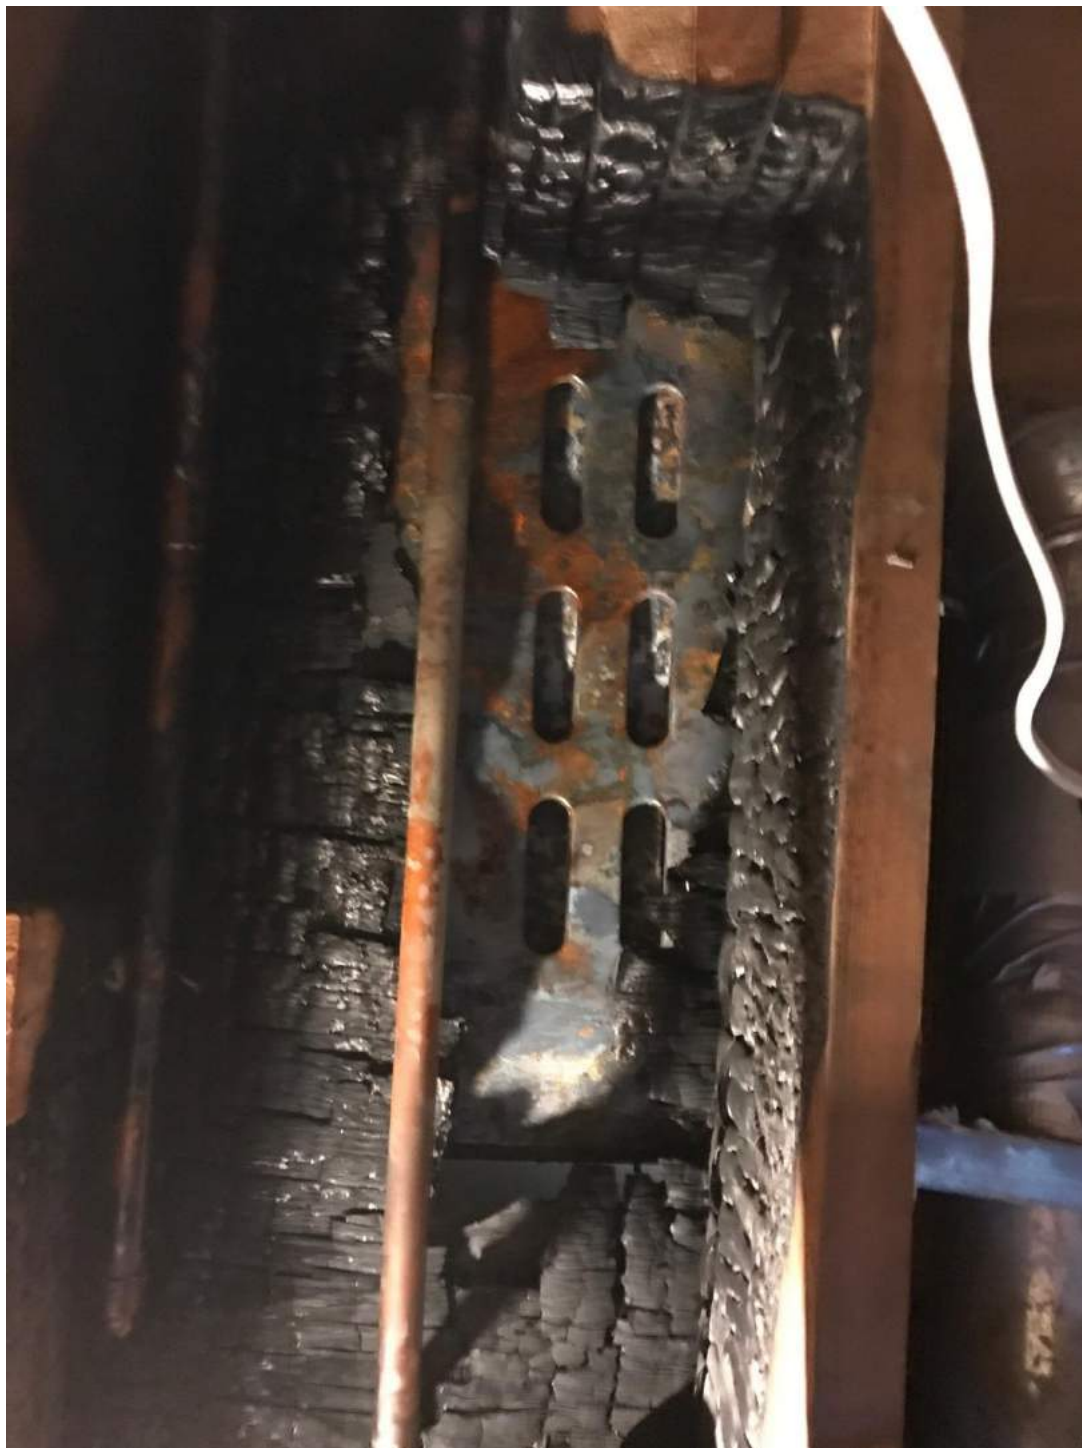
<p>Facts and Evidence</p>	<ul style="list-style-type: none"> - Burn marks and fire trails were all localized to the floor below the boiler, with the most significantly burnt areas centralized to directly below the middle of the boiler. - An invoice from the service contractor states that the gas valve and 2lb regulator were replaced, and that "[The] Gas regulator had damaged original gas valve on [The] boiler causing failure" - A test performed by the gas fitter who was on site at the time of investigation found that the boiler was operating with a manifold pressure of 5.5-5.6" WC. Where the manufacturers rating plate called for a manifold pressure of 3.5"WC. however the gas valve may have been exposed to fire damage which may have put this reading off. - Inspection of the boiler found the heat exchanger to be partially plugged with soot. - Interviewed the service technician who performed the work. When asked what work he performed, he stated exactly what was done, he also added that he checked and adjusted the gas valve to manufacturer's specifications at 3.5" WC. However this is not noted on the invoice. - Upon inspection it was found that the boiler's pressure relief valve had failed and was leaking into the drain for the water heater. Furthermore the boiler's make-up water was piped into the cold line (which is a normal practice) which after time would have caused very cold water to be introduced into the system.

Figure 8: Fire damage below boiler.
