Incident Summary #II-957403-2019 (#16160) (FINAL)

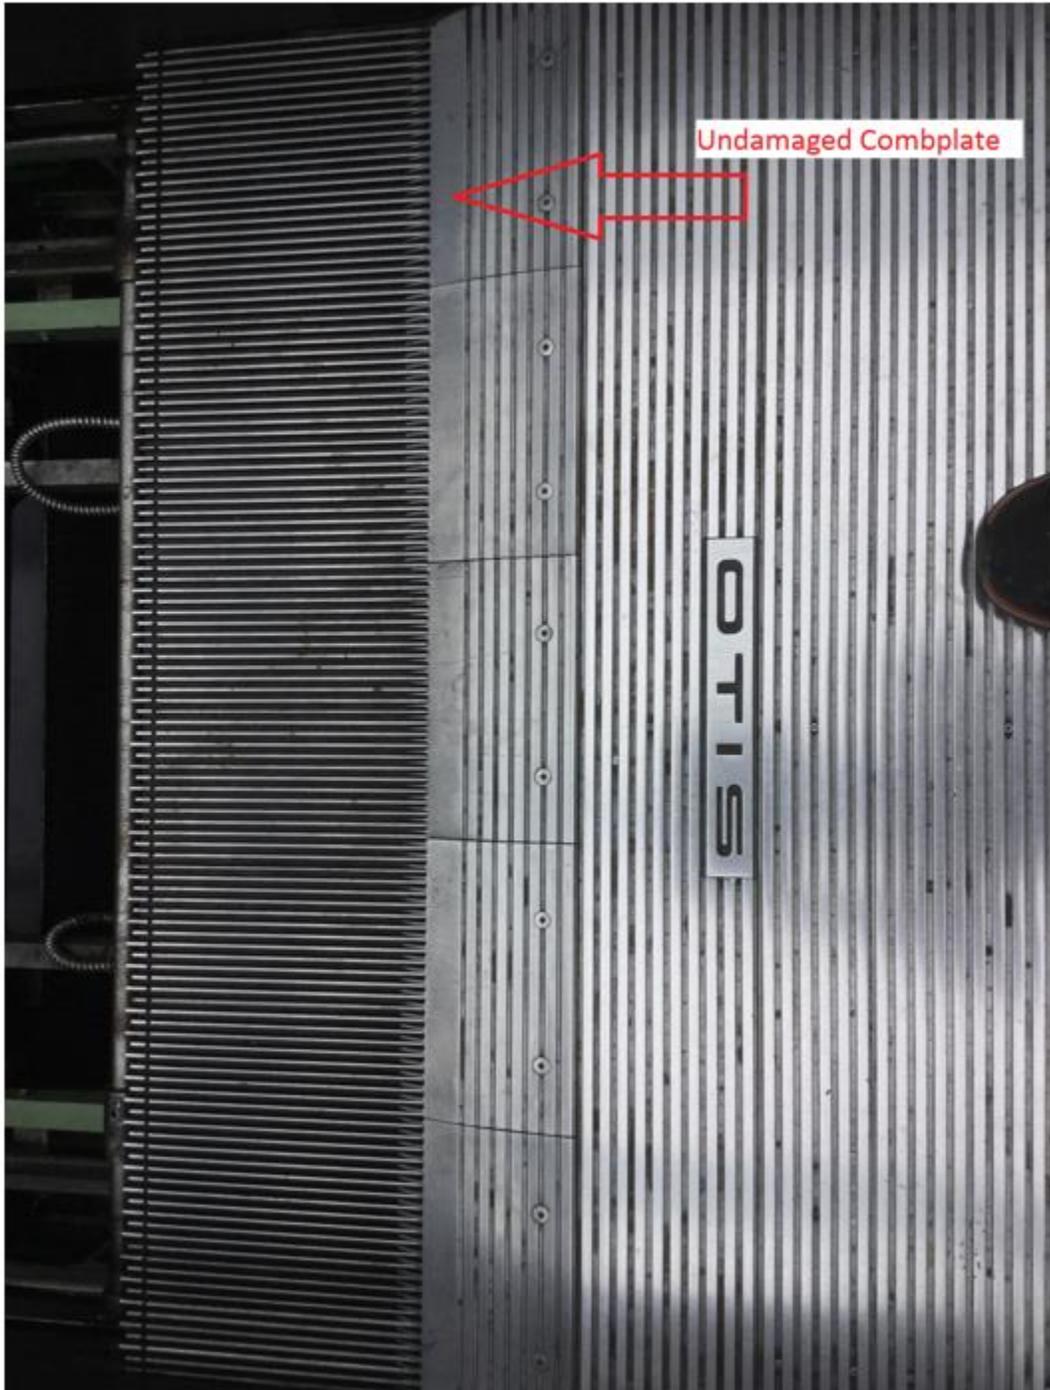
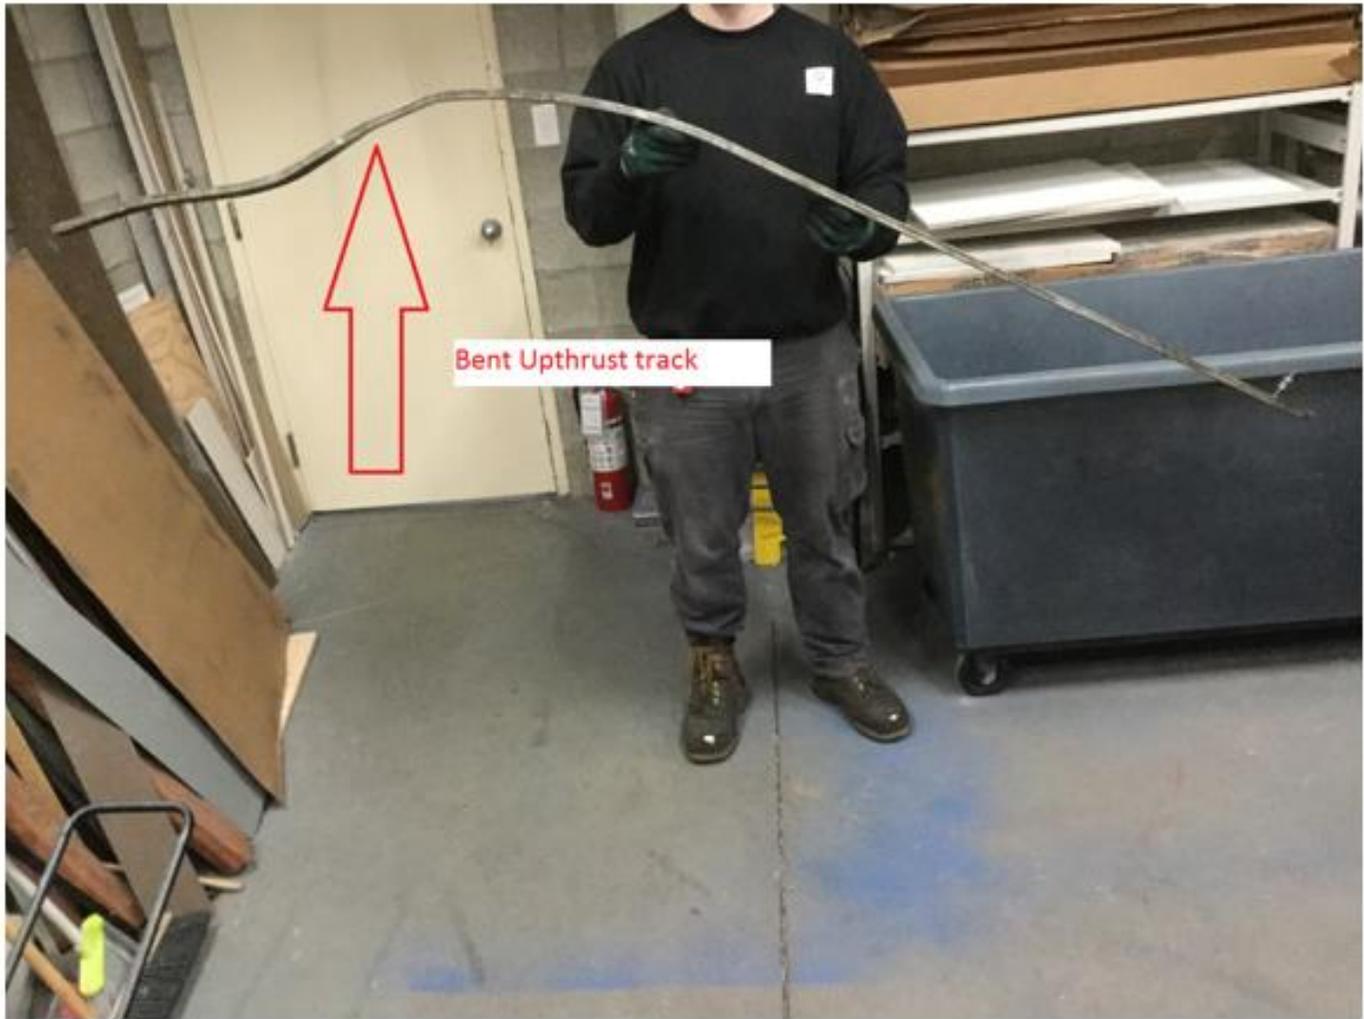
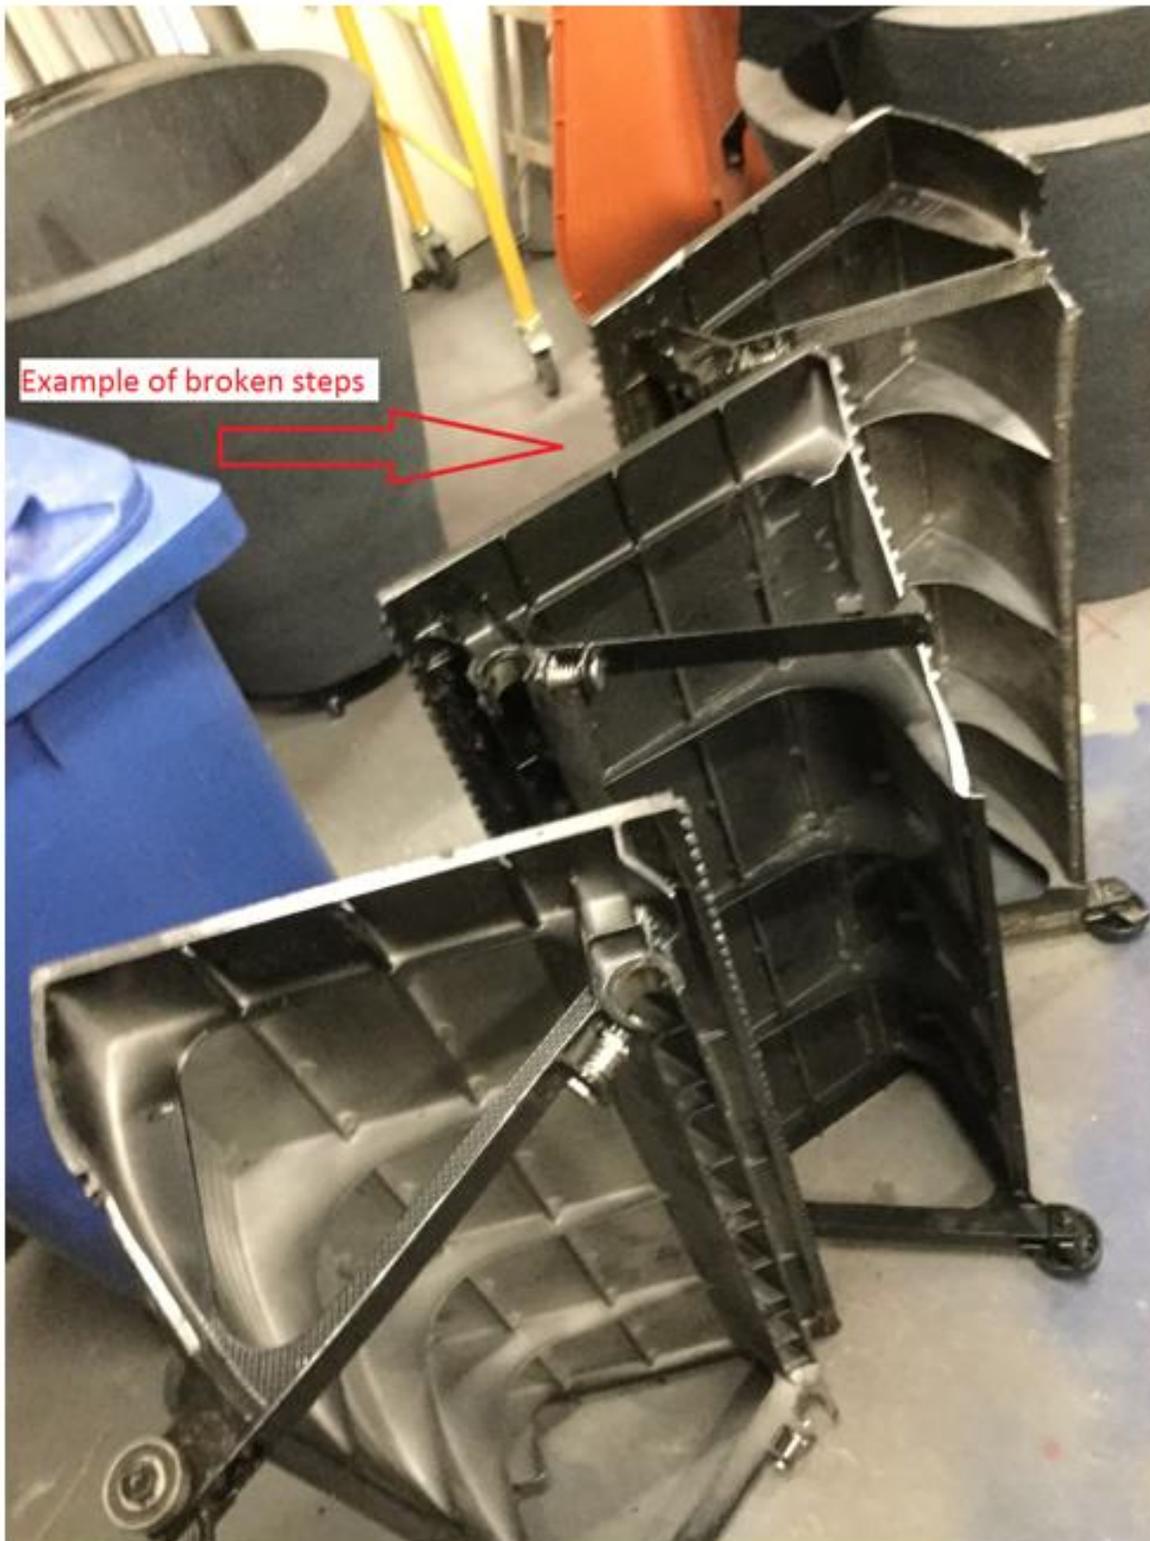
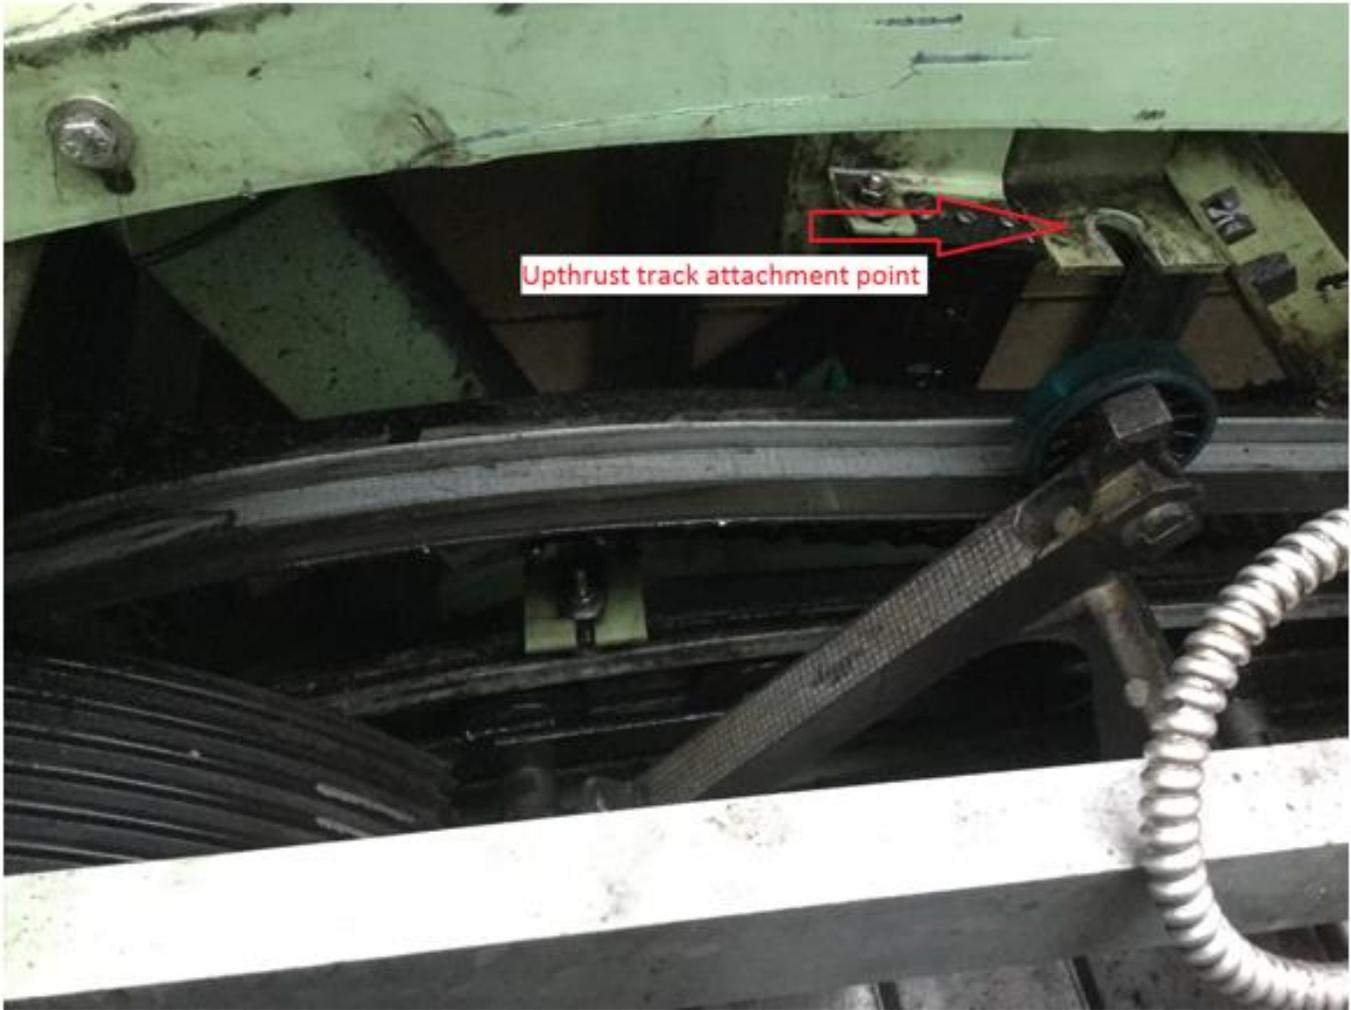
Failure scenario(s)	A mounting bolt on the up-thrust guide track at the top landing transition became loose. The guide track dropped down and caught multiple steps as they passed by, damaging the steps. A passerby heard loud noises coming from the escalator and pressed the emergency stop button, stopping the escalator.	
	Facts and evidence	Evidence observed during on-site investigation:

<p>Causes and contributing factors</p>	<p>It is possible that during a recent repair, the up-thrust track fastener was not adequately tightened after adjustment, leading to the failure of the up-thrust track. It is likely that the up-thrust track came loose and subsequently dislodged during operation leading to the damaged steps. It is possible that during the initial inspection by the maintenance contractor that they damaged more steps by operating the escalator. It is certain that the passerby limited the damage to the escalator by pressing the emergency stop button during the initial incident.</p>
